## **DRAFT** **PROJECT SCOPING REPORT/ FINAL DESIGN REPORT**

October 2011

Bridge Project  
P.I.N. 4754.78      BIN: 3317400  
Edgewood Avenue over Allen Creek  
Monroe County  
Town of Brighton

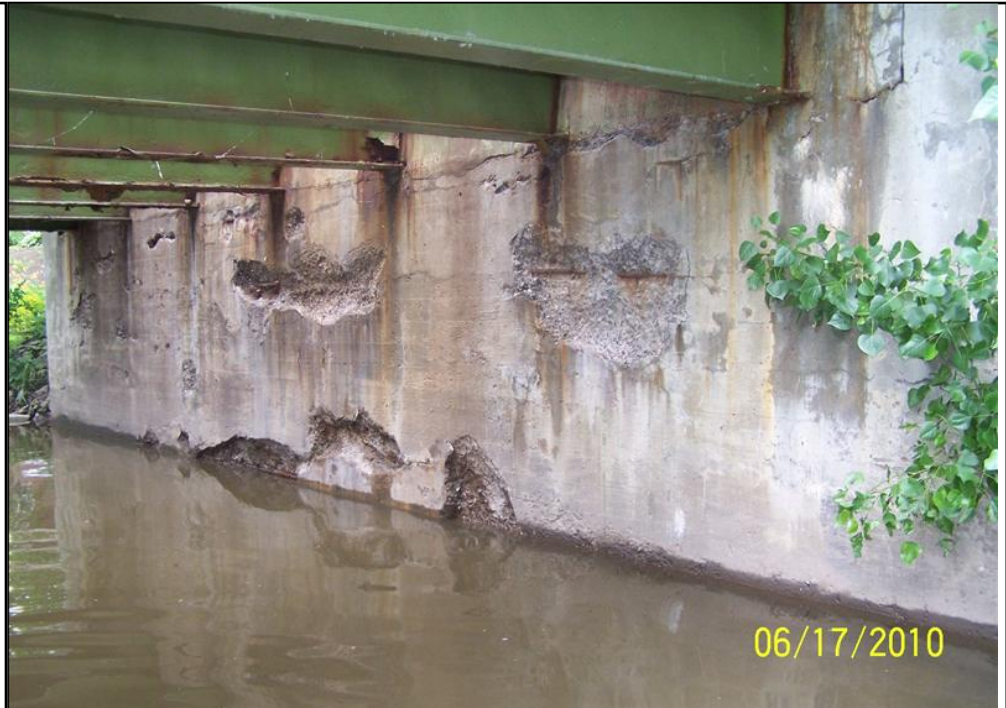
Photo Number: 1

End Abutment

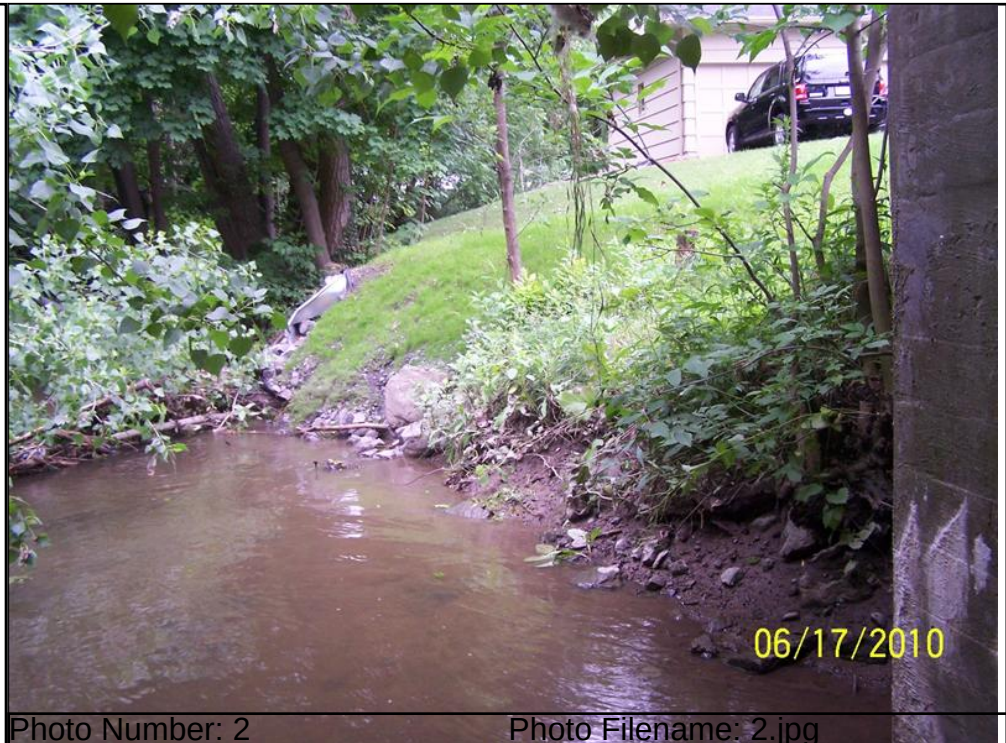
Photo Number: 2

Begin Right Bank

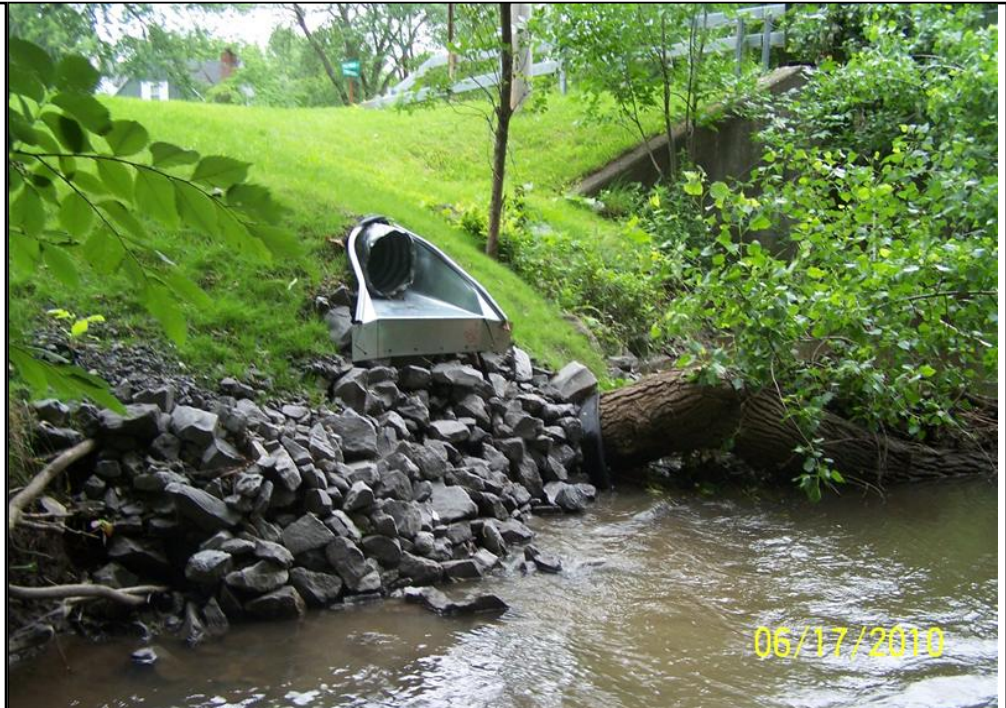
Photo Number: 3

Begin Right Bank Away  
From Bridge

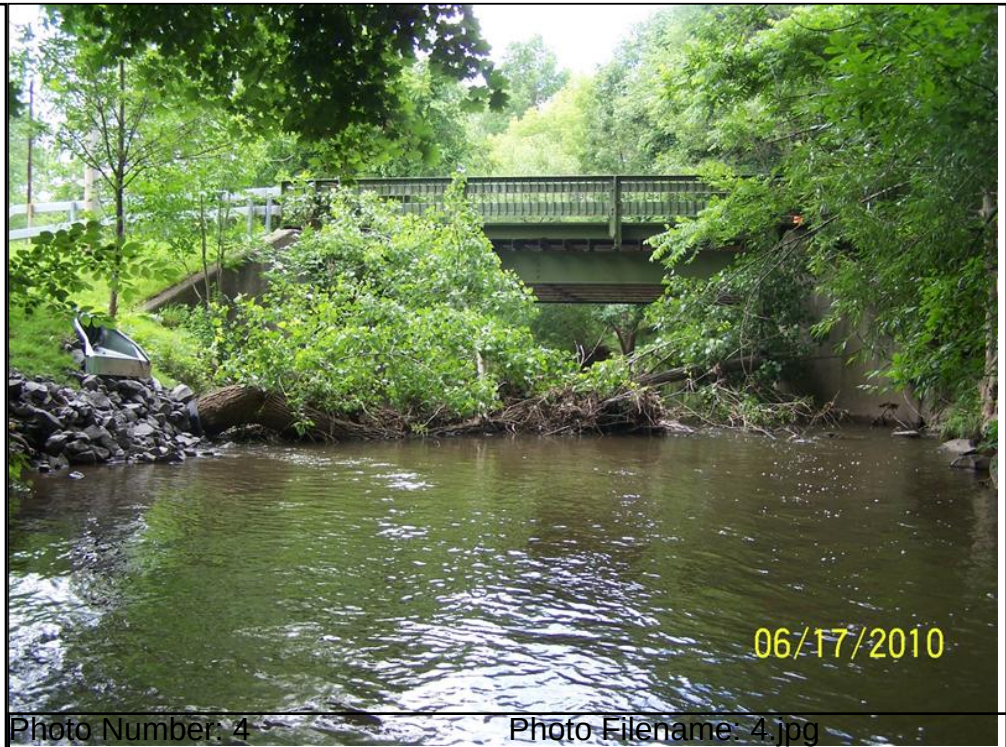
Photo Number: 4

Downstream (Right)  
Elevation

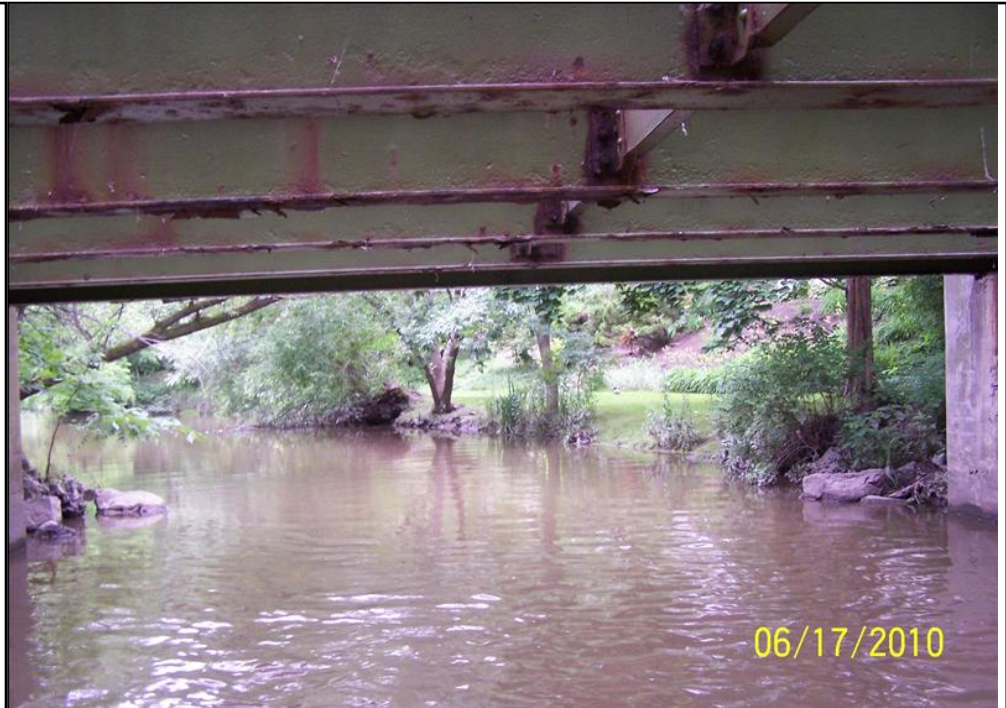
Photo Number: 5

Upstream (Left) Channel

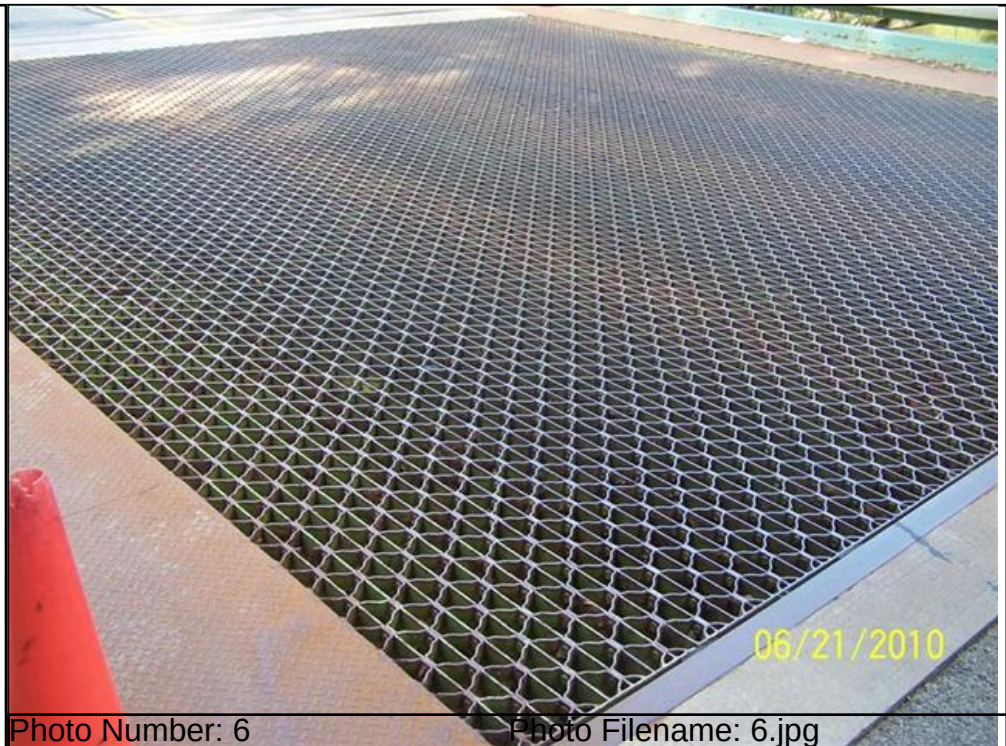
Photo Number: 6

Wearing Surface from  
End Right

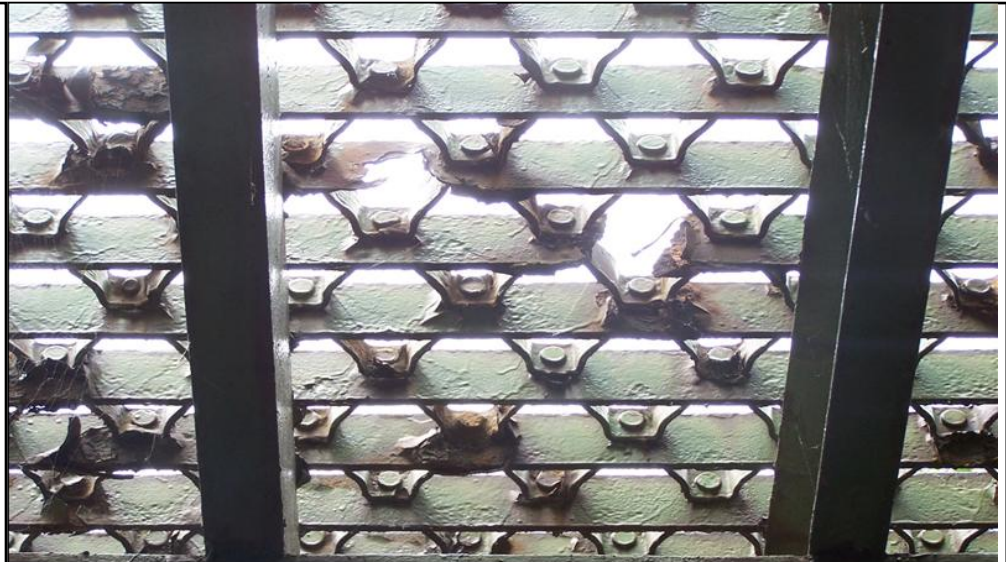
Photo Number: 7

Girder Bay 6 - 8th  
Sleeper Bay from End

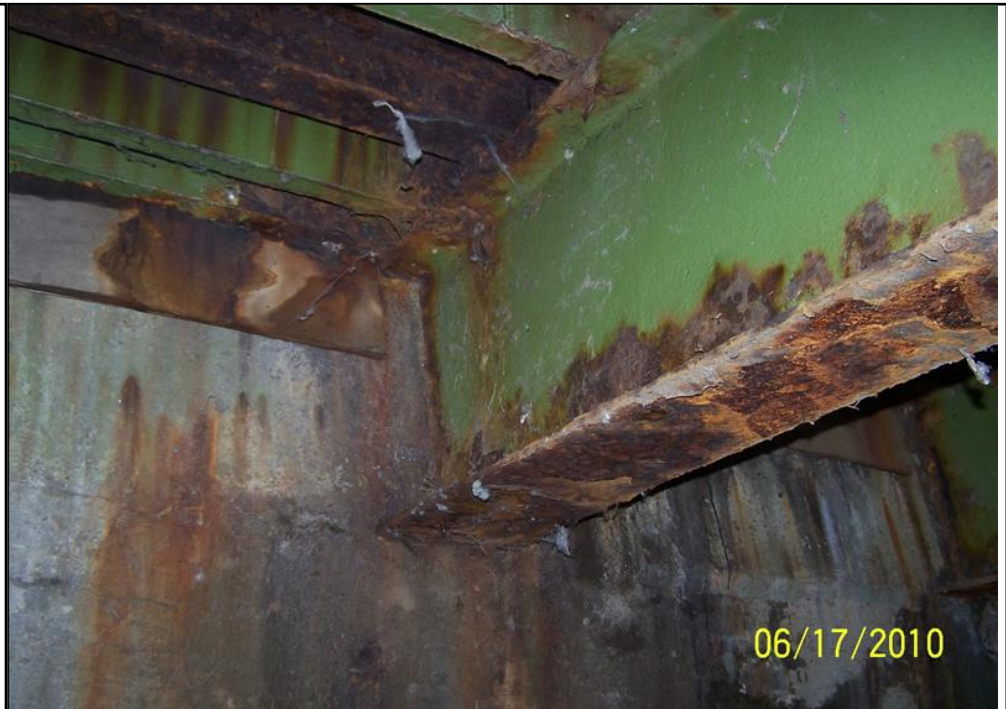
Photo Number: 8

G4 at Begin

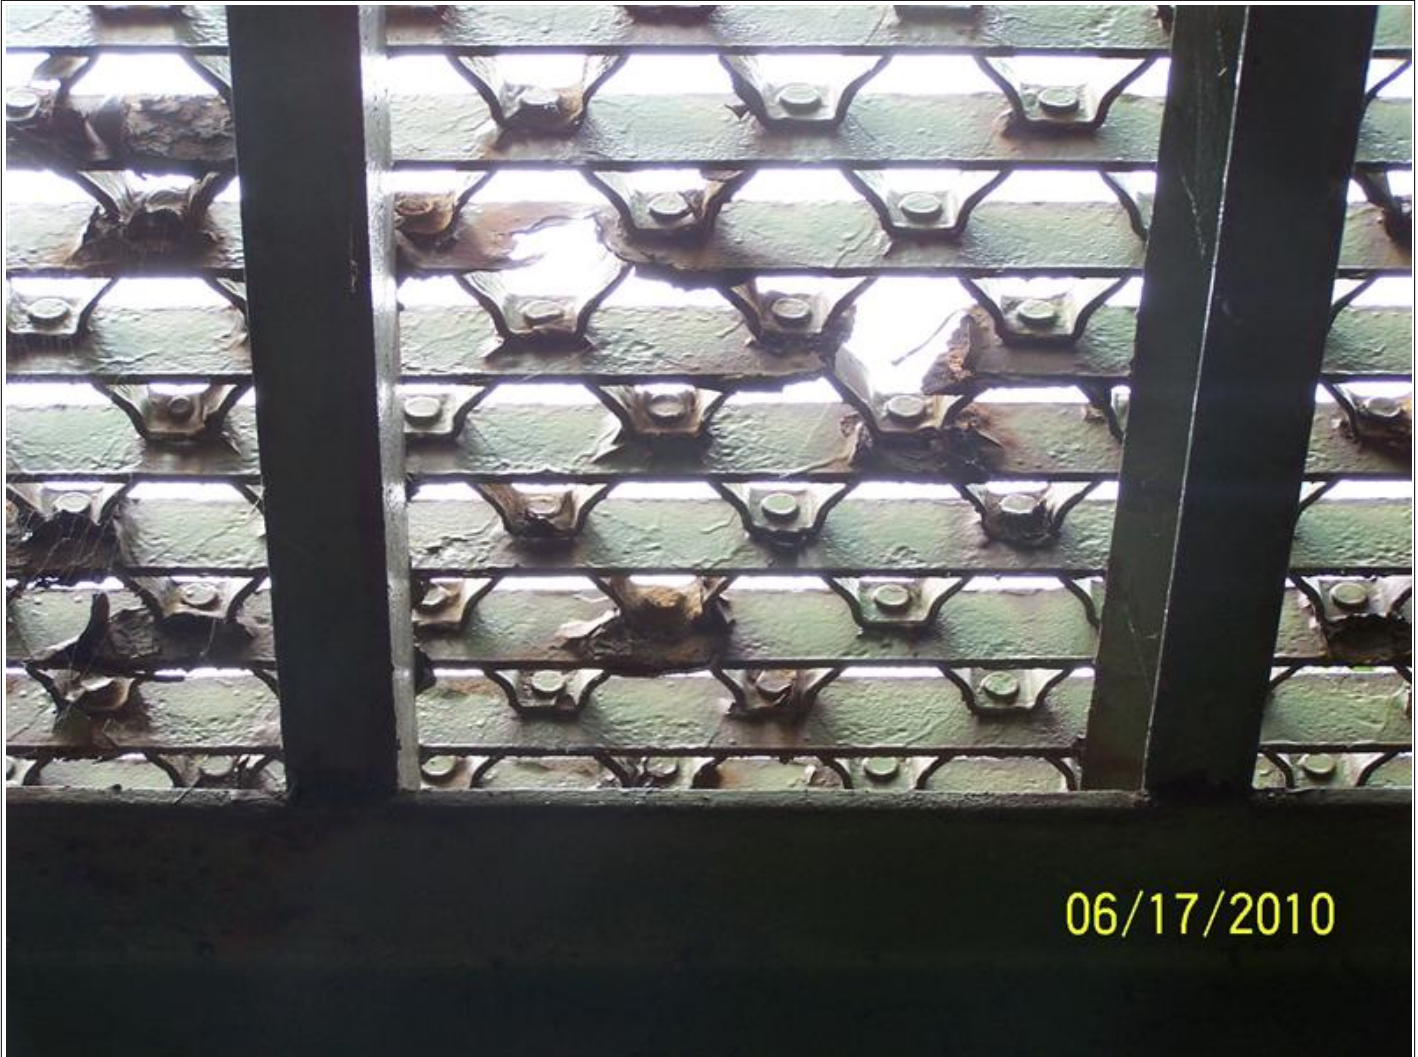
7.jpg - Attached to Safety Flag 41100014

Girder Bay 6 - 8th Sleeper Bay from End
