PUBLIC WORKS COMMITTEE MEETING

NOVEMBER 1, 2022 - 9:00 A.M.

DRAFT AGENDA

A Photographic Guide to the Evaluation of Hazard Trees in Urban Areas TREE HAZARD EVALUATION FORM 2nd Edition

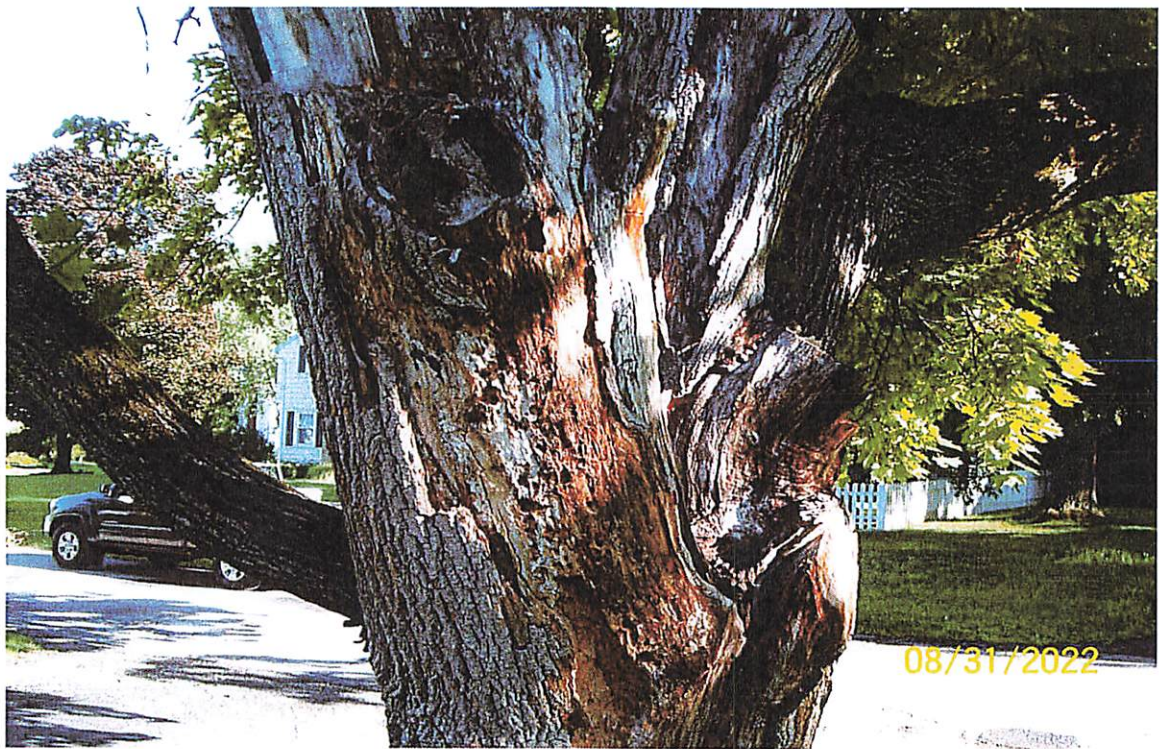
Immediate Hazard, Needs to be Removed. Severe, Deadwood, Decay and insect Damage. Recent Failure to Lean in August of 2022.

SEVERE DECAY, ROT, DEADWOOD AND INSECT DAMAGE TO ENTIRE TRUNK AND INTO MAIN LEADS.

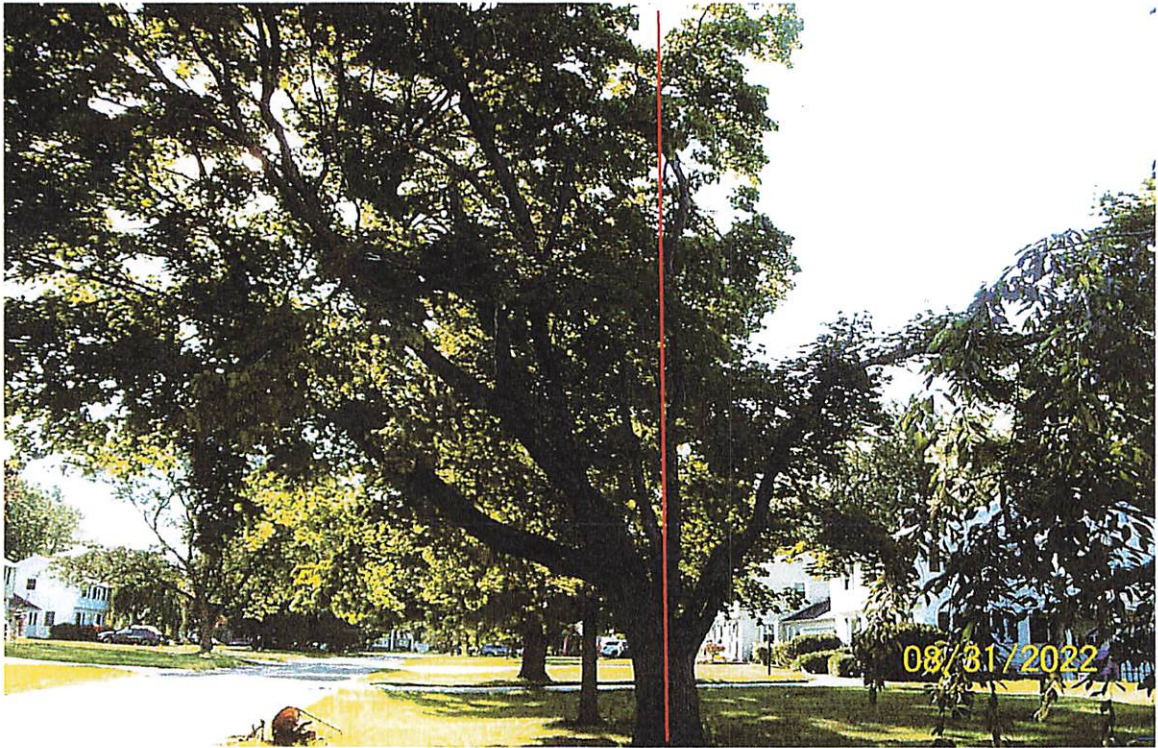
SEVERELY UNBALANCED LOAD ON REMAINING TREE TRUNK (POTENTIAL HAZARD)

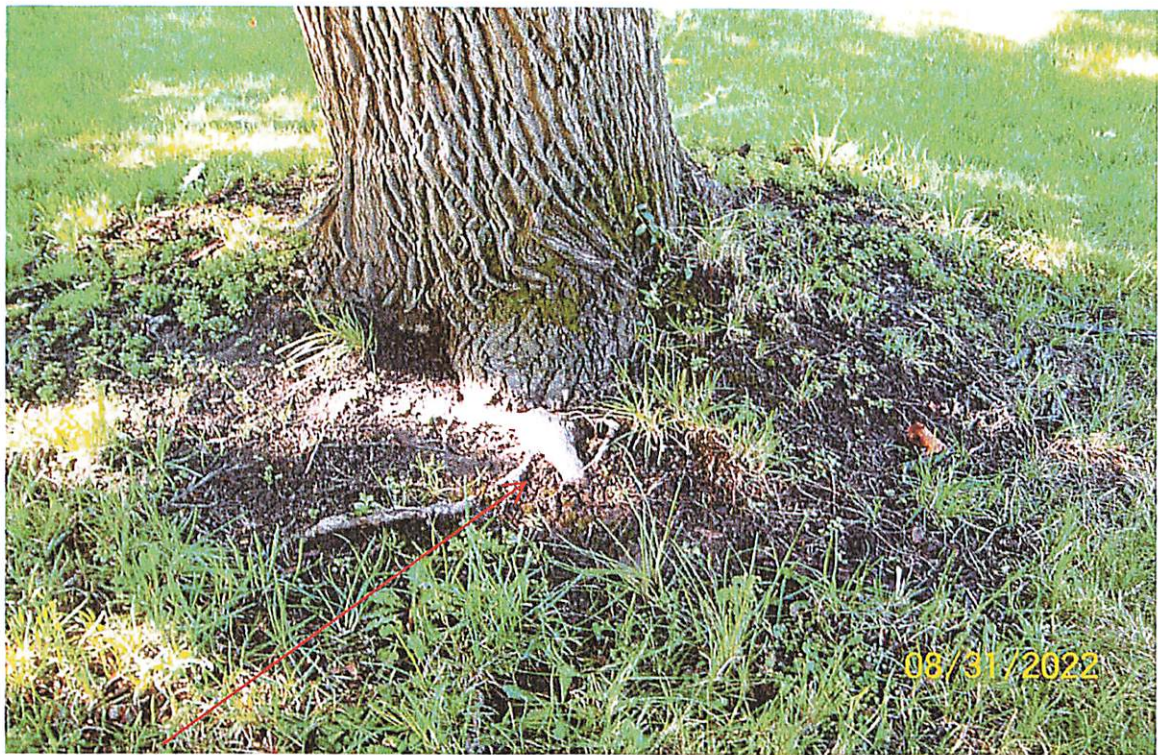
GIRDLING TREE ROOTS

8/22 RECENT DAMAGE / HAZARD

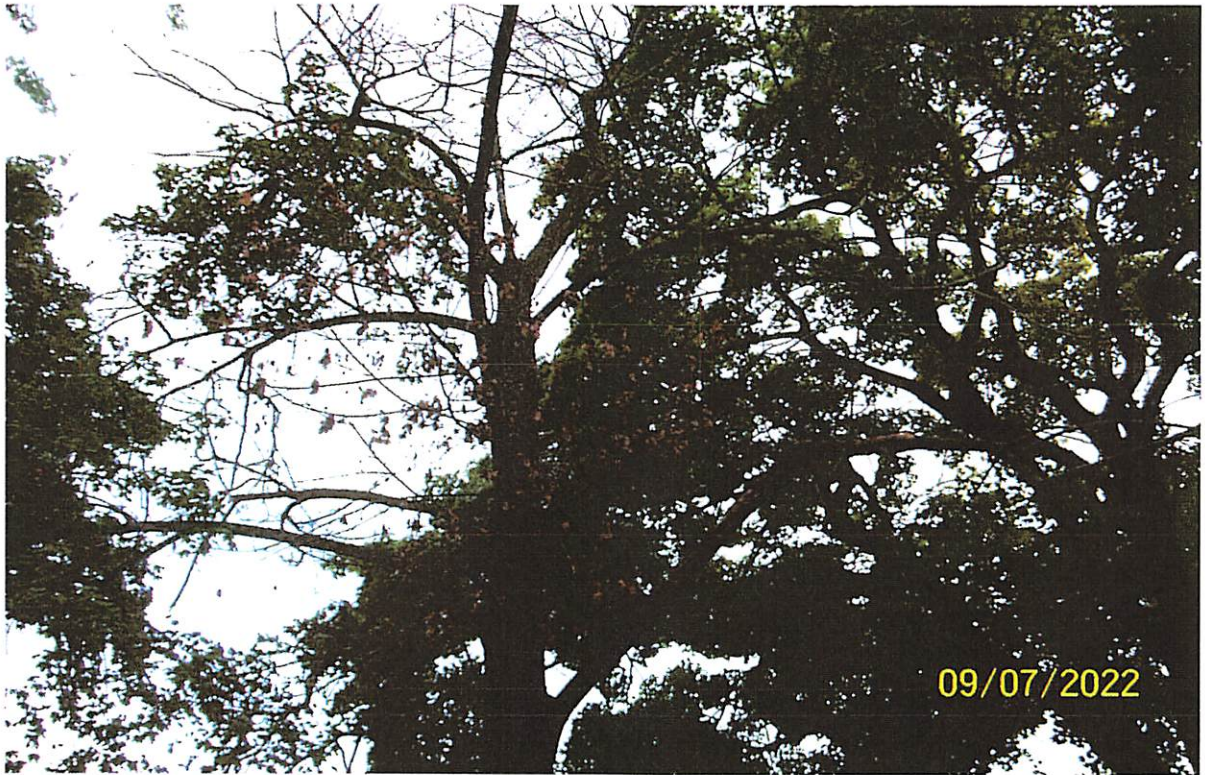
Tree needs to be Removed (DEAD), Neighboring trees are dominating sunlight and canopy growth. Trees in area are not properly spaced for species of trees. (mainly Silver Maples & Norway Maples)

ADJACENT TREES DOMINATING SUNLIGHT AND GROWTH FOR CANOPY

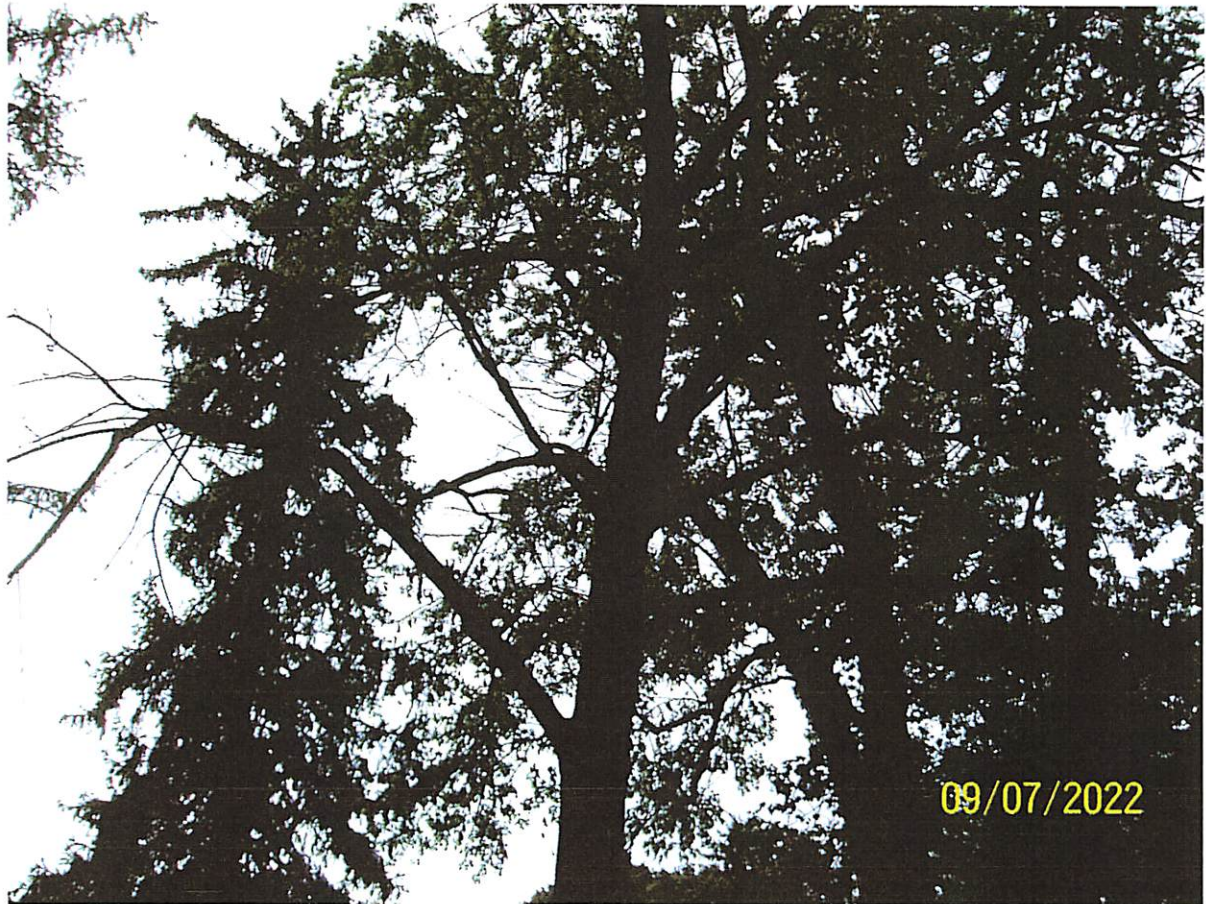
DEAD LIMBS / BRANCHES & FOLIAGE (ENTIRE TREE)

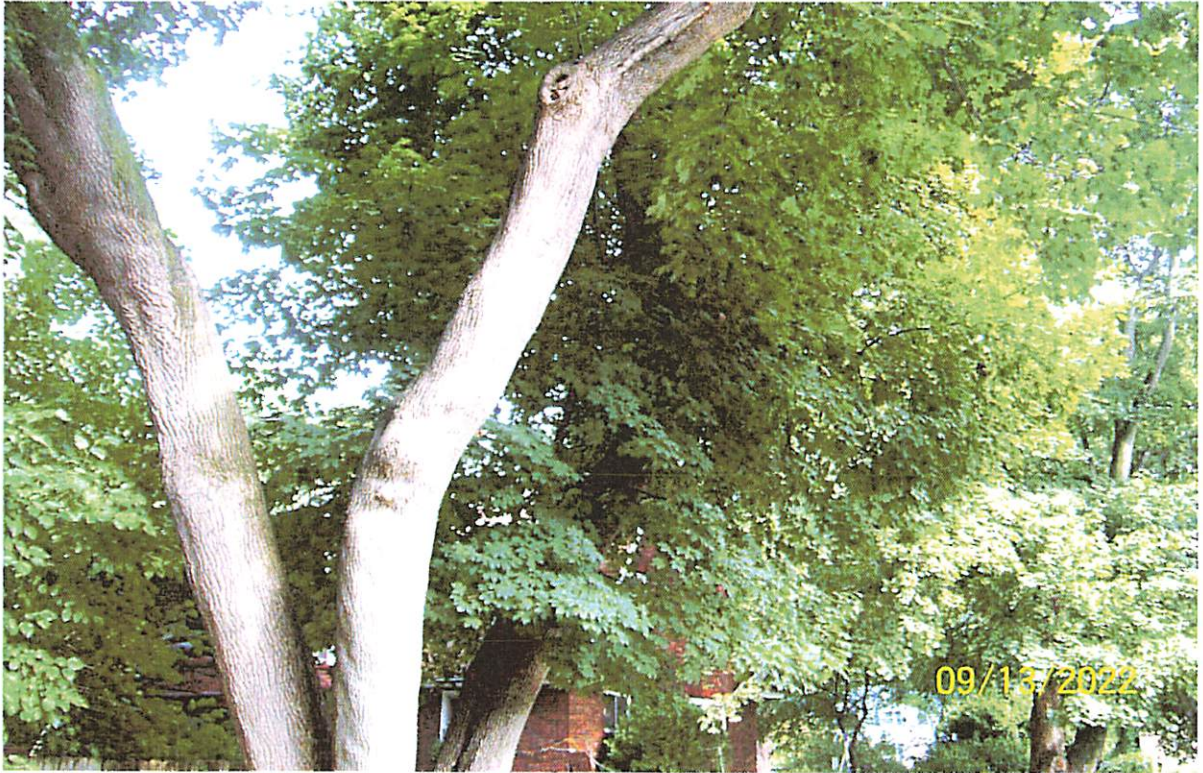
Suggest Removing Northerly Tree TRUNK, Severe Frost Cracking with Decay & Rot. Northerly TRUNK is primarily attached to Dead & decaying Tree stump (previously removed, with severe Decay & Insect infested). EXCESSIVE End weight due to lean of Northerly TRUNK.

ORIGINALLY 4 TRUNKS – 3 REMAINING – SUGGEST THE NORTHERLY TRUNK BE REMOVED

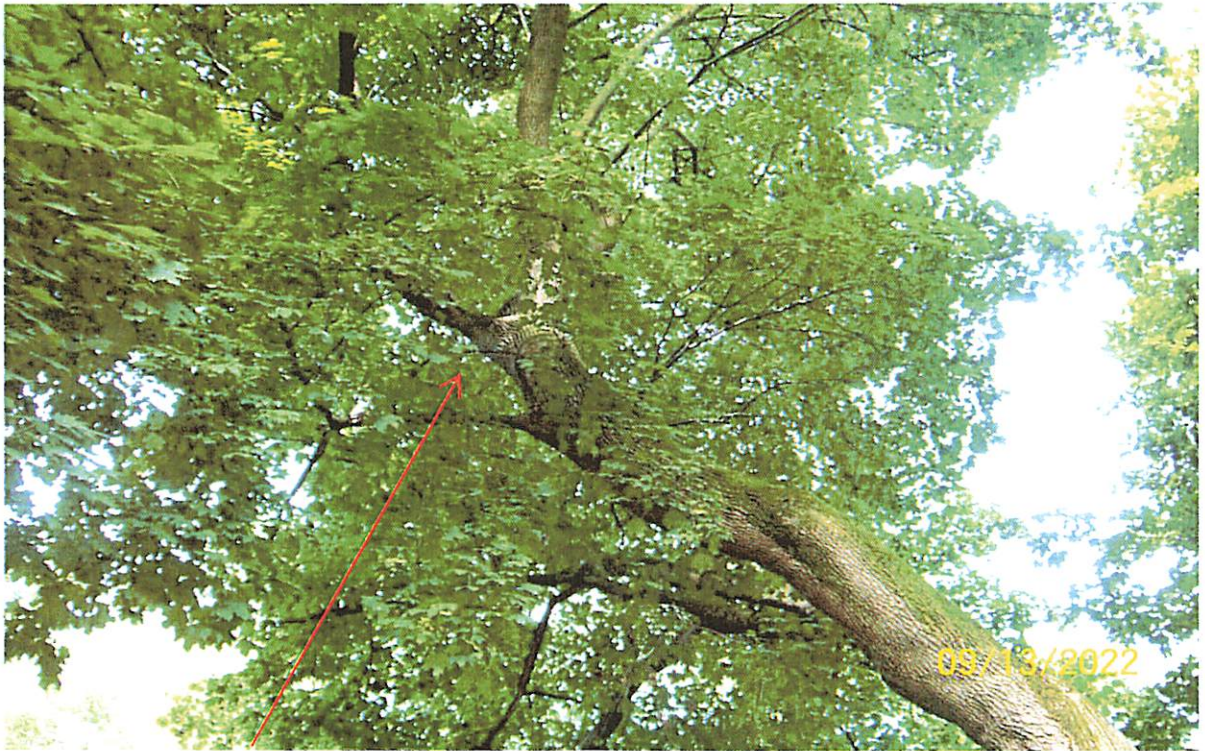
2 SOUTHERLY TRUNKS (FULL FOLIAGE) --- NORTHERLY TRUNK (FULL FOLIAGE W/ POWDERY MILDEW ON LEAVES)

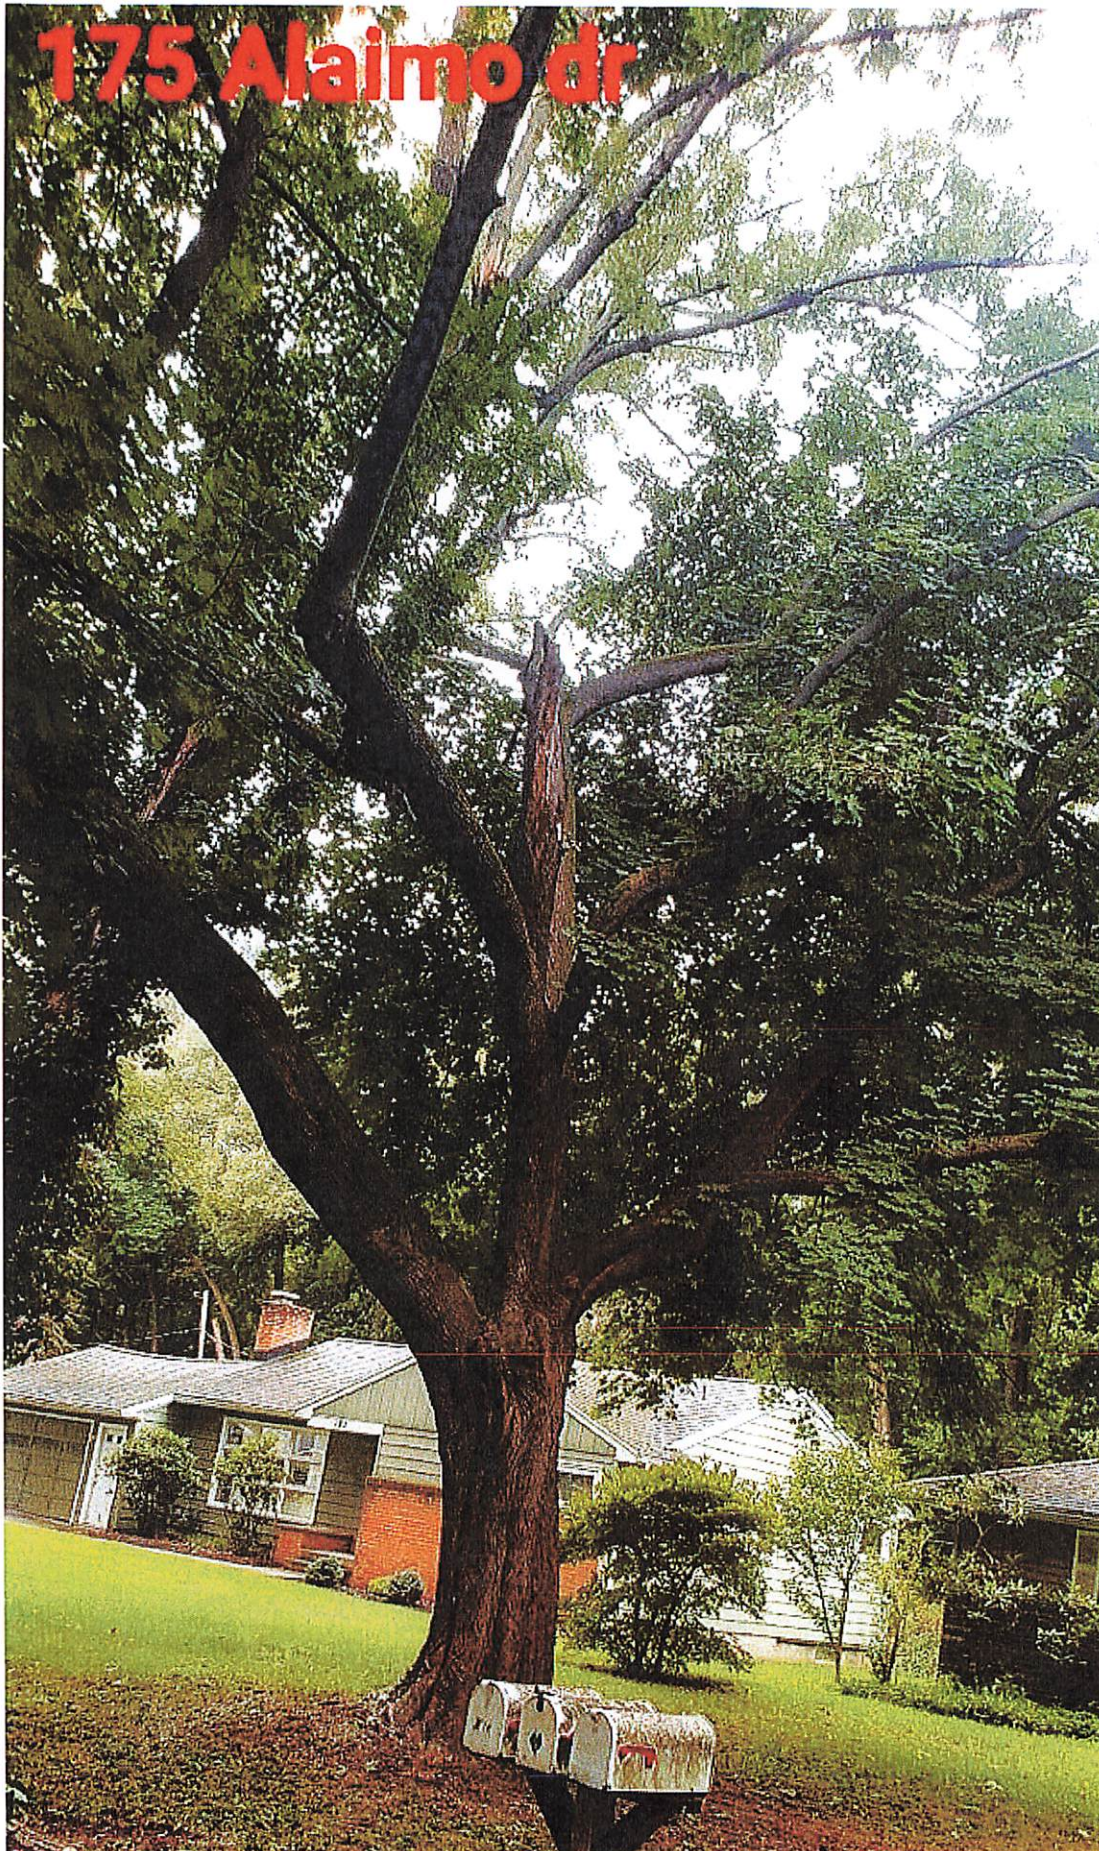
Termite infestation / upper center trunk broke off. length of failed trunk was approximately 20 ft.

Remove tree: ☒ Y ☐ N Replace? ☒ Y ☐ N Move target: Y N Other: _____

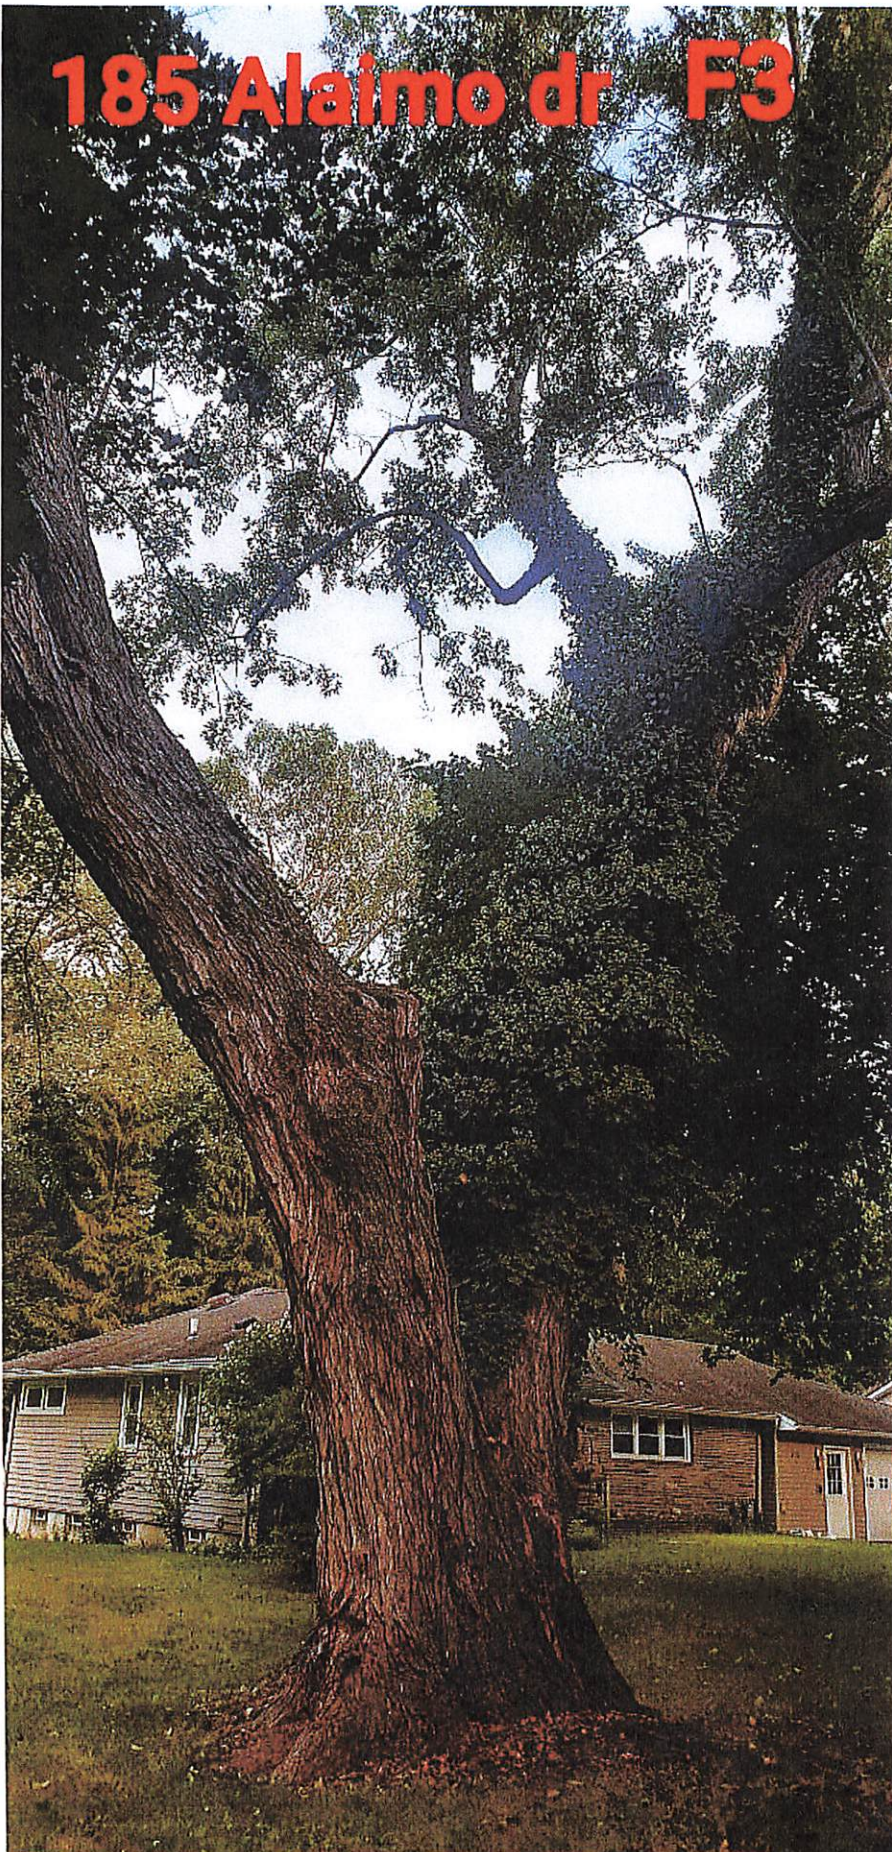
Termite Infestation.
Falling trunks.
