# PUBLIC WORKS COMMITTEE

#### **OLD BUSINESS**

#### **NEW BUSINESS**

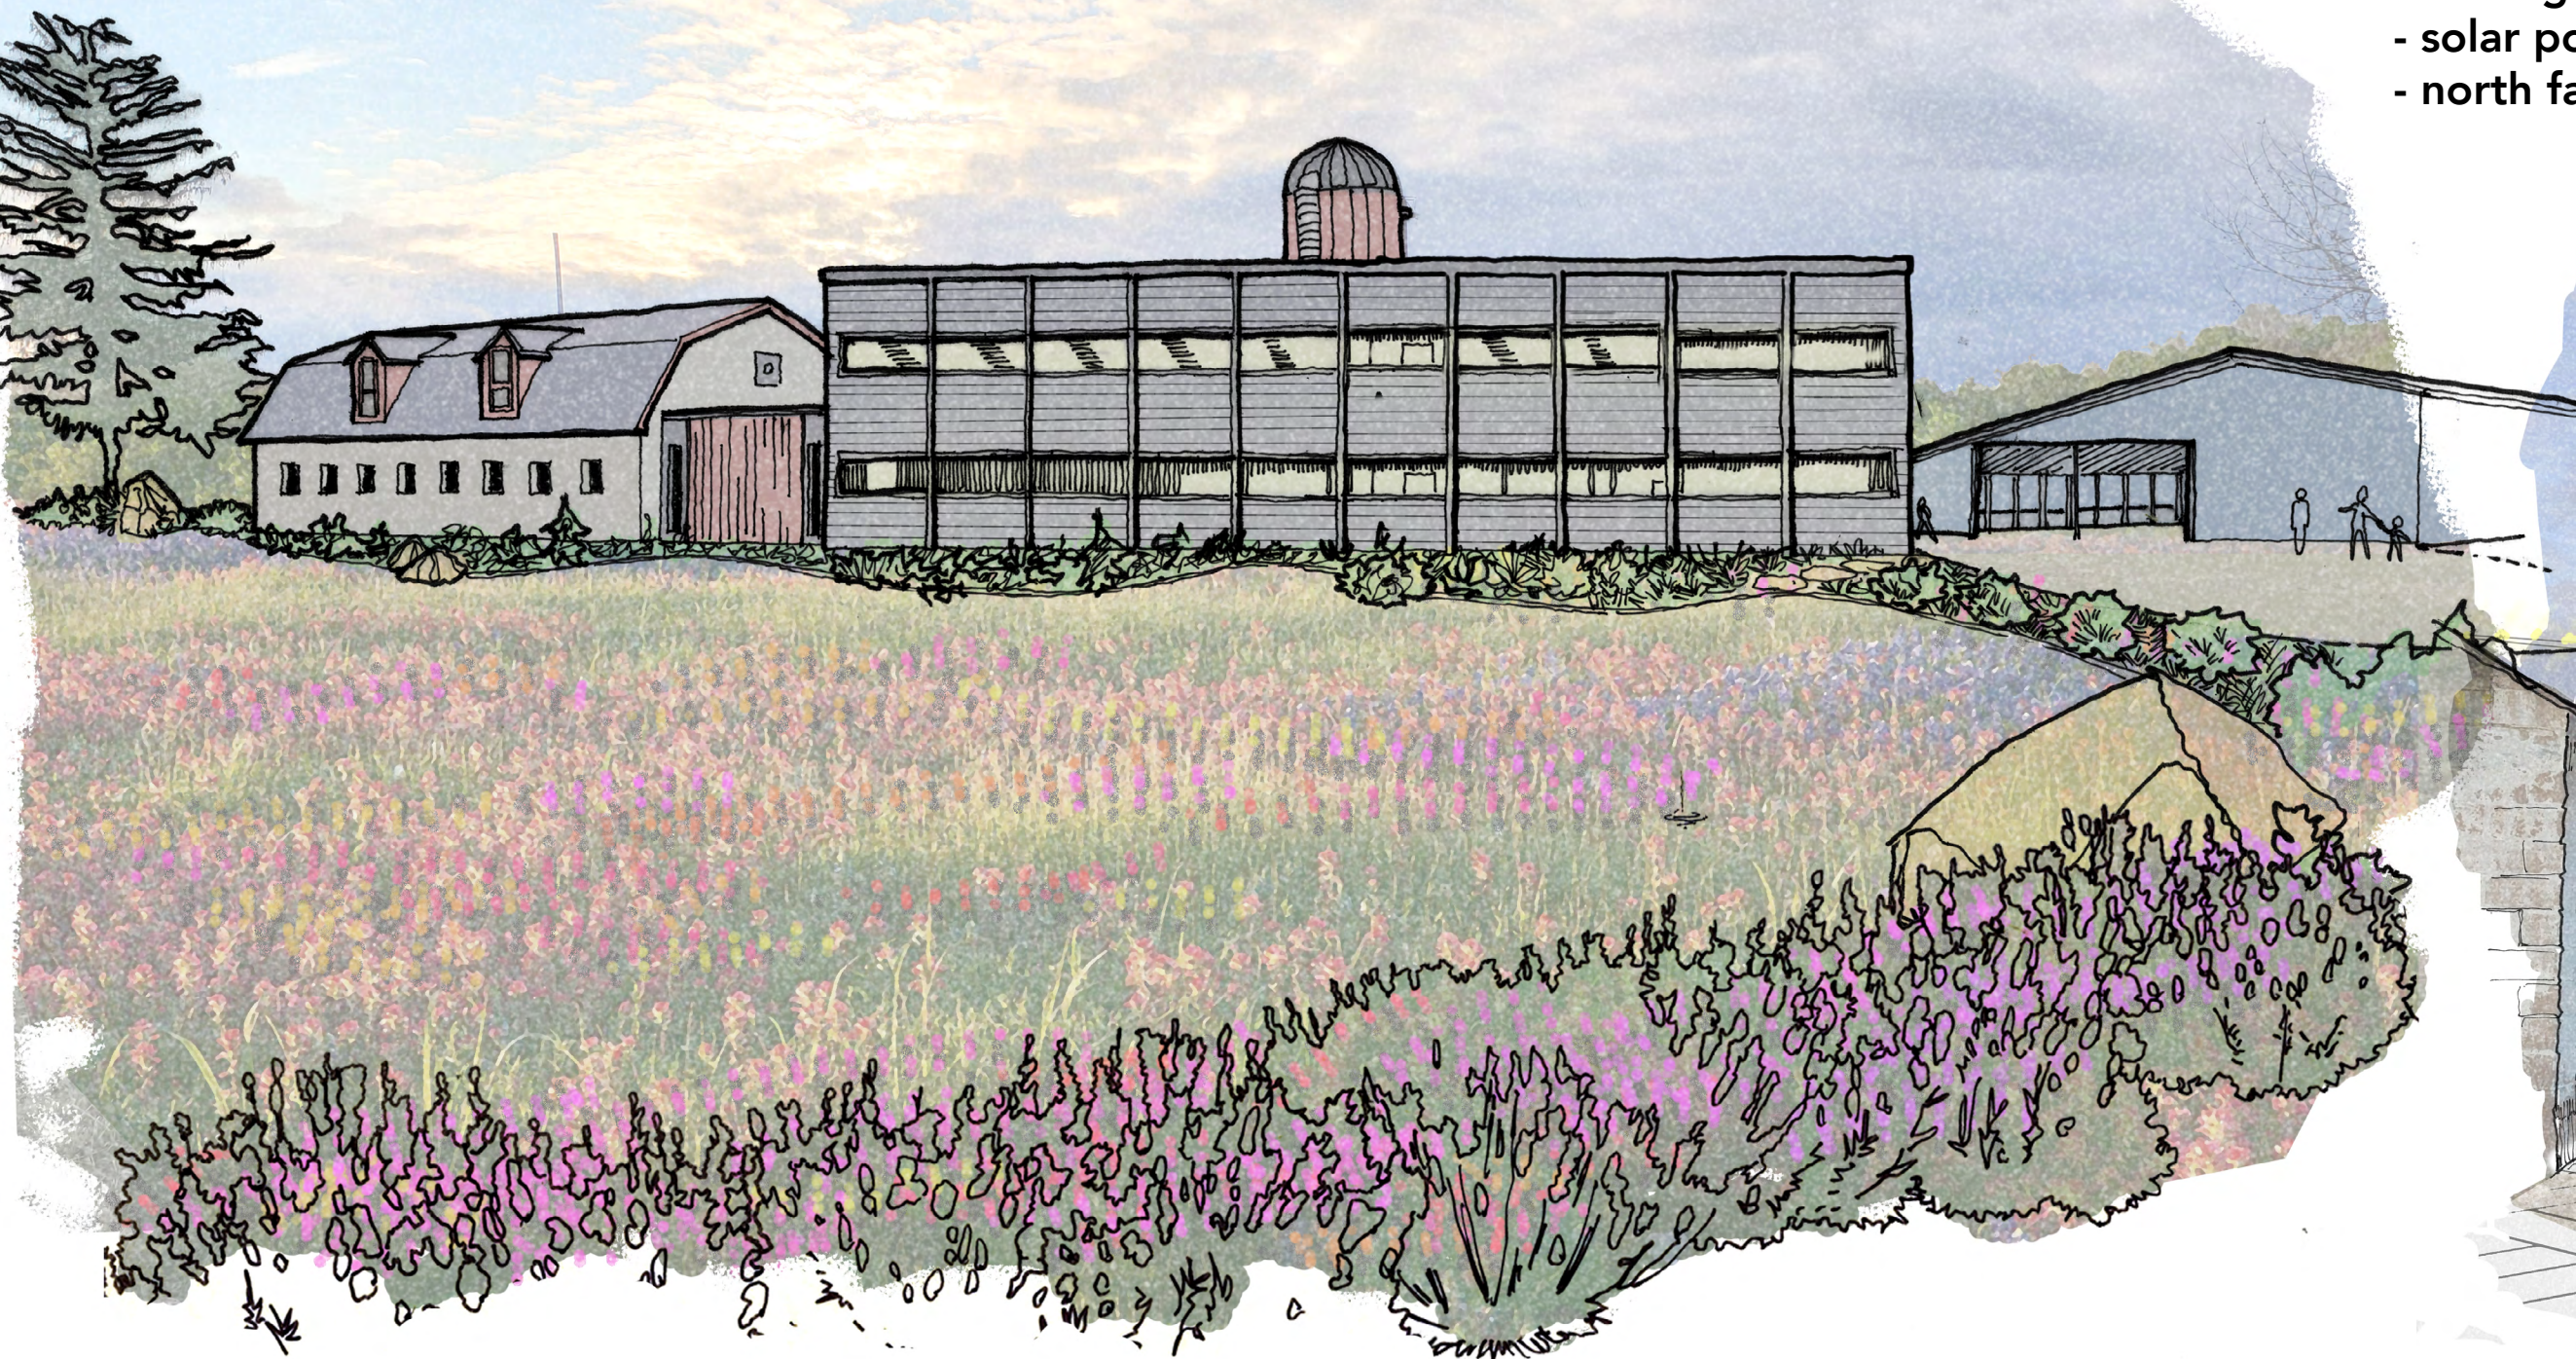
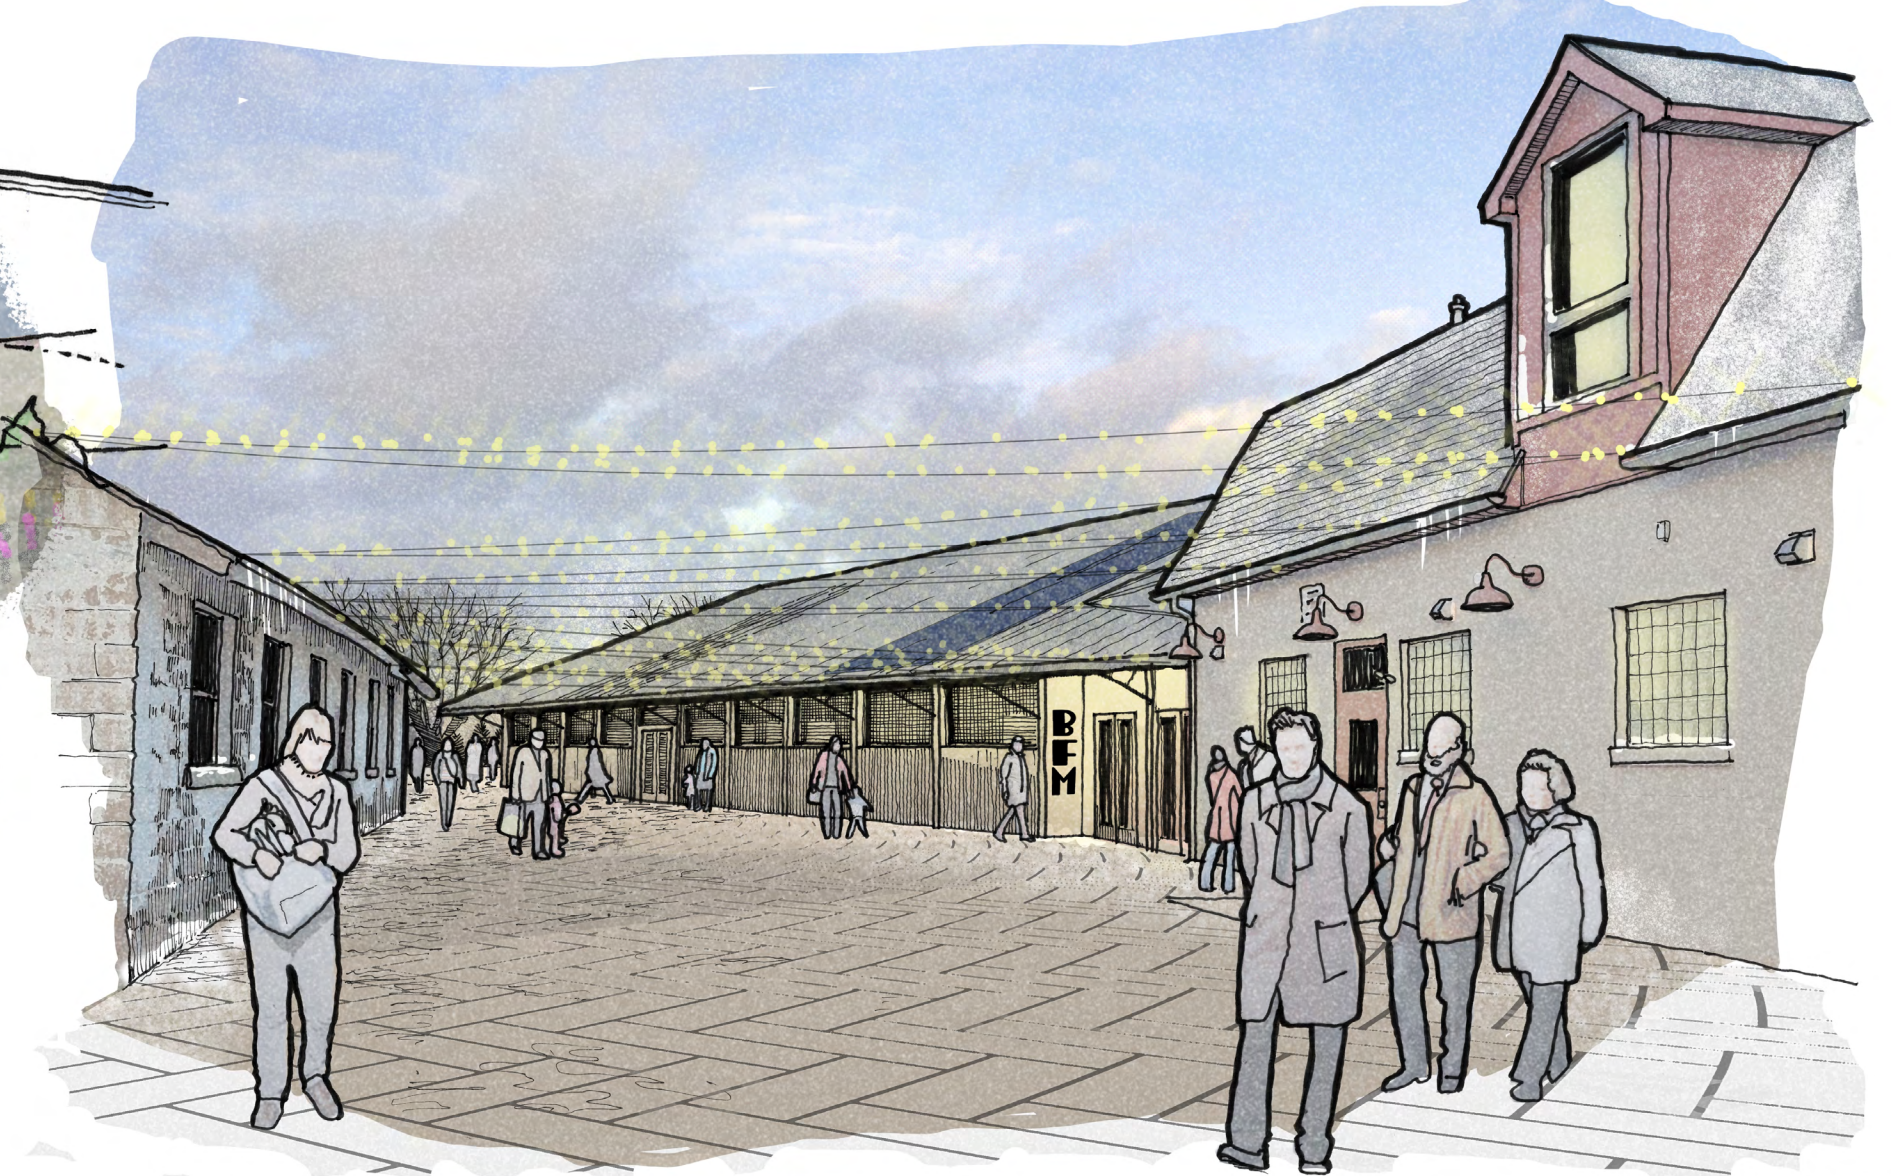
### OPTION A

- north-facing shed roof
- low profile faces market plaza
- deep overhang for protection at entrances and along perimeter of market plaza
- snow guards for snow control
- solar power photovoltaic panels (PV's) on roof
- north facing windows provide consistent light

View from Westfall Road

View from Market Plaza

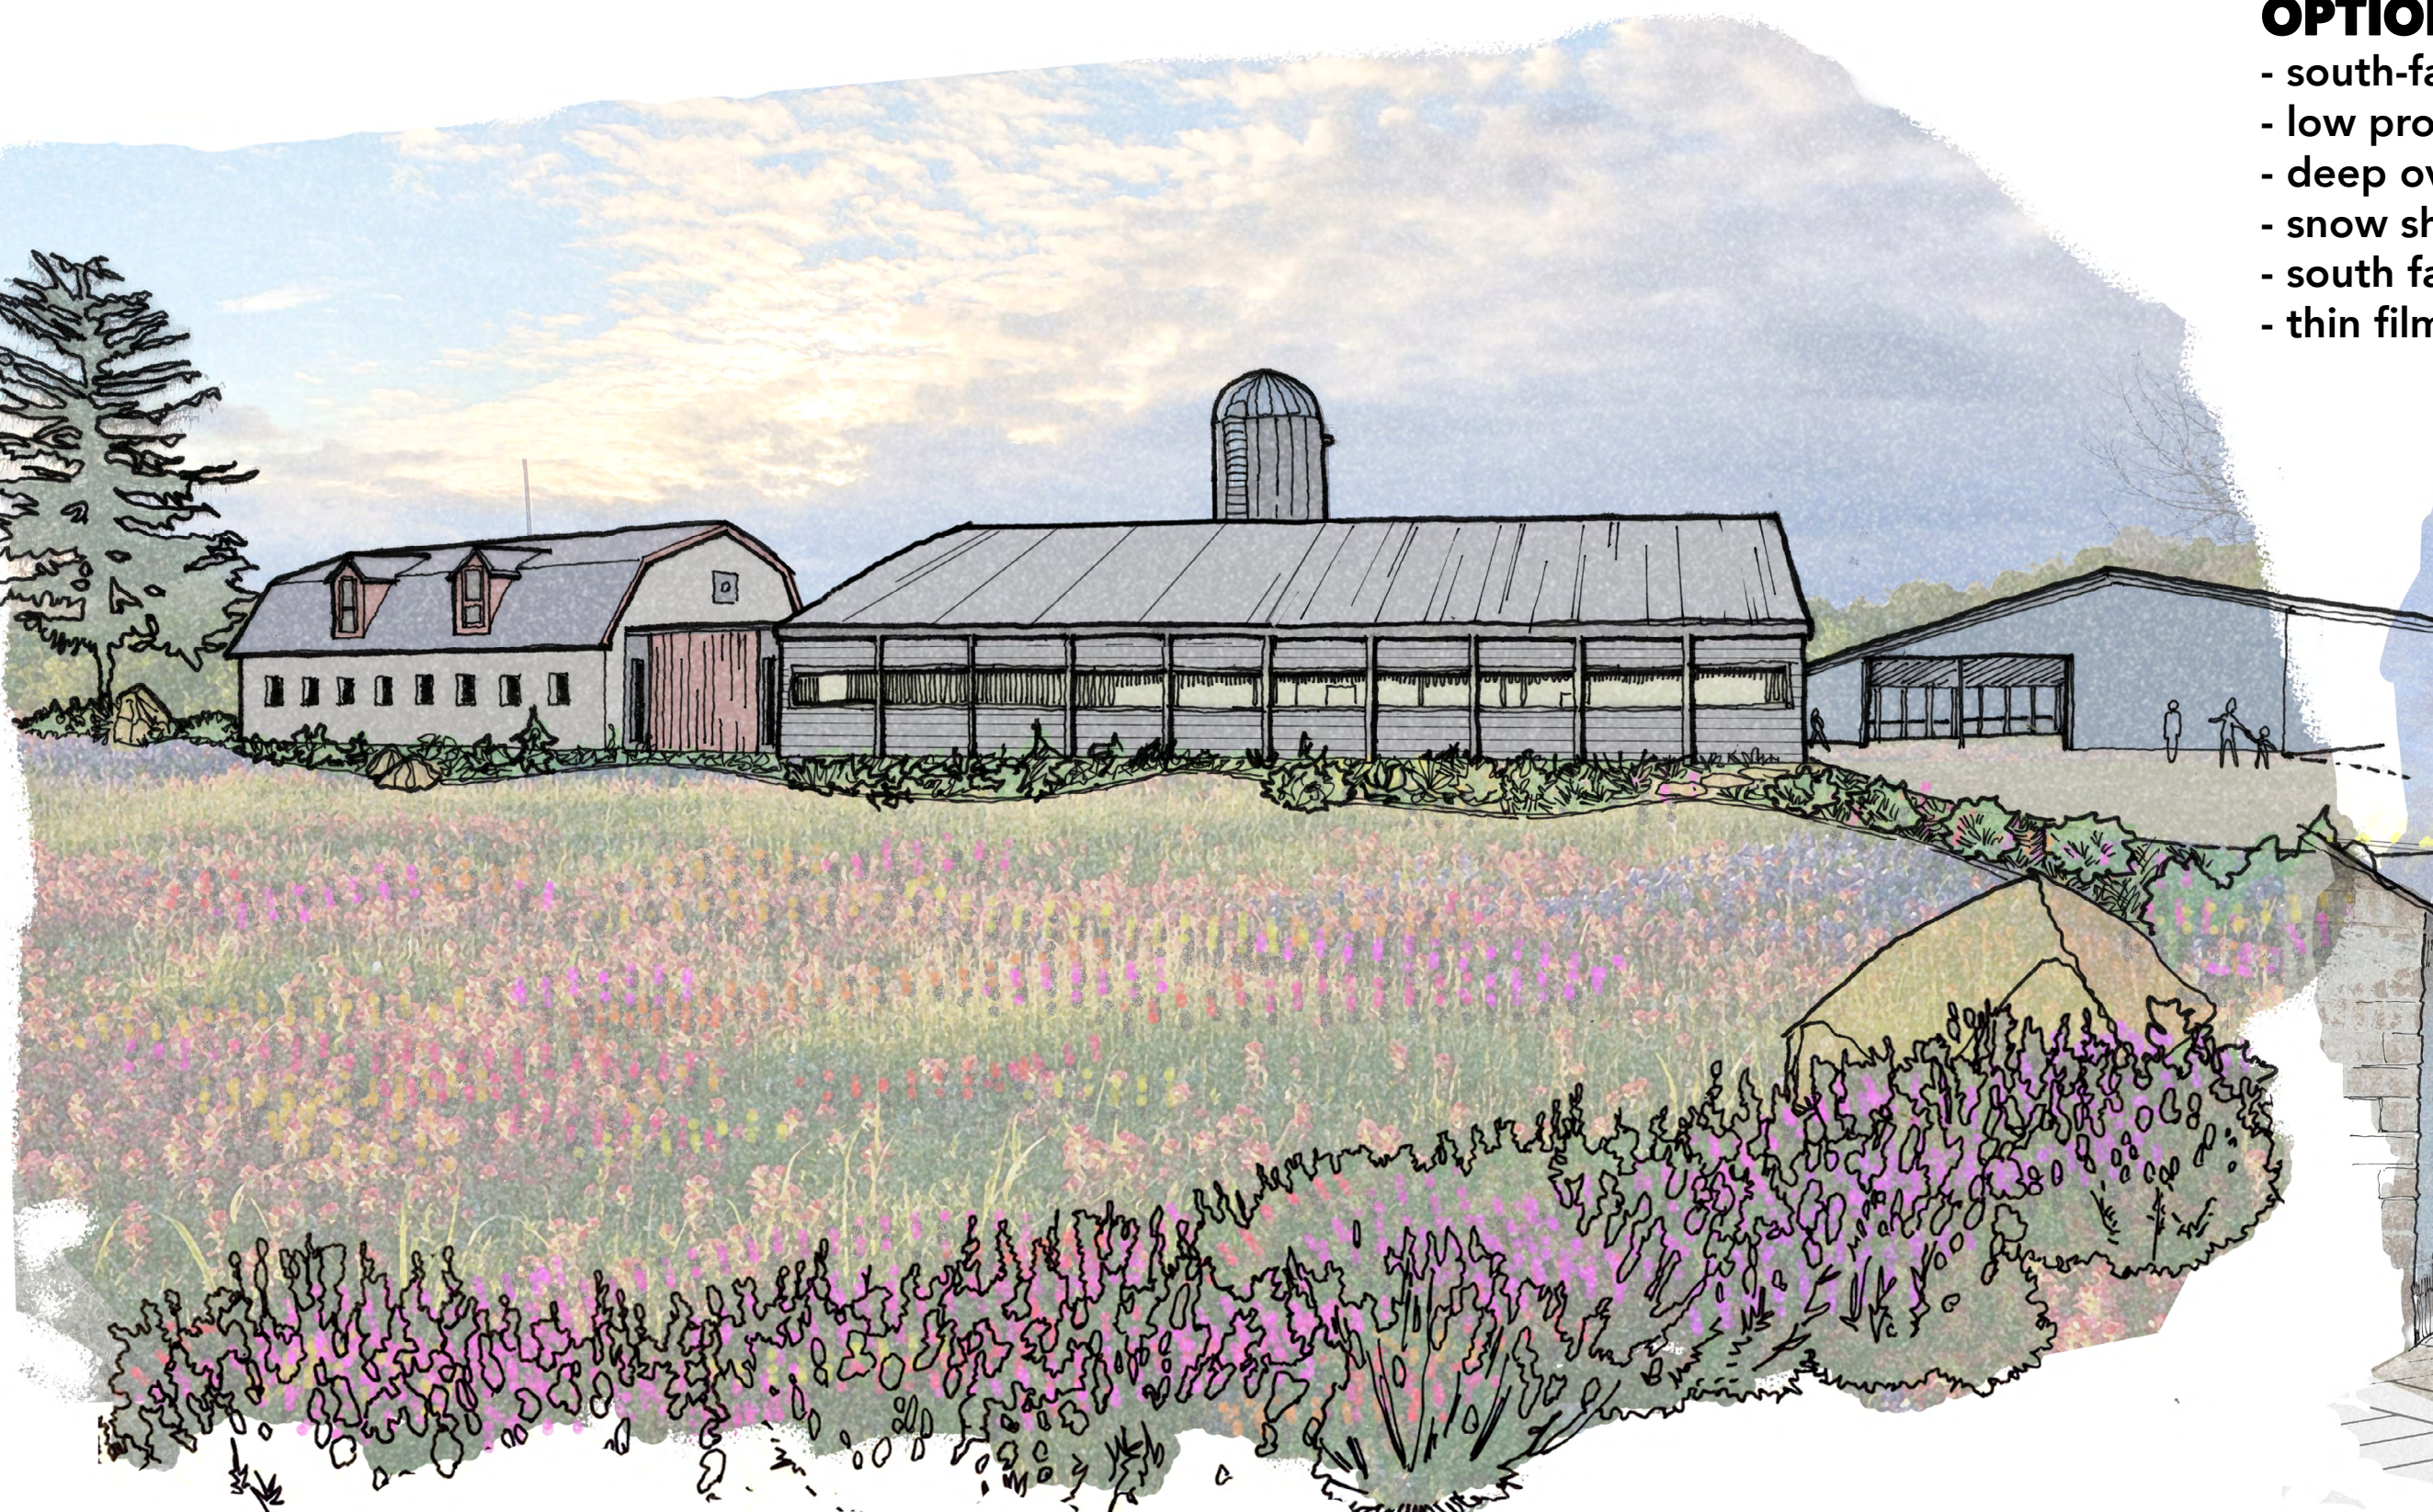
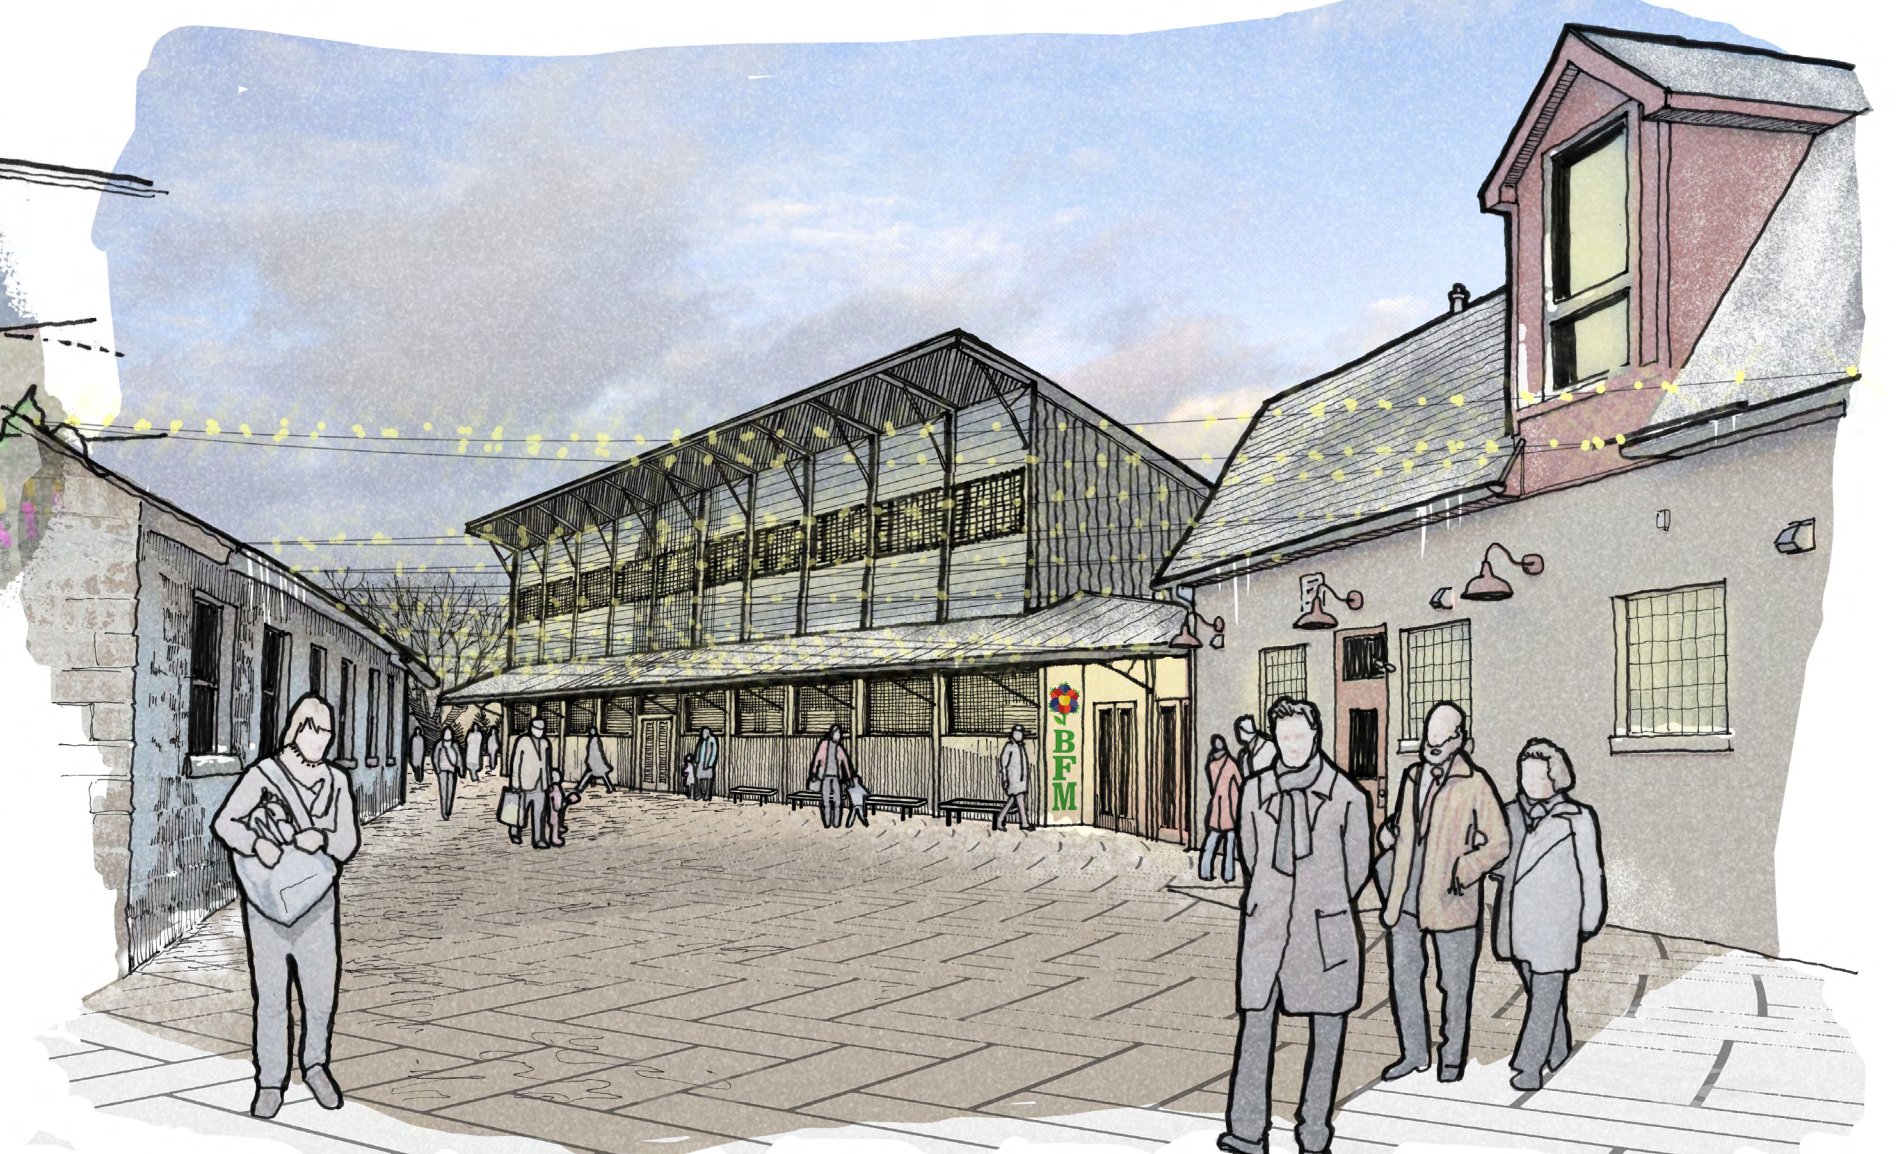
### OPTION B

- south-facing shed roof
- low profile faces Westfall Road
- deep overhang for protection at entrances and along perimeter of market plaza
- snow sheds towards north elevation
- south facing windows to capture abundant light on sunny days
- thin film PV's on roof

View from Westfall Road

View from Market Plaza

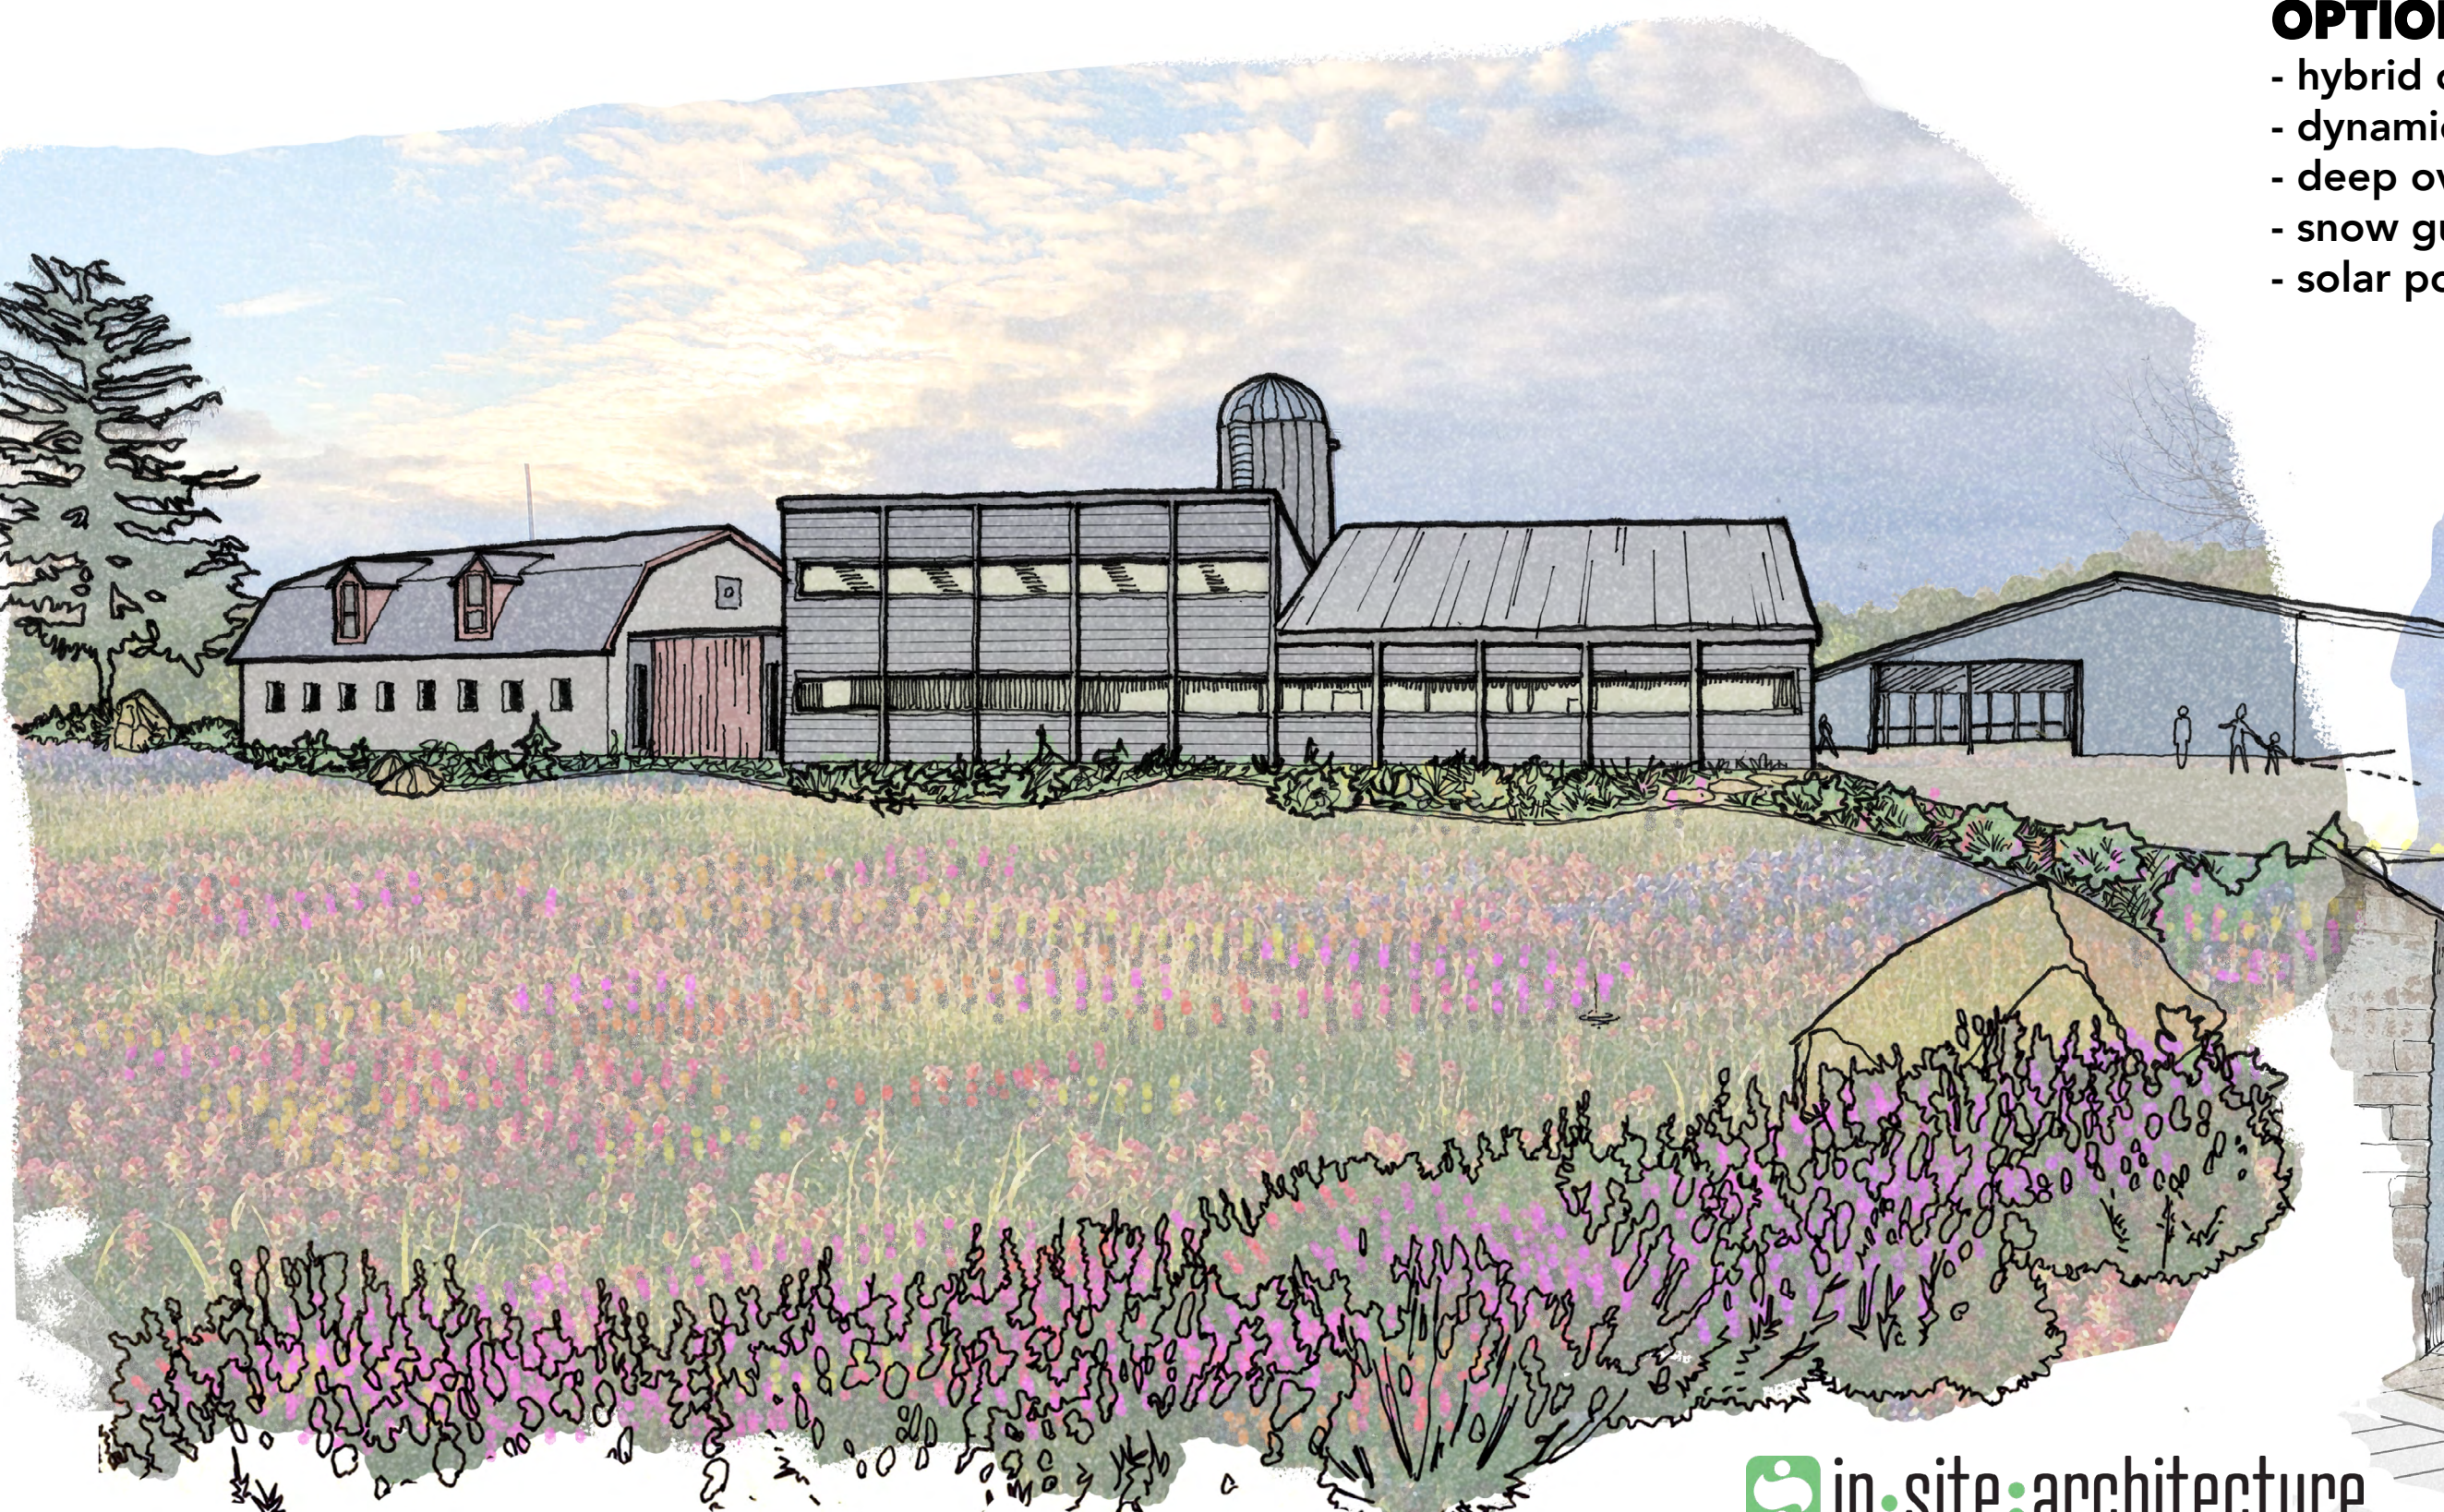
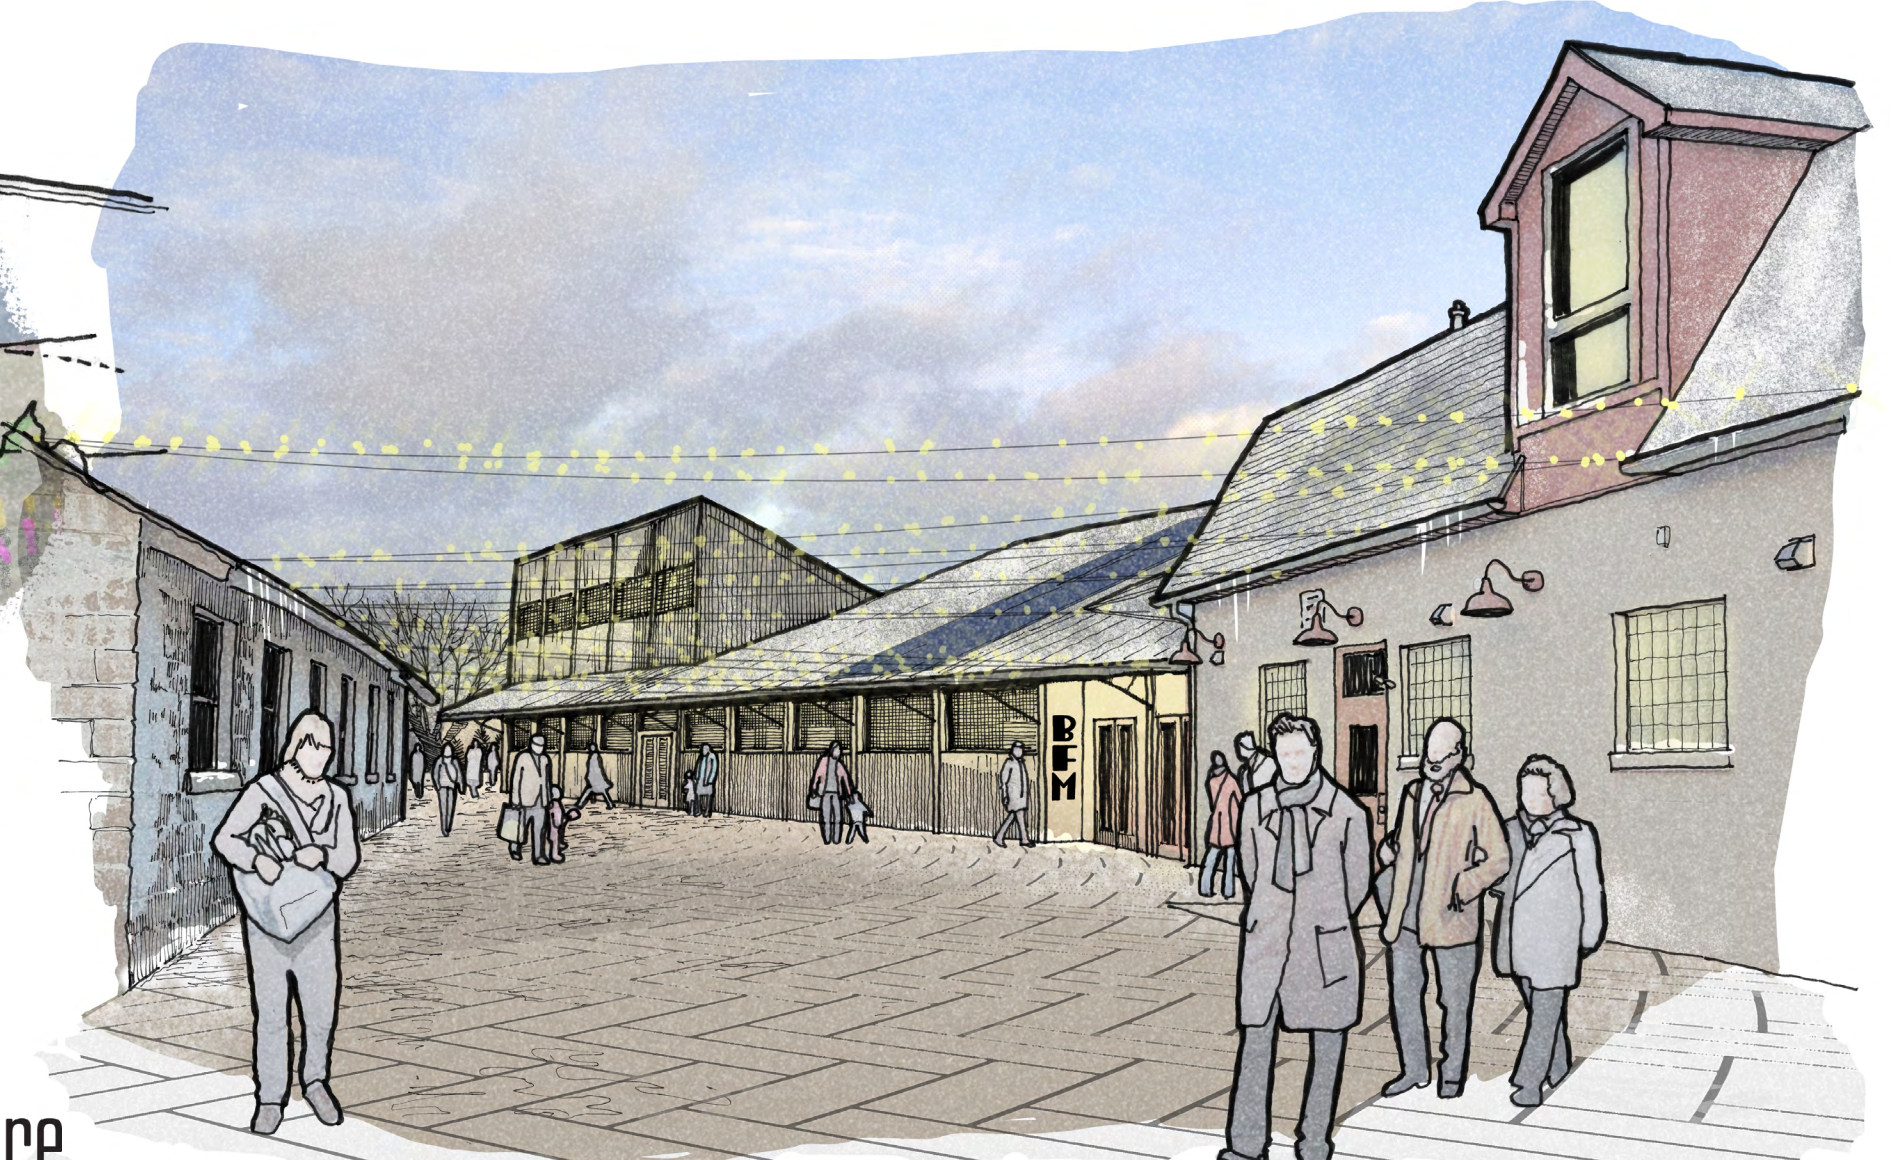
### OPTION C

- hybrid of Option A and Option B
- dynamic roof form
- deep overhang for protection at entrances and along perimeter of market plaza
- snow guards for snow control
- solar power photovoltaic panels (PV's) on roof

View from Westfall Road

View from Market Plaza

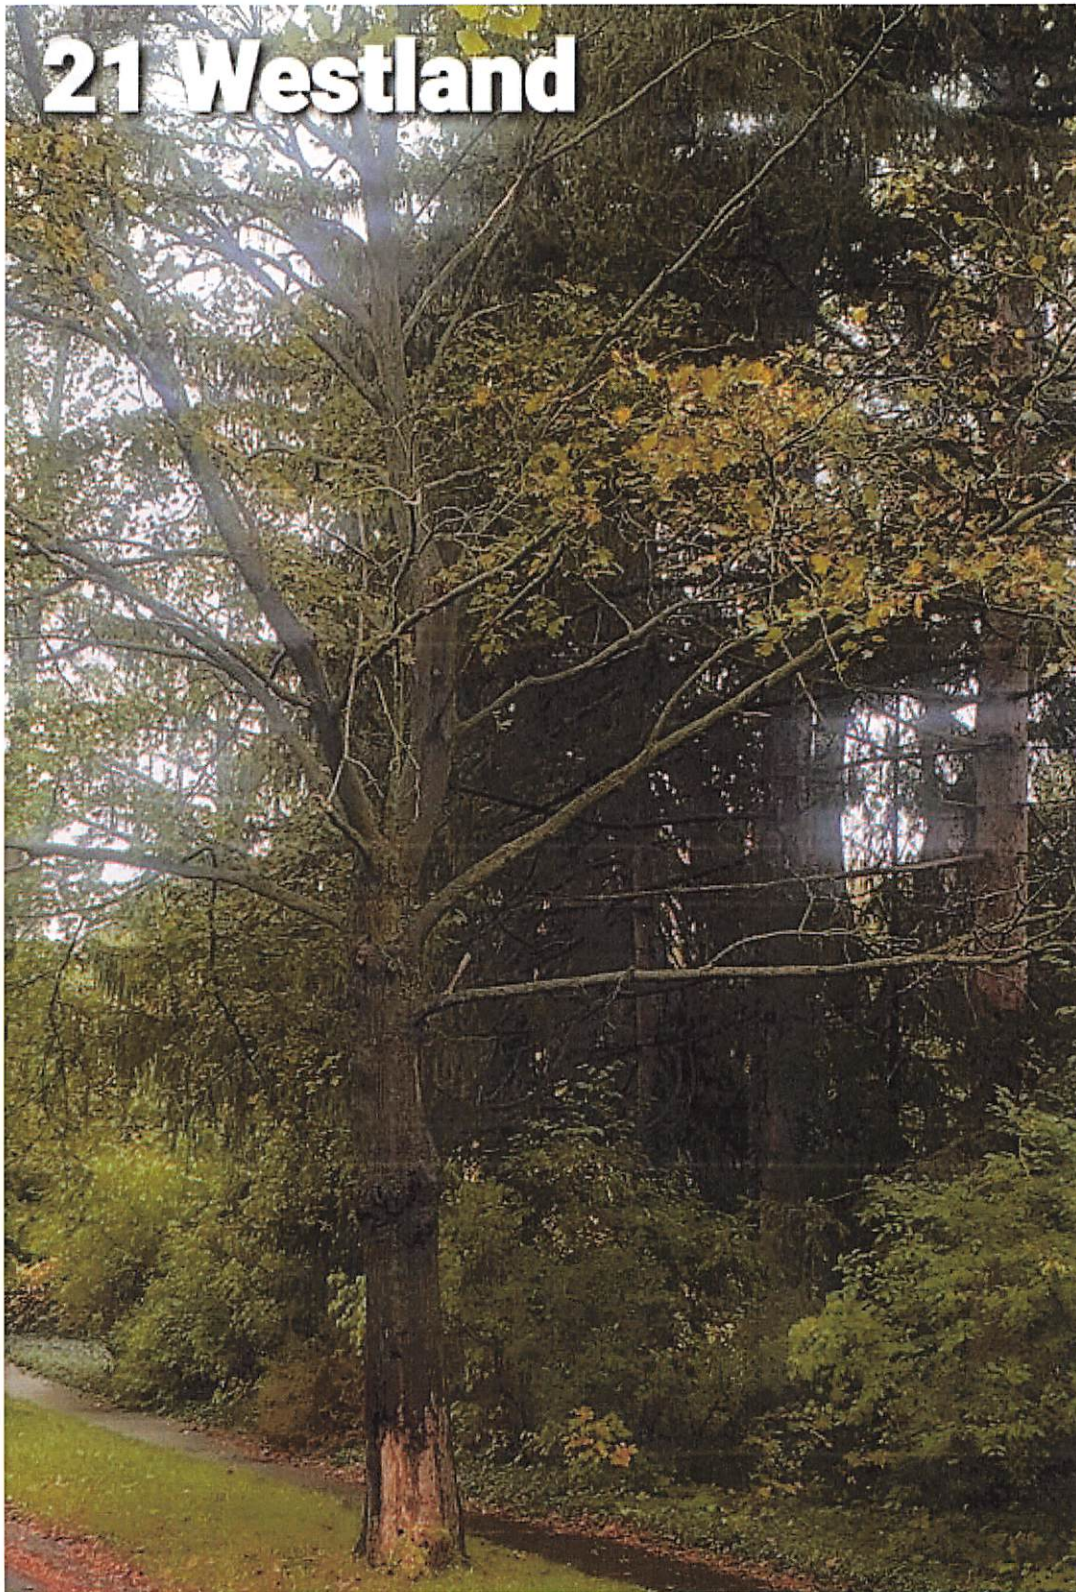
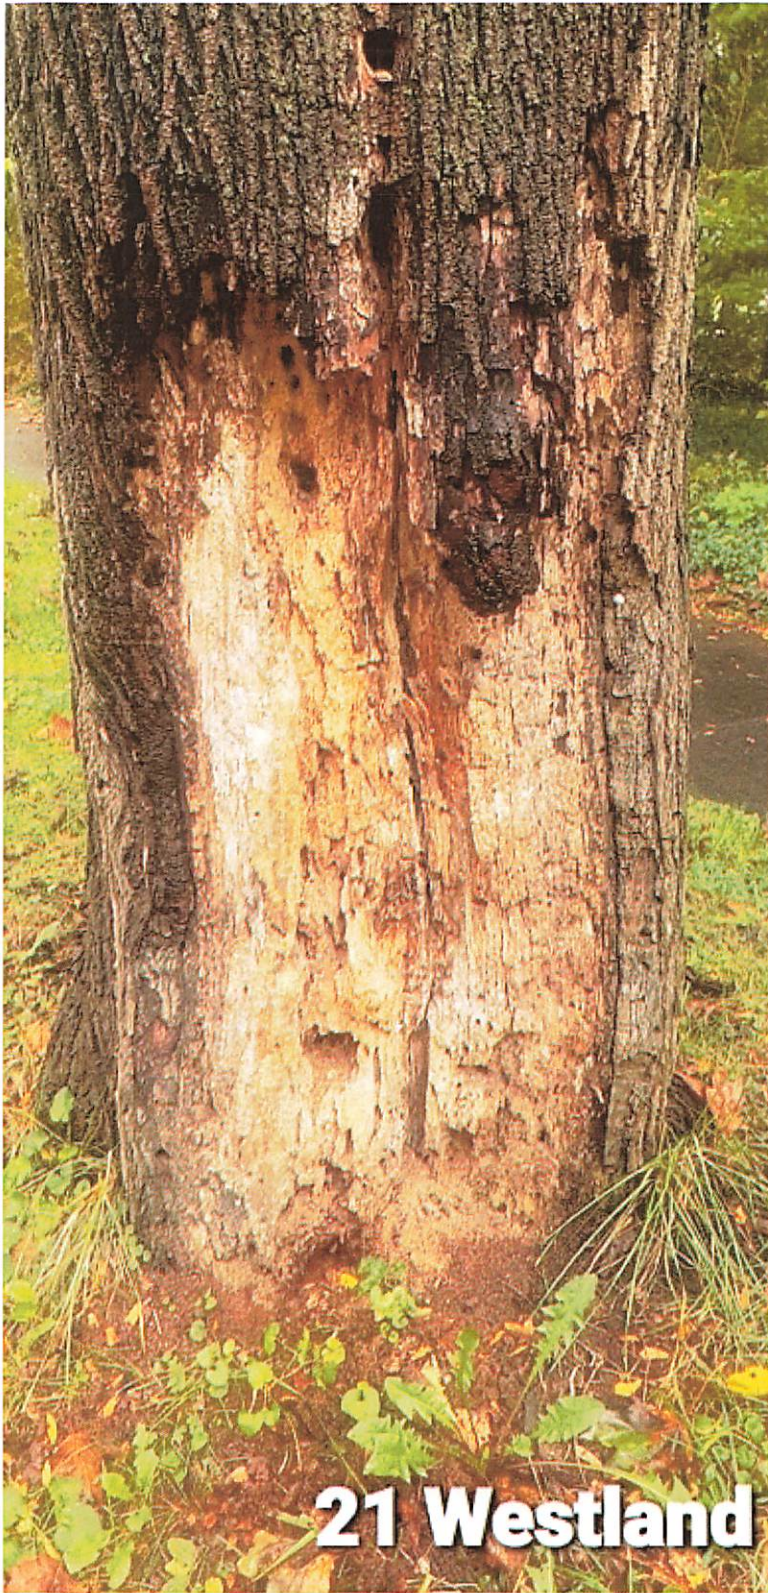
**TREE HAZARD EVALUATION FORM** 2nd EditionSite/Address: 21 Westland - Edgemere Side

Tree part most likely to fail: Trunk at base

4 + 4 + 4 = 12

Tree is dead. Most likely to fail at base of trunk due to termite infestation.

Remove tree ☒ Y ☐ N Replace? ☒ Y ☐ N Move target: Y ☒ N Other: \_\_\_\_\_
