# PUBLIC WORKS COMMITTEE

#### **OLD BUSINESS**

#### **NEW BUSINESS**

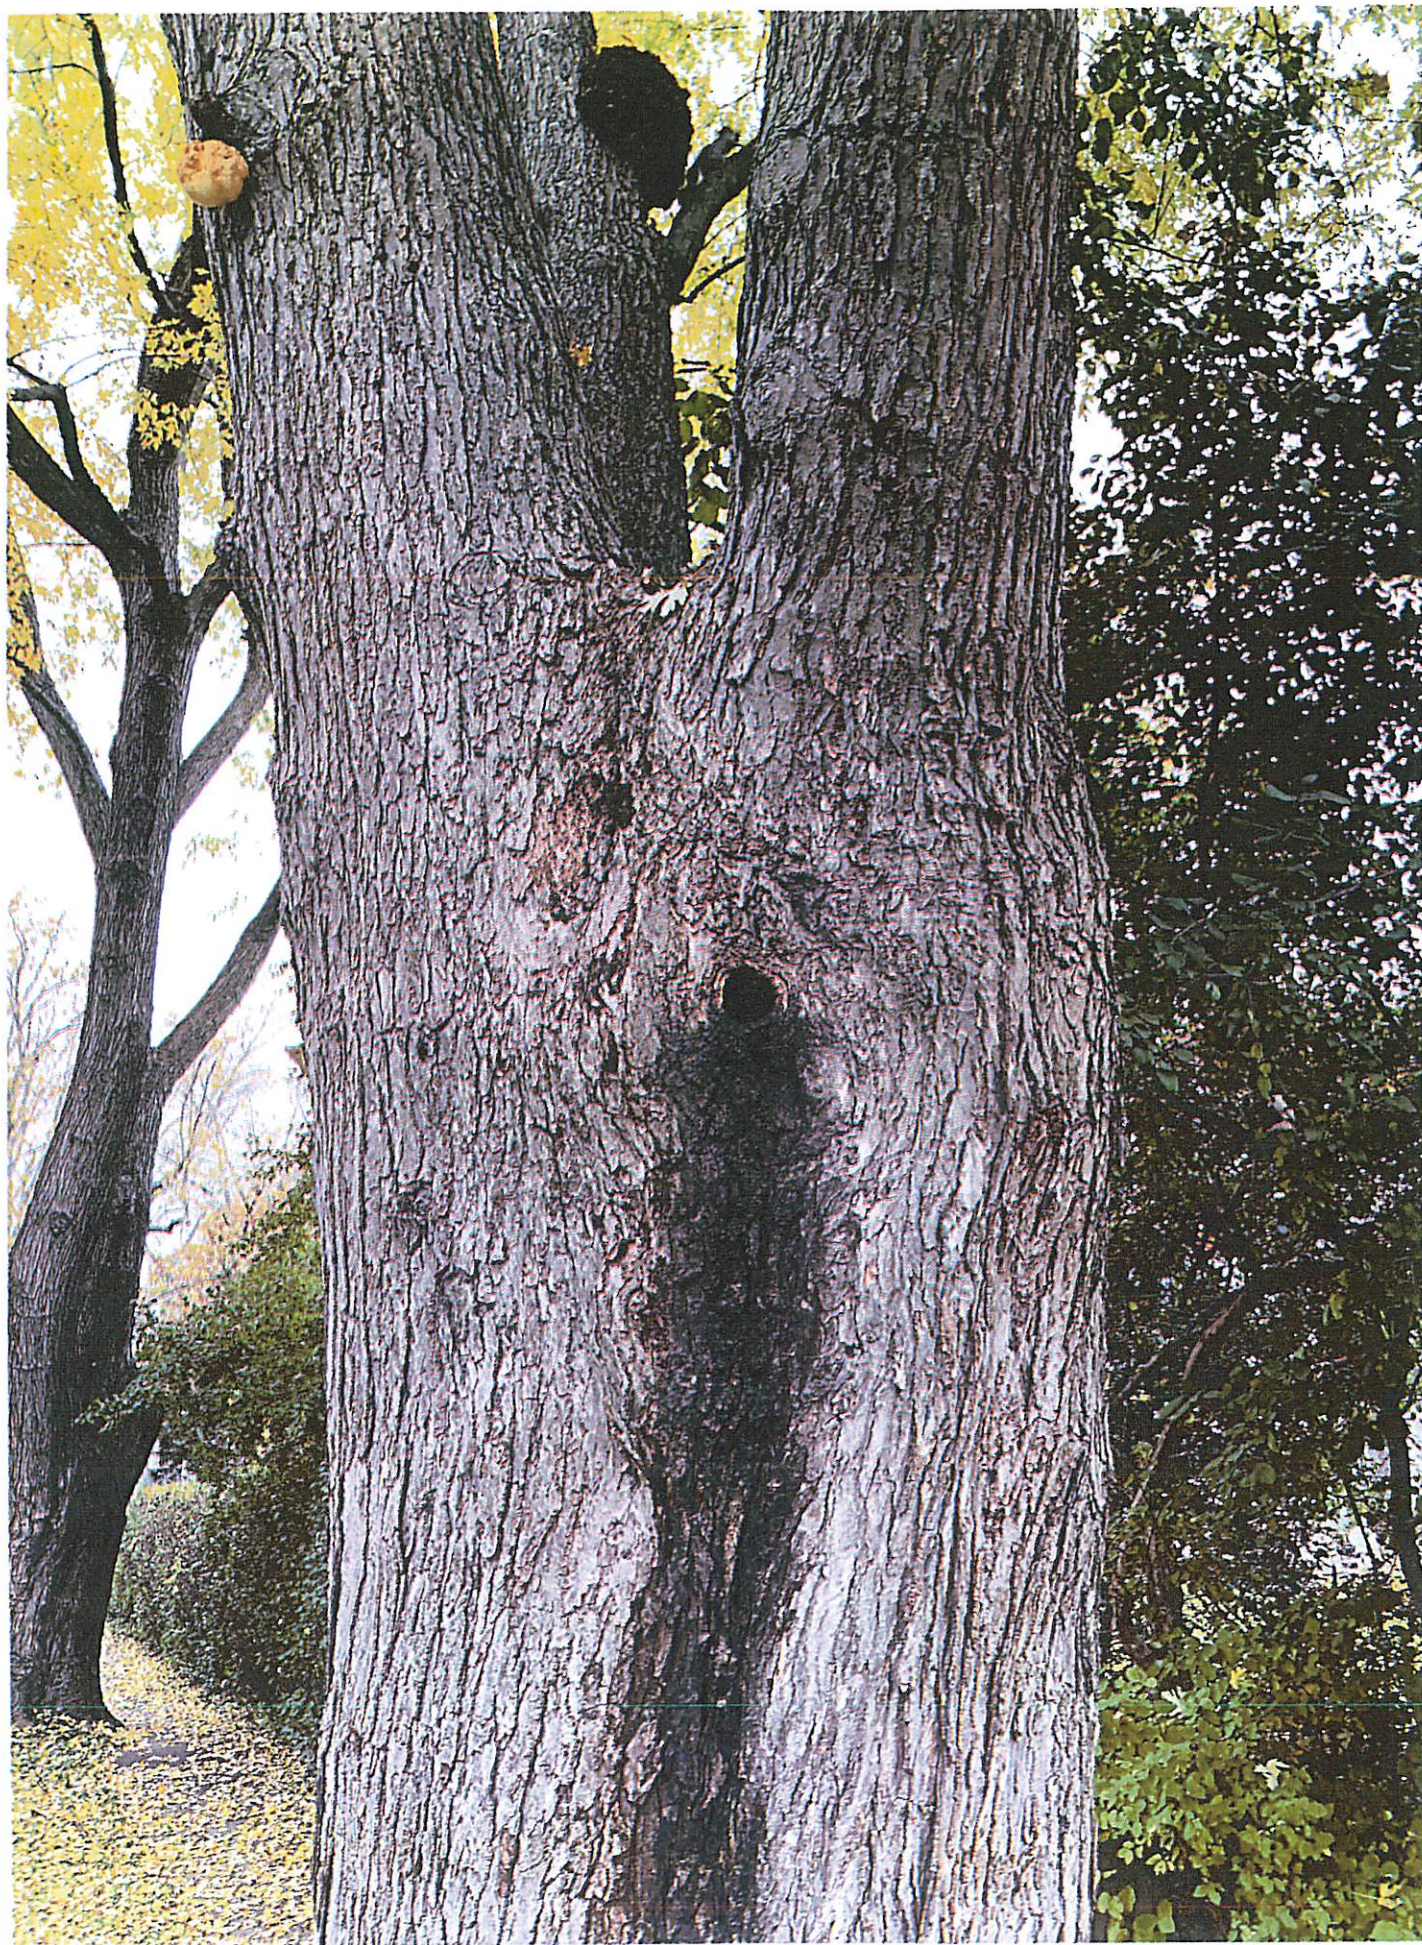
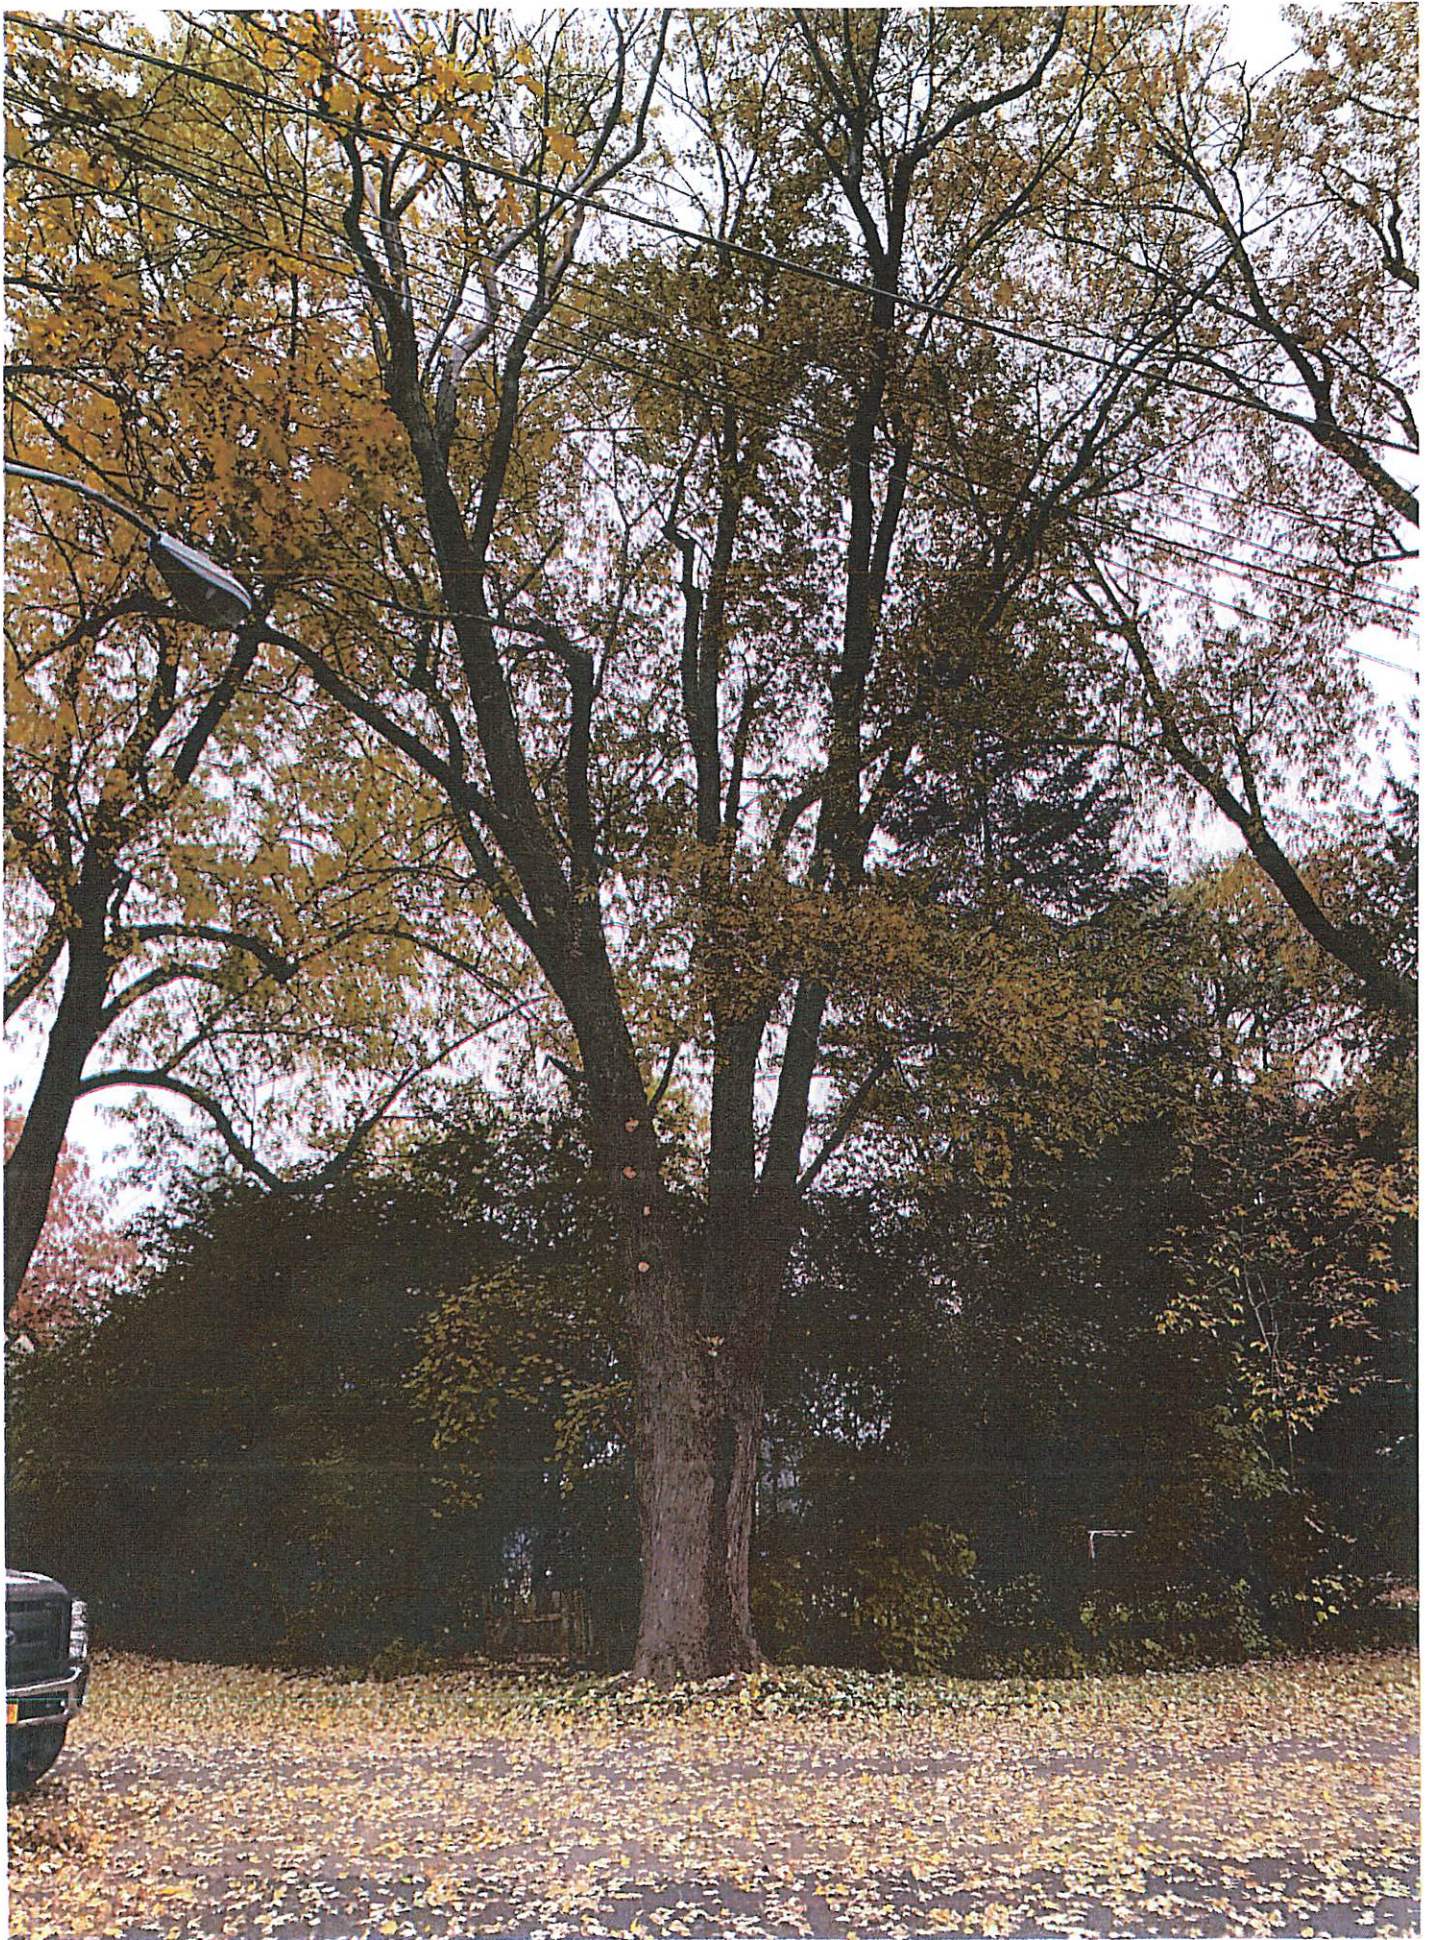
**TREE HAZARD EVALUATION FORM** 2nd EditionSite/Address: Across from 31 Walder

Tree part most likely to fail: Trunks, Scaffolds, branches

4 + 4 + 4 = 12

Remove tree: ☒ Y ☐ N Replace? ☐ Y ☒ N Move target: ☐ Y ☒ N Other: \_\_\_\_\_

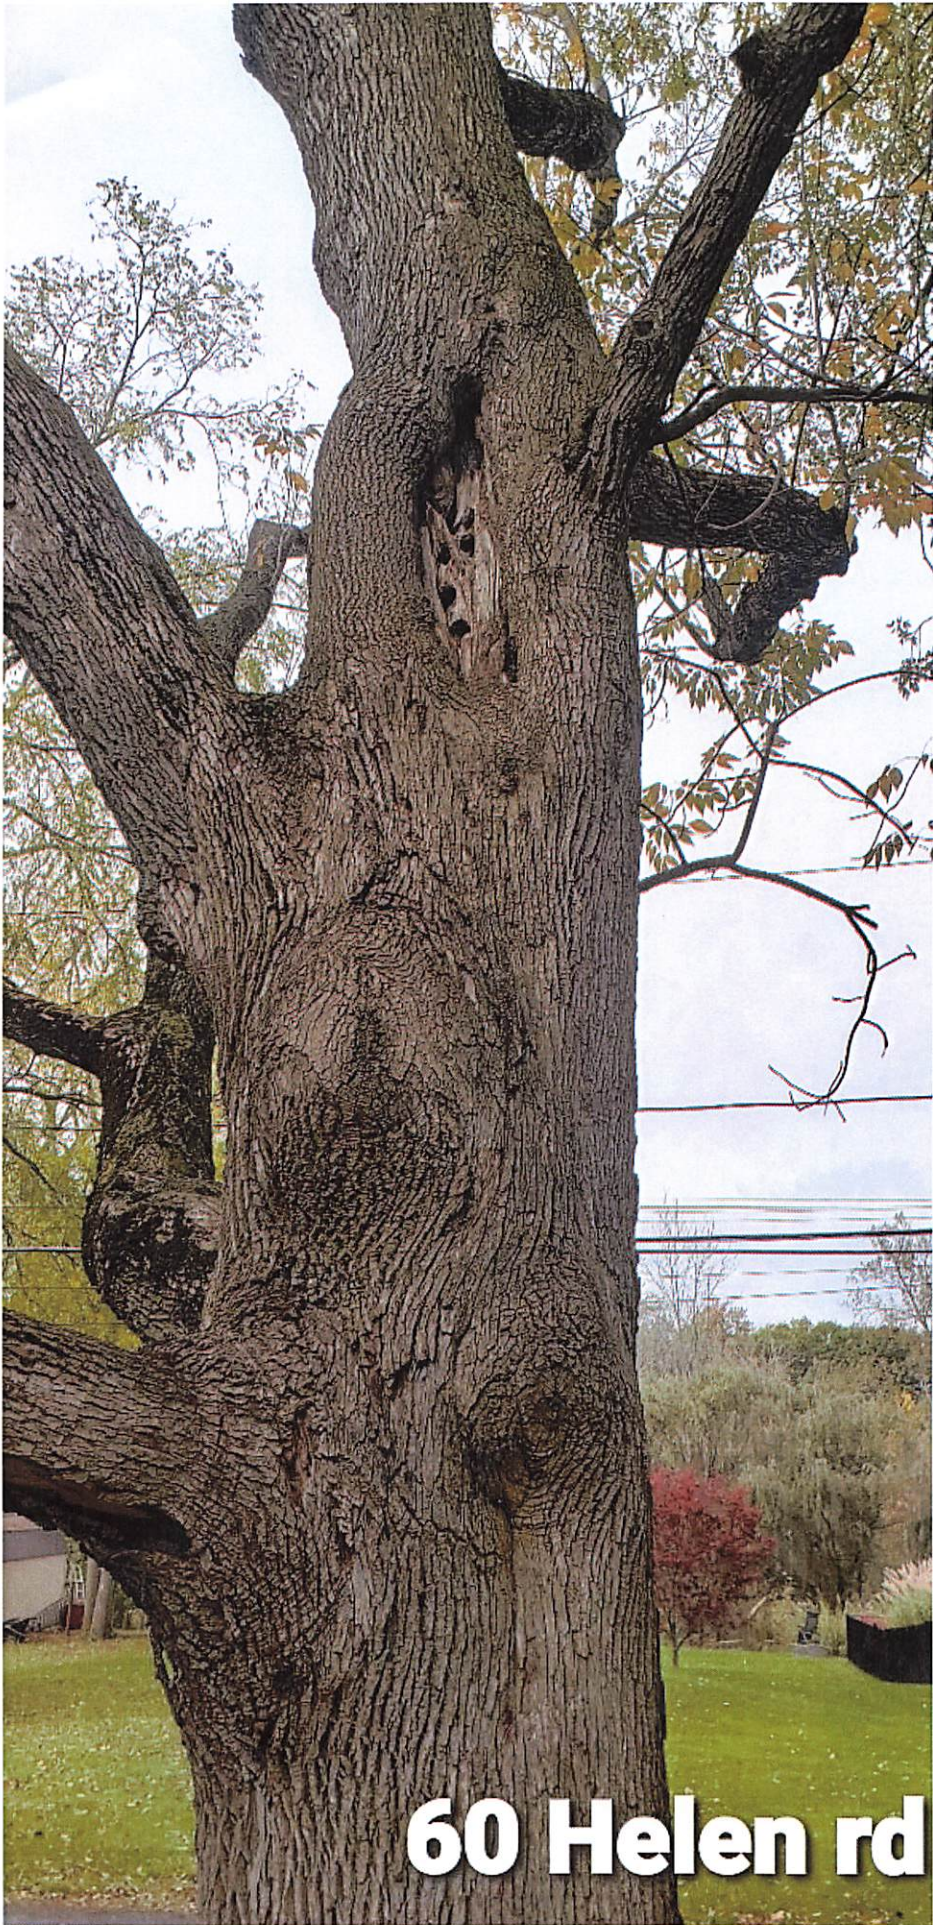
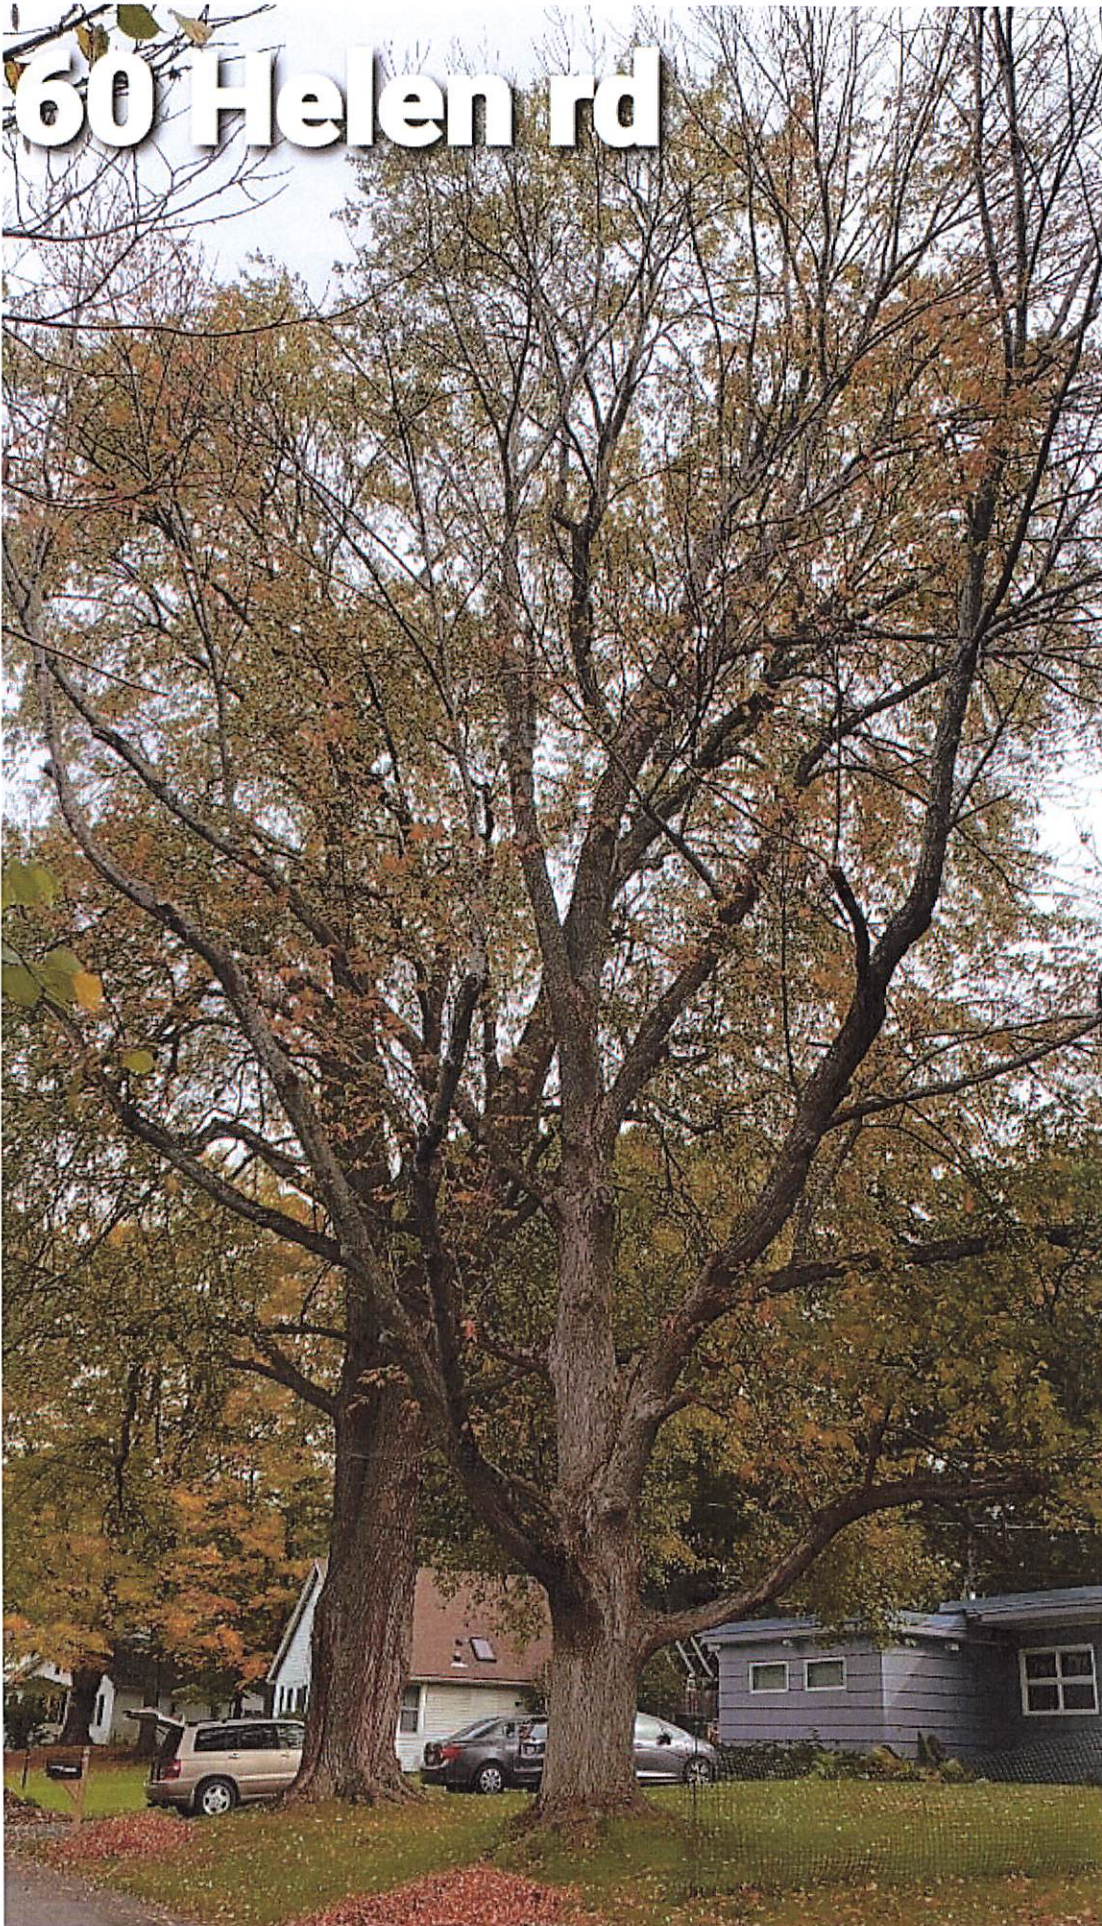
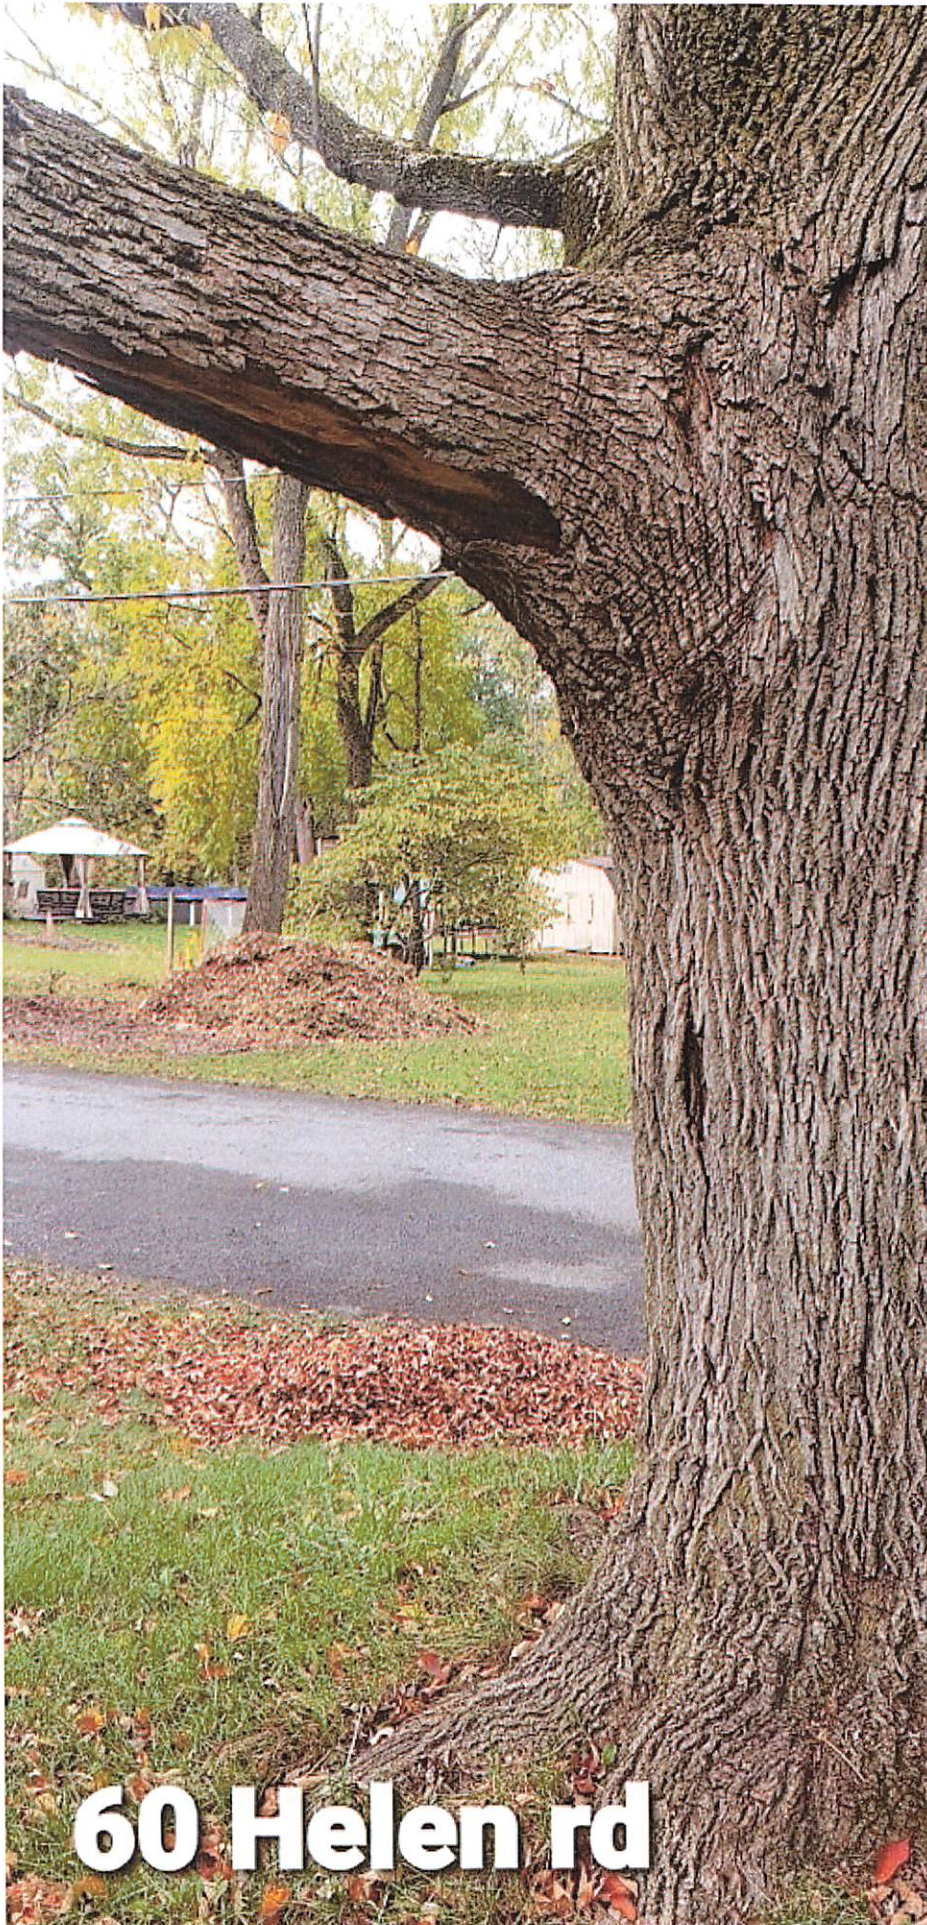
**60 Helen rd**

Foliage color: ☐ normal ☐ chlorotic ☐ necrotic Epicormics? Y N  
 Foliage density: ☐ normal ☒ sparse Leaf size: ☐ normal ☒ small  
 Annual shoot growth: ☐ excellent ☐ average ☐ poor Twig Dieback? ☒ Y N  
 Woundwood development: ☐ excellent ☐ average ☒ poor ☐ none  
 Vigor class: ☐ excellent ☐ average ☐ fair ☐ poor  
 Major pests/diseases: Ants - Termites - woodpecker holes.

Tree part most likely to fail: Scaffolds - trunk

4 + 4 + 4 = 12

Remove tree: ☒ Y ☐ N Replace? Y ☒ N Move target: Y ☒ N Other: \_\_\_\_\_
