PUBLIC WORKS COMMITTEE MEETING

BRIGHTON TOWN HALL AUDITORIUM

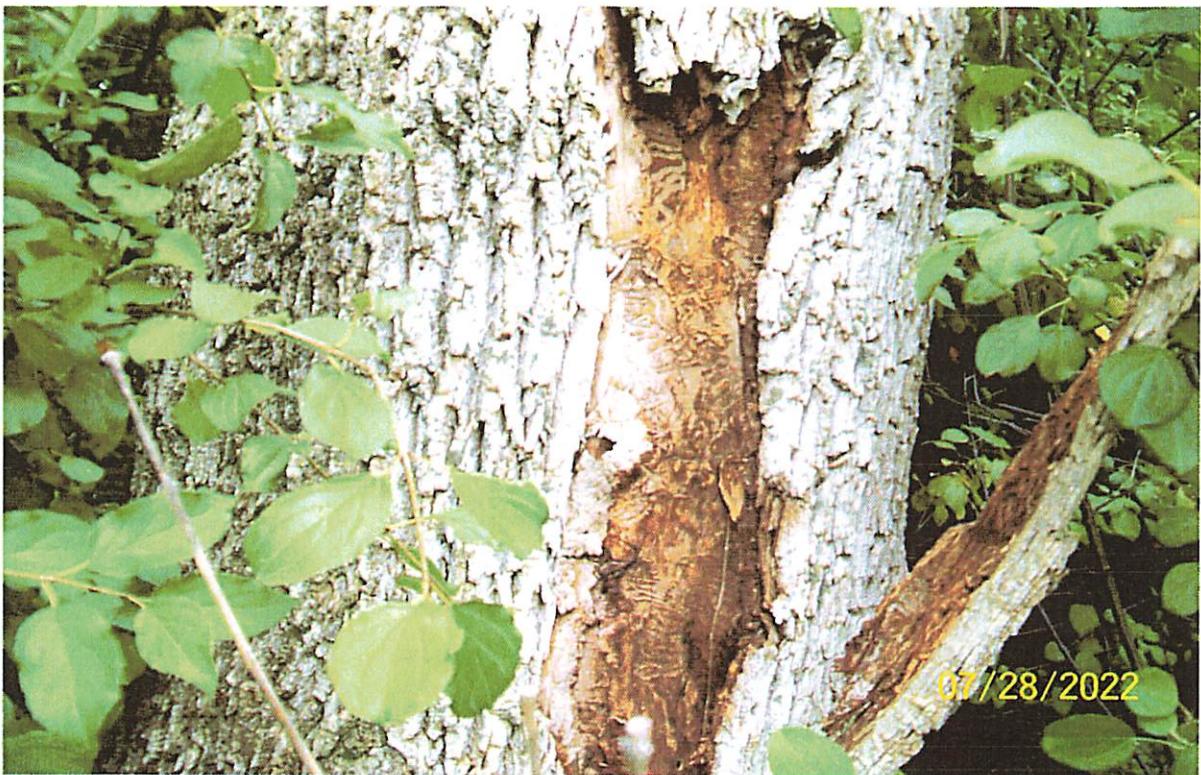
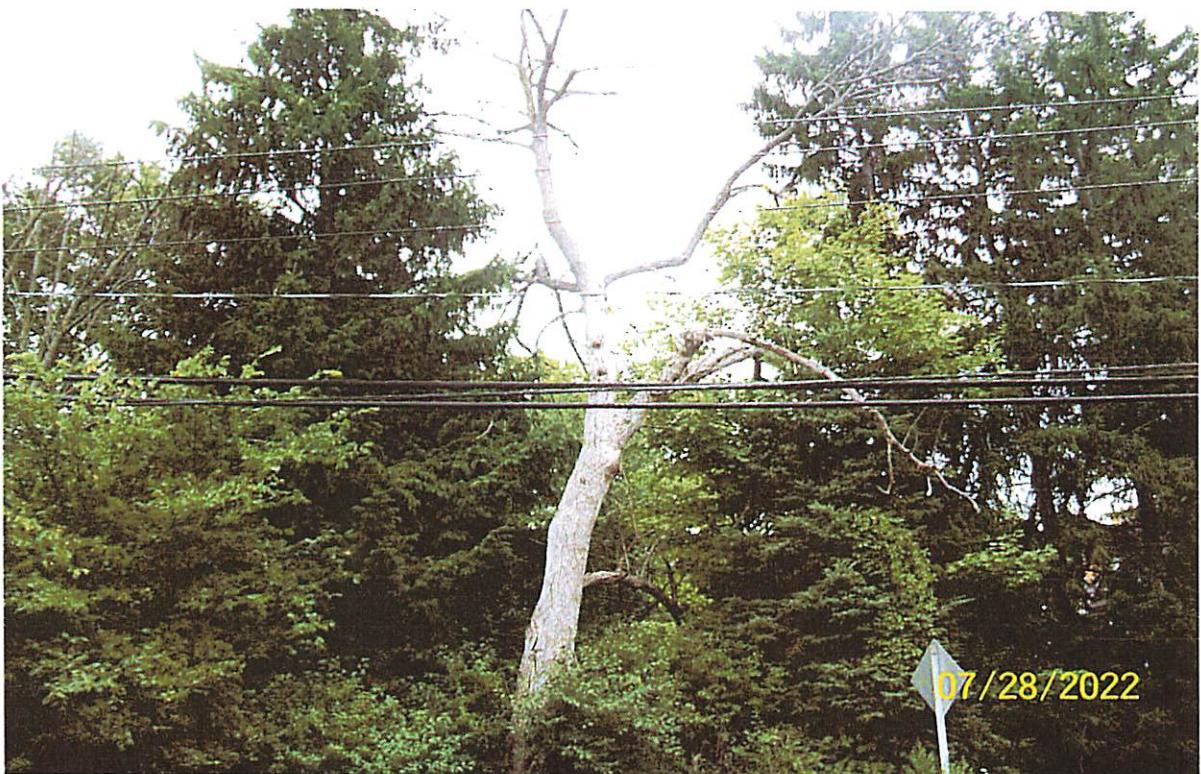
Site/Address: 1300 French Road
 Map/Location: Town of Brighton
 Owner: public private unknown other
 Date: 7/28/22 Inspector: Kyle Sears
 Date of last inspection: _____

<u>4</u>	<u>4</u>	<u>4</u>	<u>12</u>
Potential	Failure	Size	Target = Hazard Rating
<input type="checkbox"/> Immediate action needed			
<input type="checkbox"/> Needs further inspection			
<input checked="" type="checkbox"/> Dead tree

Tree #: _____ Species: ASH (S. 'Diana')
 DBH: 88" # of trunks: 1 Height: 50' Spread: 24'
 Form: generally symmetric minor asymmetry major asymmetry stump sprout stag-headed
 Crown class: dominant co-dominant intermediate suppressed (DEAD)
 Live crown ratio: _____ % Age class: young semi-mature mature over-mature/senescing
 Pruning history: crown cleared excessively thinned topped crown raised pollarded crown reduced flush cuts cabled/braced
 none multiple pruning events Approx. dates: _____
 Special Value: specimen heritage/historic wildlife unusual street tree screen shade indigenous protected by gov. agency

Foliation color: normal chlorotic necrotic Epiphytes? Y N Growth obstructions: _____
 Foliation density: normal sparse Leaf size: normal small stakes wire/fines signs cables
 Annual shoot growth: excellent average poor Twig Dieback? Y N curb/pavement guards
 Wound/wood development: excellent average poor none other _____
 Vigor class: excellent average fair poor
 Major pests/diseases: (DEAD)

TREE NEEDS TO BE REMOVED

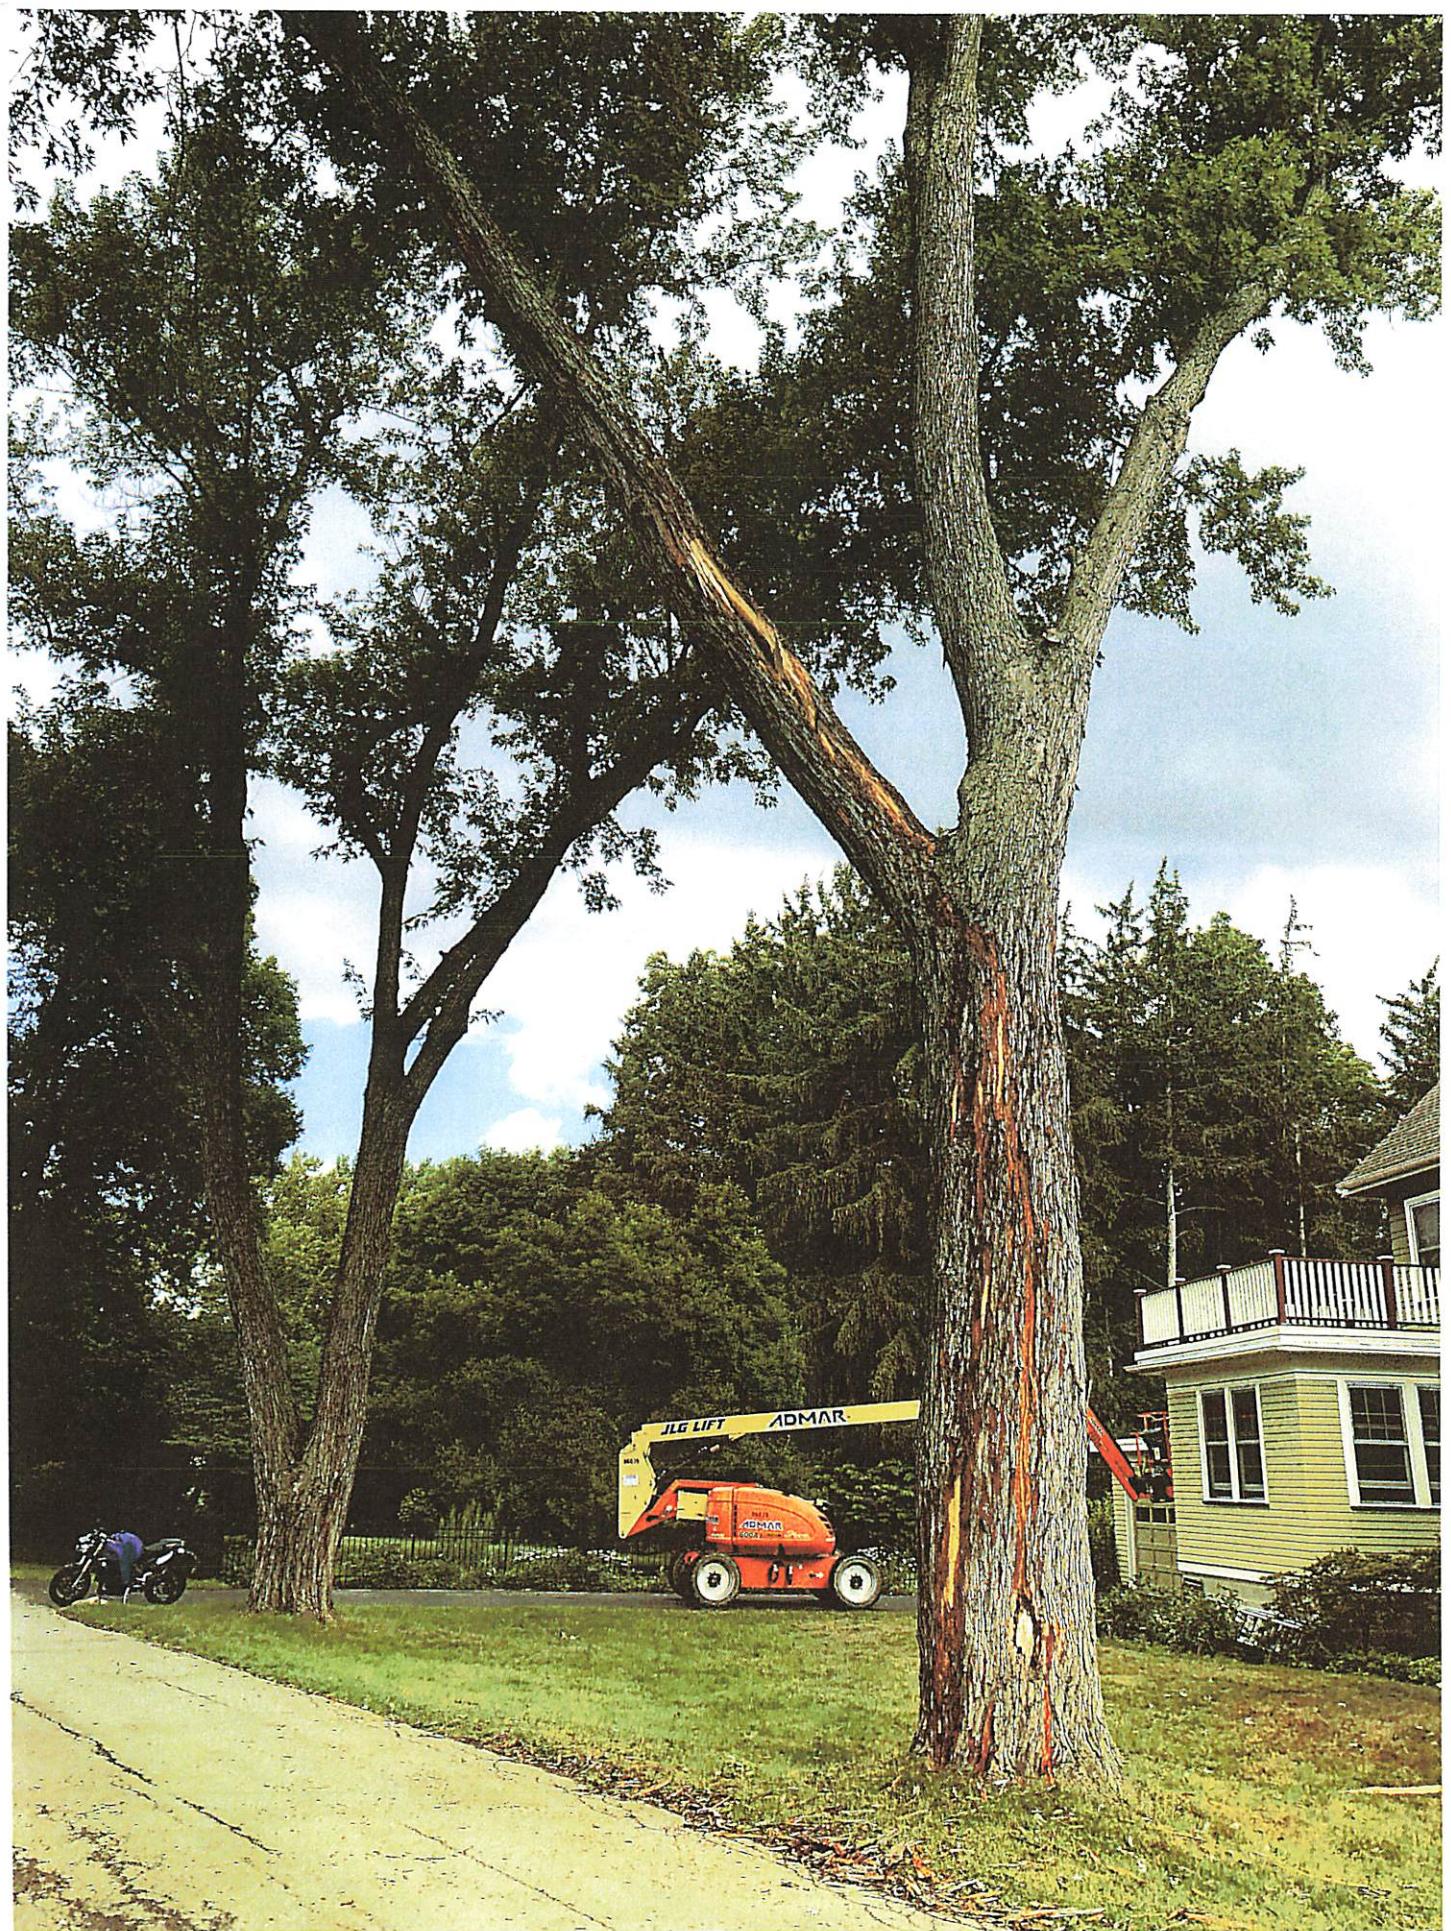
Site/Address: 1393 Clover st

Major pests/diseases: Struck by lightning.

DEFECT	ROOT CROWN	TRUNK	SCAFFOLDS	BRANCHES
Poor taper			M	
Bow, sweep				
Codominants/forks				
Multiple attachments				
Included bark				
Excessive end weight				
Cracks/splits		S	S	S
Hangers				
Girdling				
Wounds/seam				1
Decay				
Cavity				
Conks/mushrooms/bracket				
Bleeding/sap flow				
Lobse/cracked bark		S	S	S
Nesting hole/bee hive				
Deadwood/stubs				
Borers/termites/ants				
Cankers/galls/burls				
Previous failure

Tree part most likely to fail: Trunk, Scaffolds & Branches

Bark is separated from trunk, scaffolds, branches due to a lightning strike.

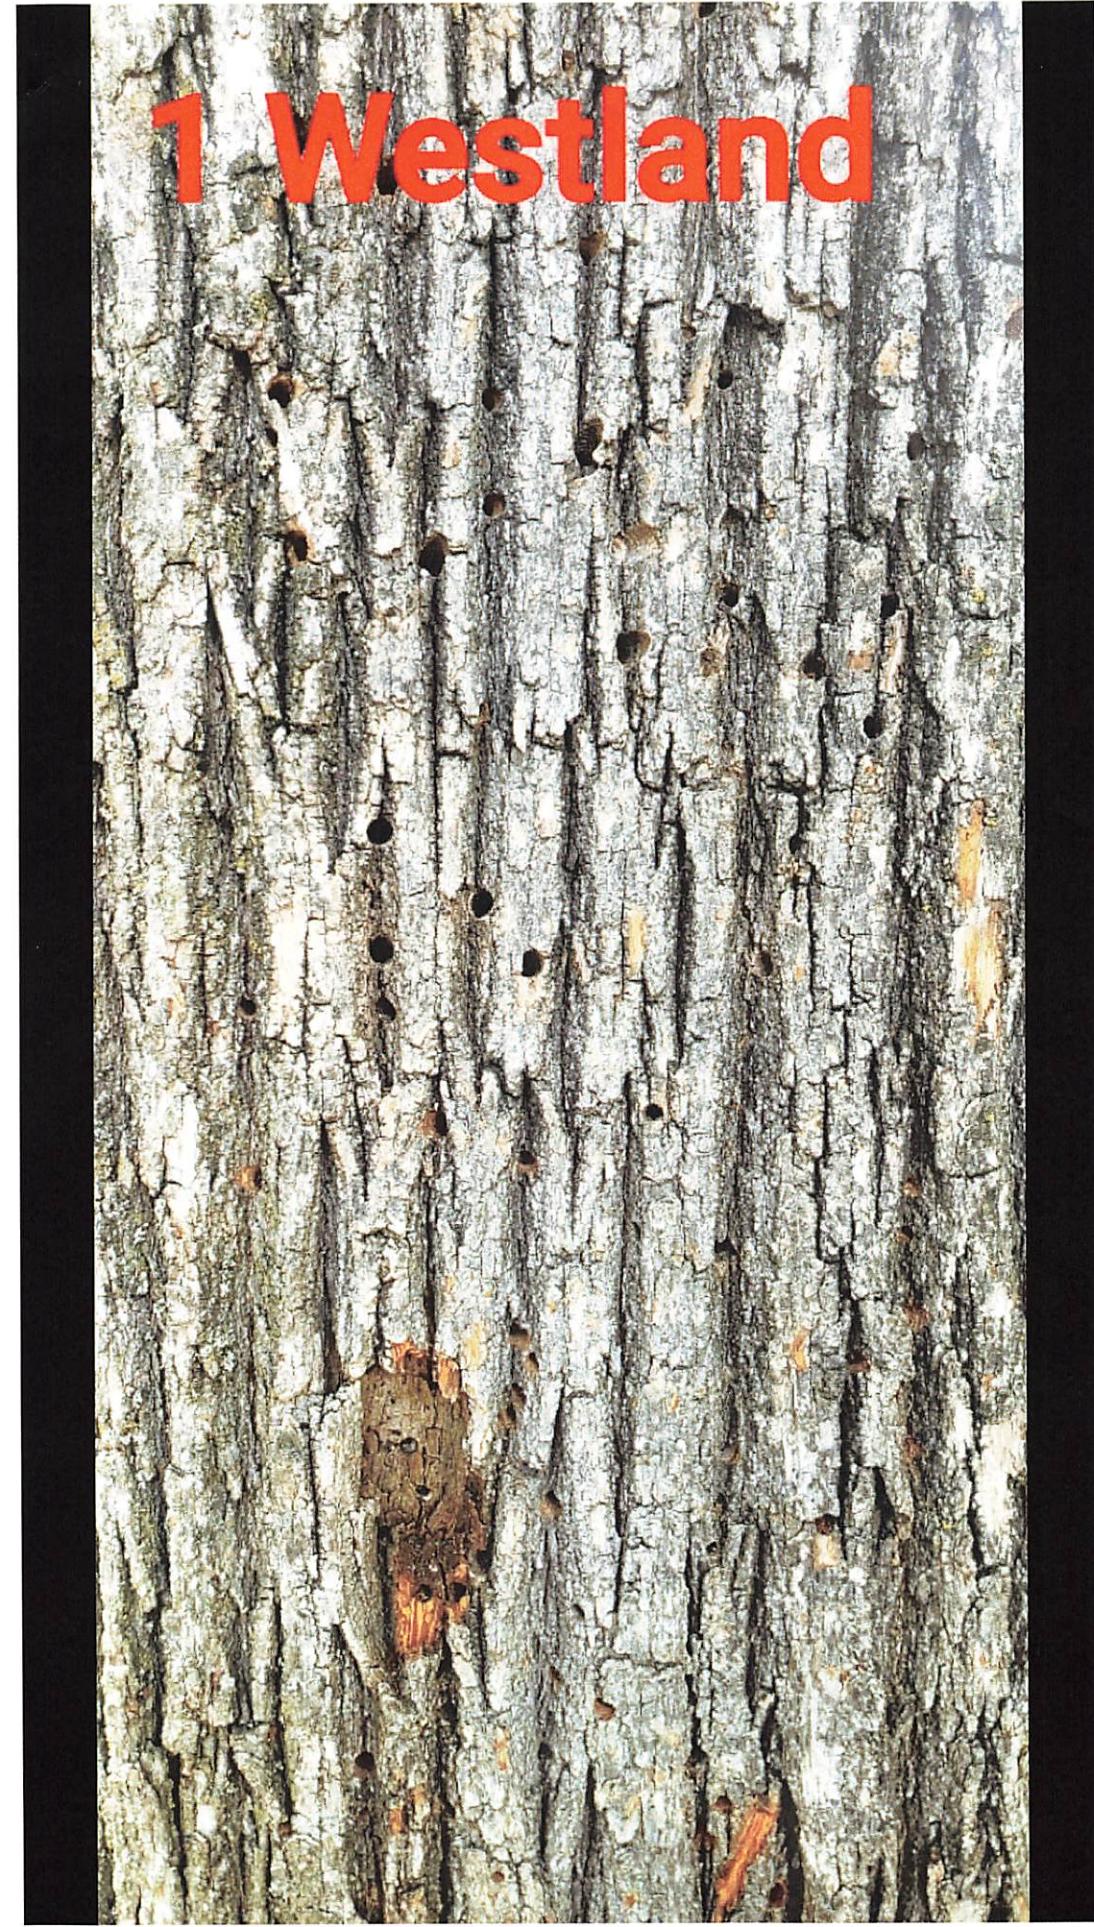
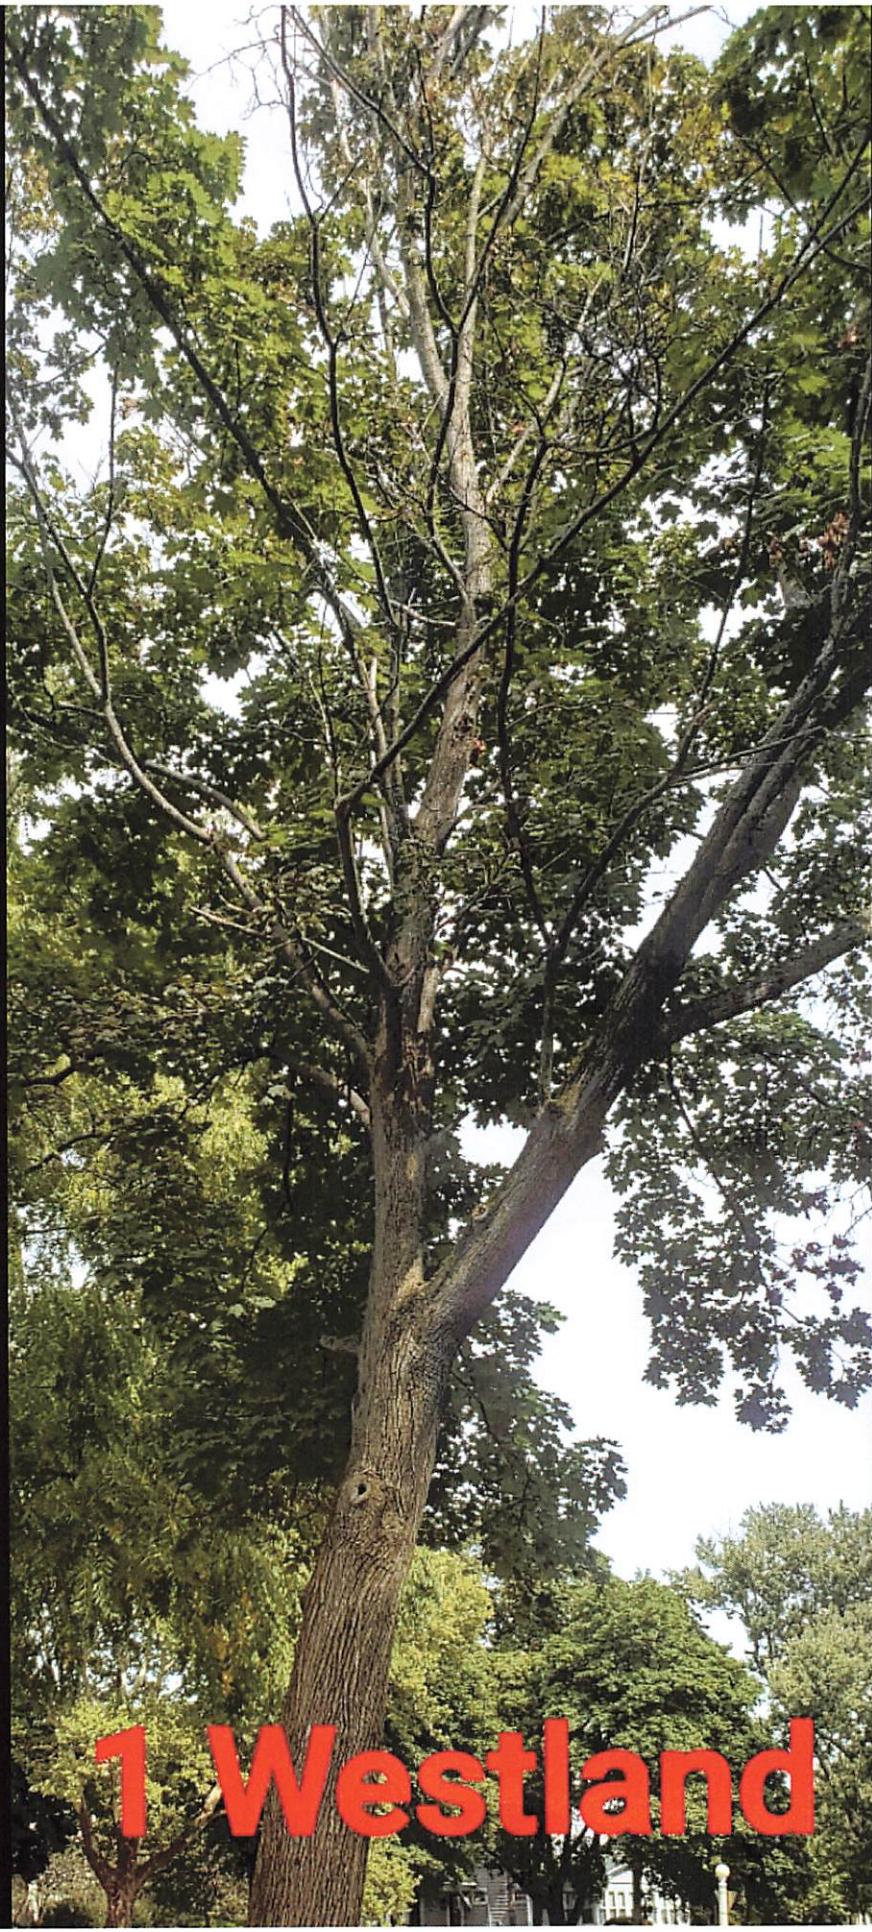
1 Westland

DEFECT	ROOT CROWN	TRUNK	SCAFFOLDS	BRANCHES
Poor taper				
Bow, sweep				
Codominants/forks			m	
Multiple attachments				
Included bark		m	m	m
Excessive end weight				
Cracks/splits		s	s	s
Hangers				
Girdling				
Wounds/seam		m	s	l s
Decay		m	s	s
Cavity				
Conks/mushrooms/bracket				
Bleeding/sap flow				
Lobse/cracked bark		s	s	s
Nesting hole/bee hive		s	s	s
Deadwood/stubs			s	s
Borers/termites/ants		s	s	s
Cankers/galls/burls				
Previous failure		s	s	s

Tree part most likely to fail: Trunk/ scaffolds.

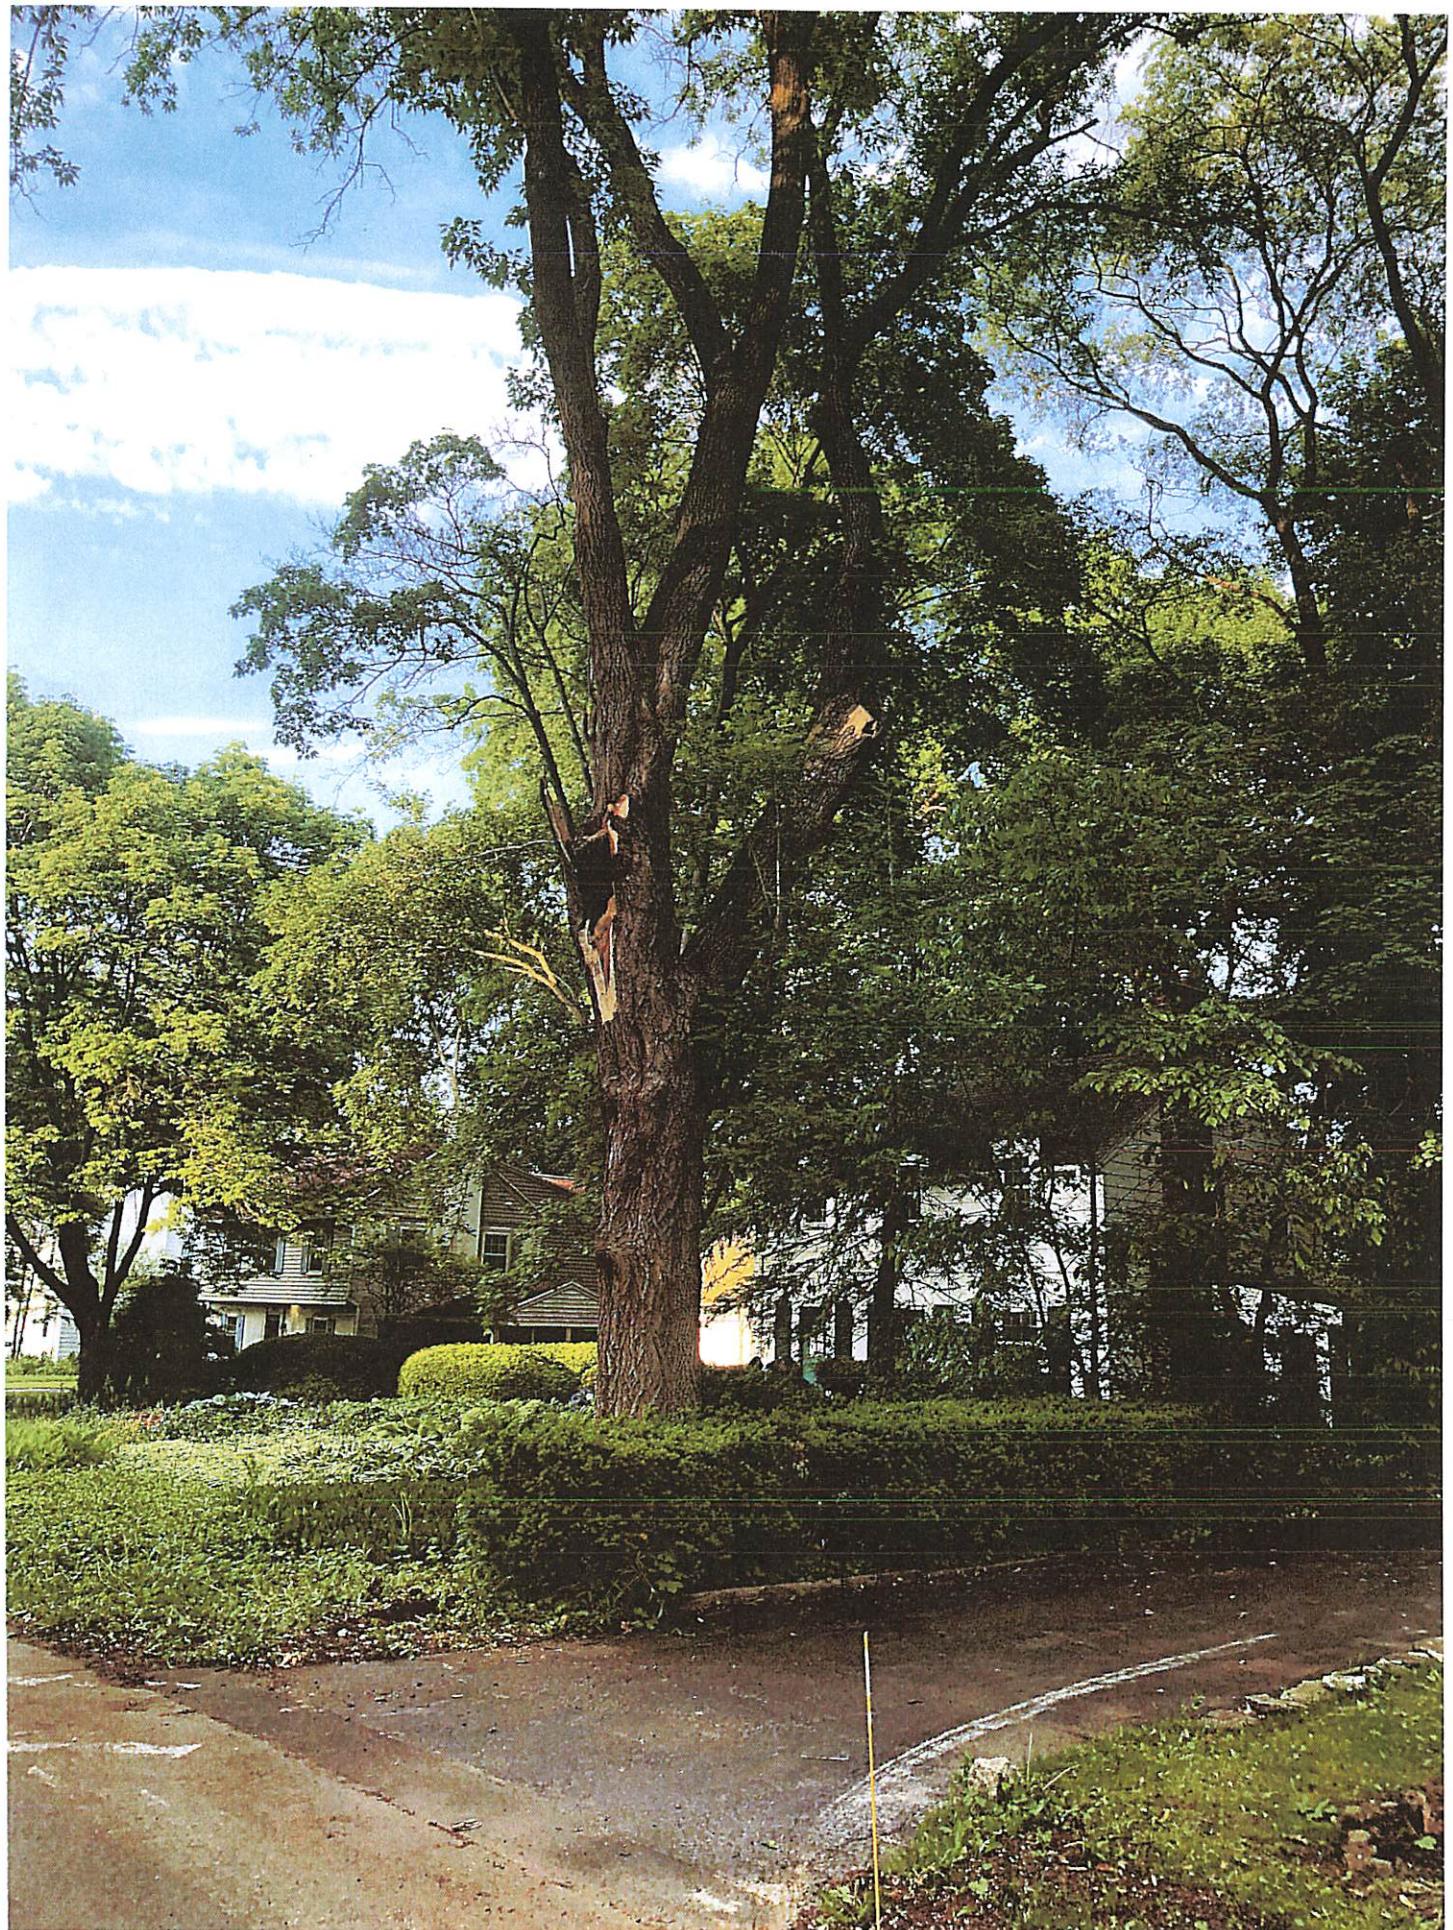
DEFECT	ROOT CROWN	TRUNK	SCAFFOLDS	BRANCHES
Poor taper				
Bow, sweep				
Codominants/forks		S		
Multiple attachments		S	S	
Included bark		M	M	M
Excessive end weight				
Cracks/splits		S	S	S
Hangers				
Girdling				
Wounds/seam				
Decay	M	S	S	S
Cavity				
Conks/mushrooms/bracket				
Bleeding/sap flow				
Loose/cracked bark		M	M	M
Nesting hole/bee hive	S	S	S	S
Deadwood/stubs				
Borers/termites/ants	S	S	S	S
Cankers/galls/burls				
Previous failure		S	S	S
