PUBLIC WORKS COMMITTEE MEETING

JANUARY 10, 2023 - 9:00 A.M.

DRAFT AGENDA

Re: *Stop Control at Idlewood Road and Poplar Way
Warrant Study*

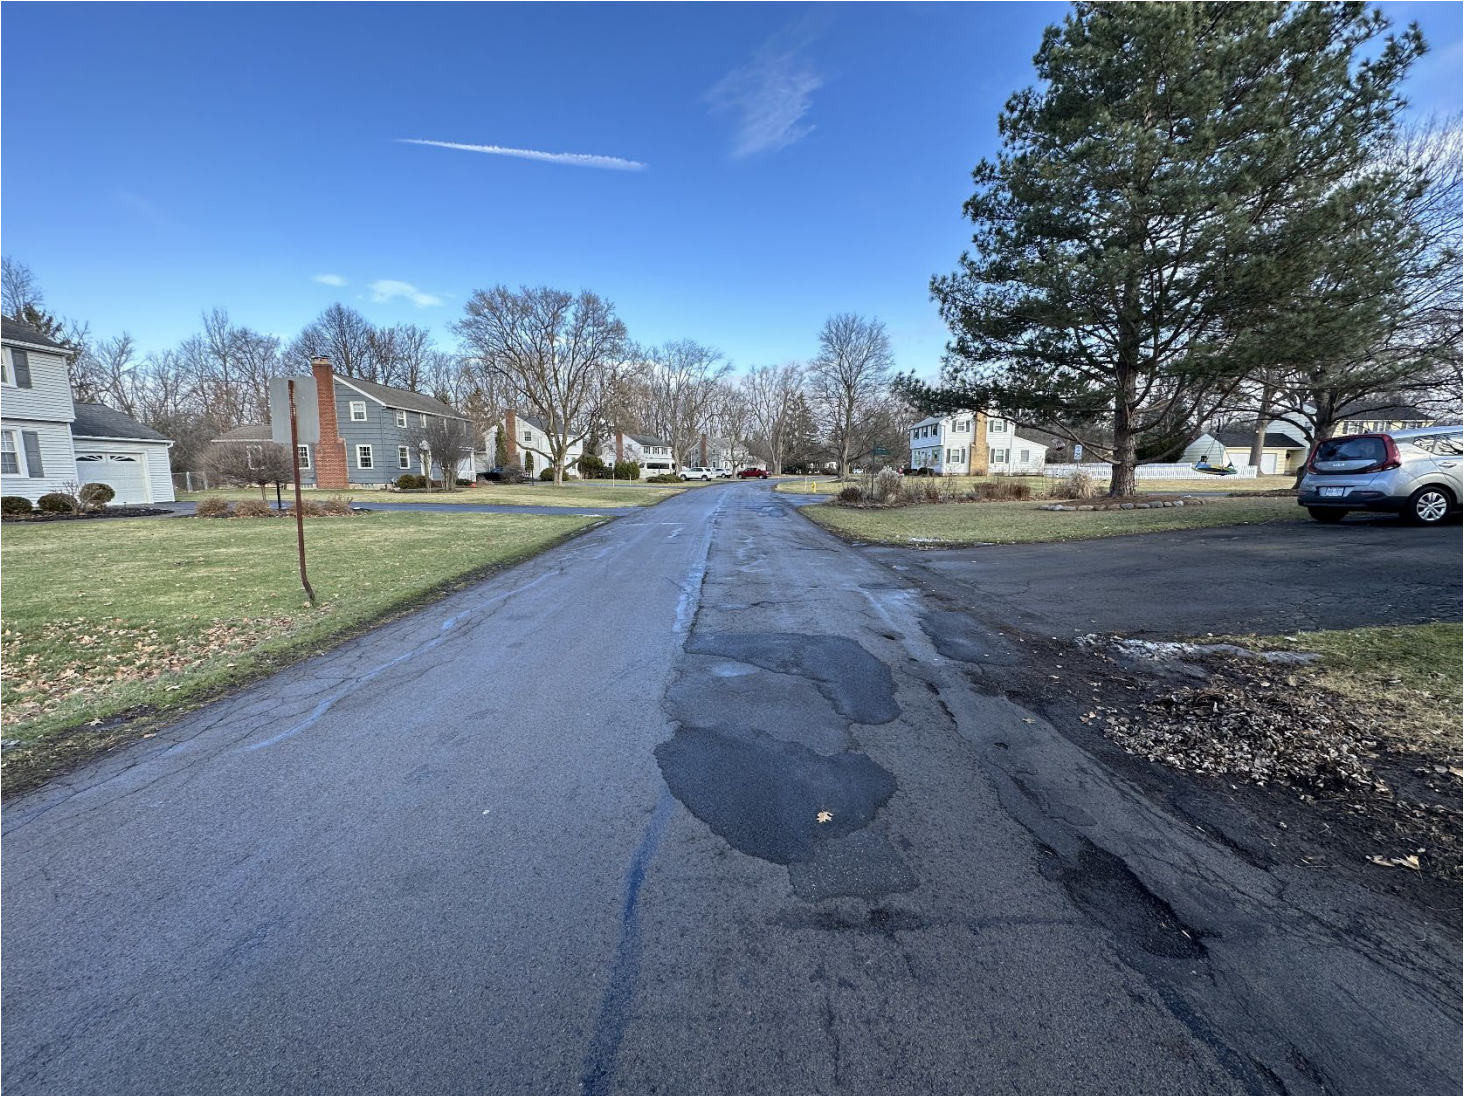
Figure 1- Idlewood Road NB

Historically, there haven't been concerns reported (to DPW) by local drivers about the ability to see conflicting traffic for any of the three approaches at this intersection. A recent inspection (see attached pictures) by this Department to the intersection in question confirmed that the approaches to the intersection are relatively free of visual restrictions that would require the road user to stop in order to adequately observe conflicting traffic. There are mature trees and decorative shrubs visible along the intersection approaches, however, they provide minimal visual impact to the road user's ability to see conflicting traffic.

1. The existing traffic conditions do not meet the warrants for a STOP control at the intersection of Idlewood Road and Poplar Way.
2. The MUTCD states that the use of YIELD or STOP signs should not be used for speed control. Research has shown that (a) the installation of STOP signs, while reducing roadway speeds immediately adjacent to

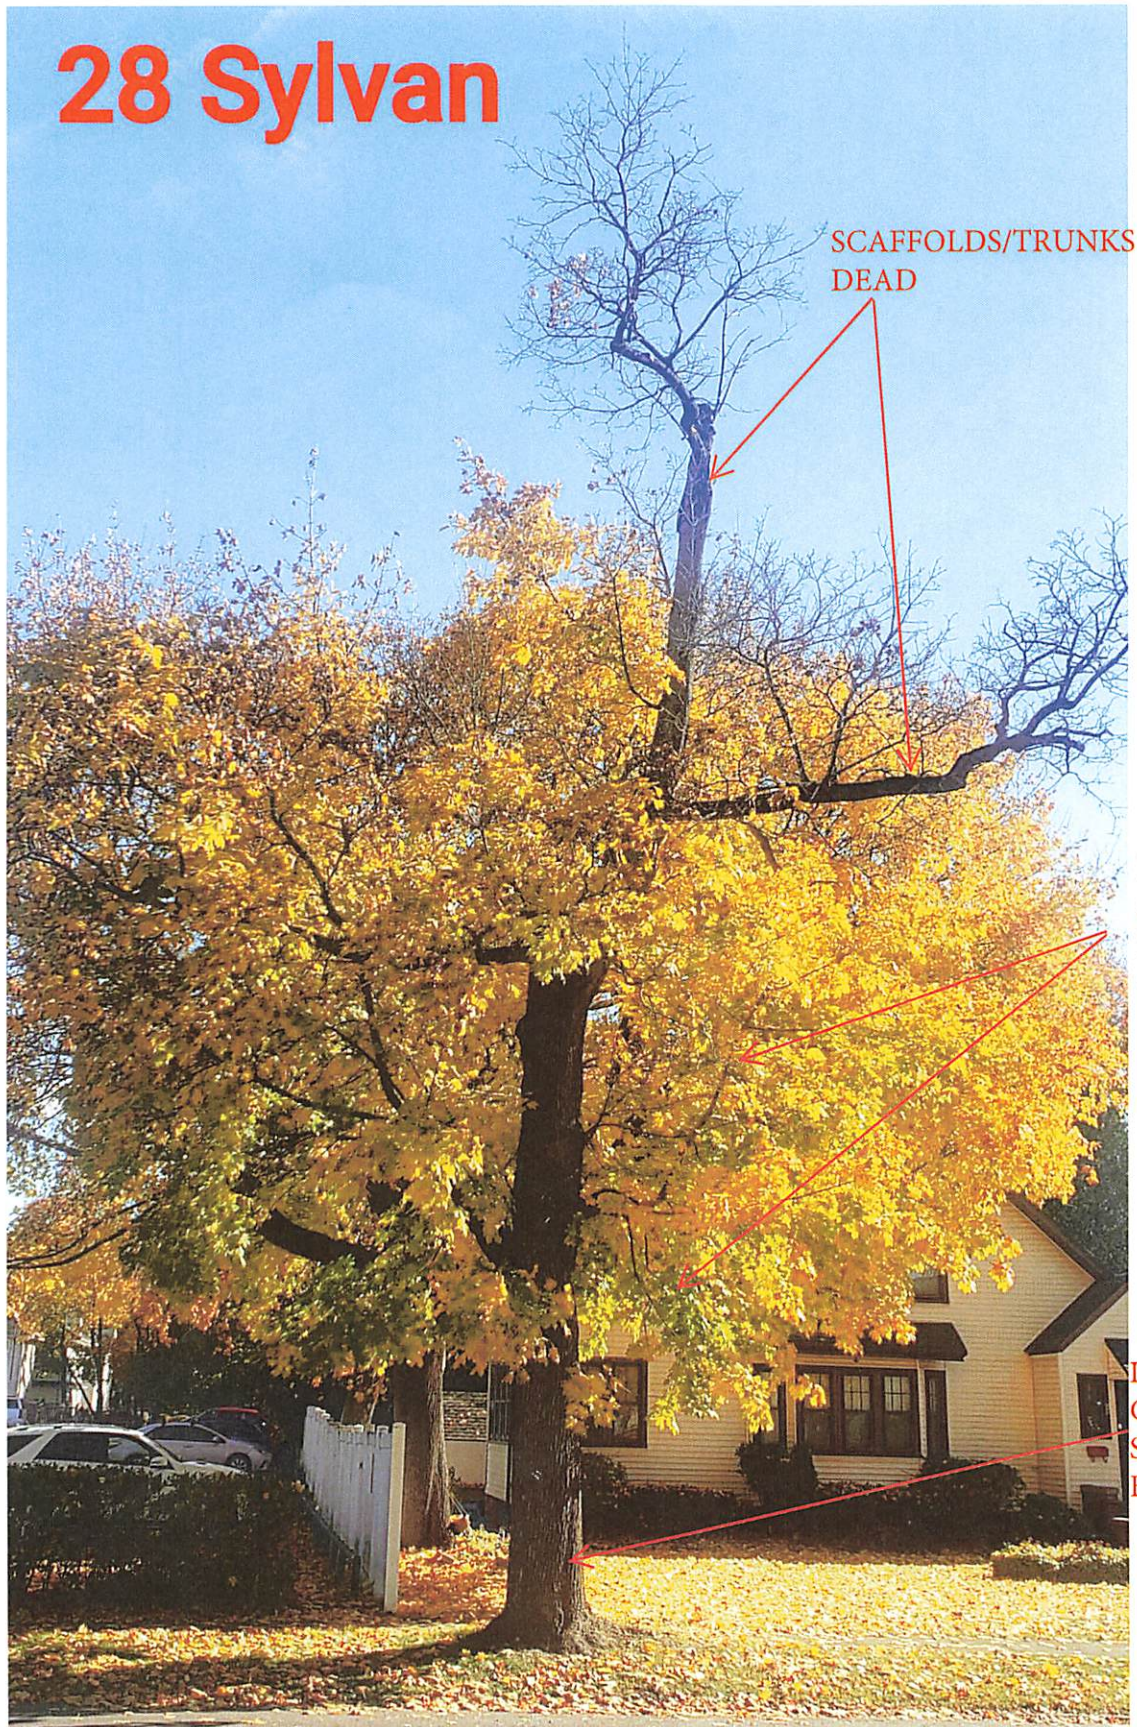
28 Sylvan

SCAFFOLDS/TRUNKS
DEAD

LEAVES ON
SMALL
BRANCHES
ONLY

LOOSE/
CRACKING/
SPLITTING
BARK

Remove tree: ☒ Y N Replace? ☒ Y N Move target: Y ☒ N Other: _____

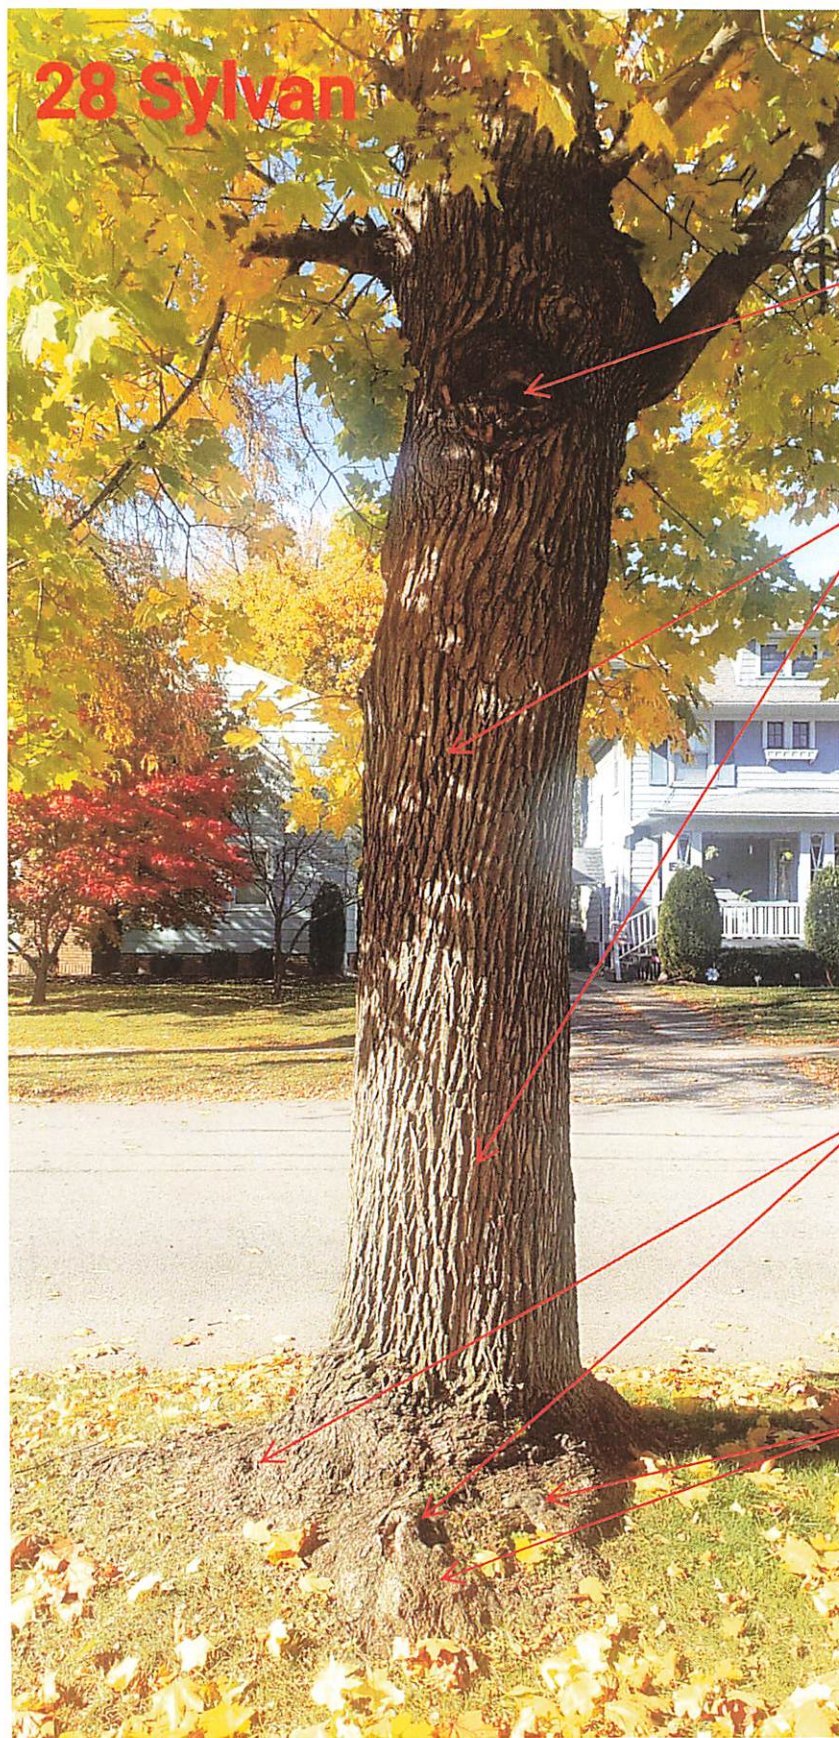
28 Sylvan

NESTING HOLE

LOOSE/CRACKING BARK

BORERS/TERMITES/ANTS
NESTING HOLE

GIRDLING ROOTS

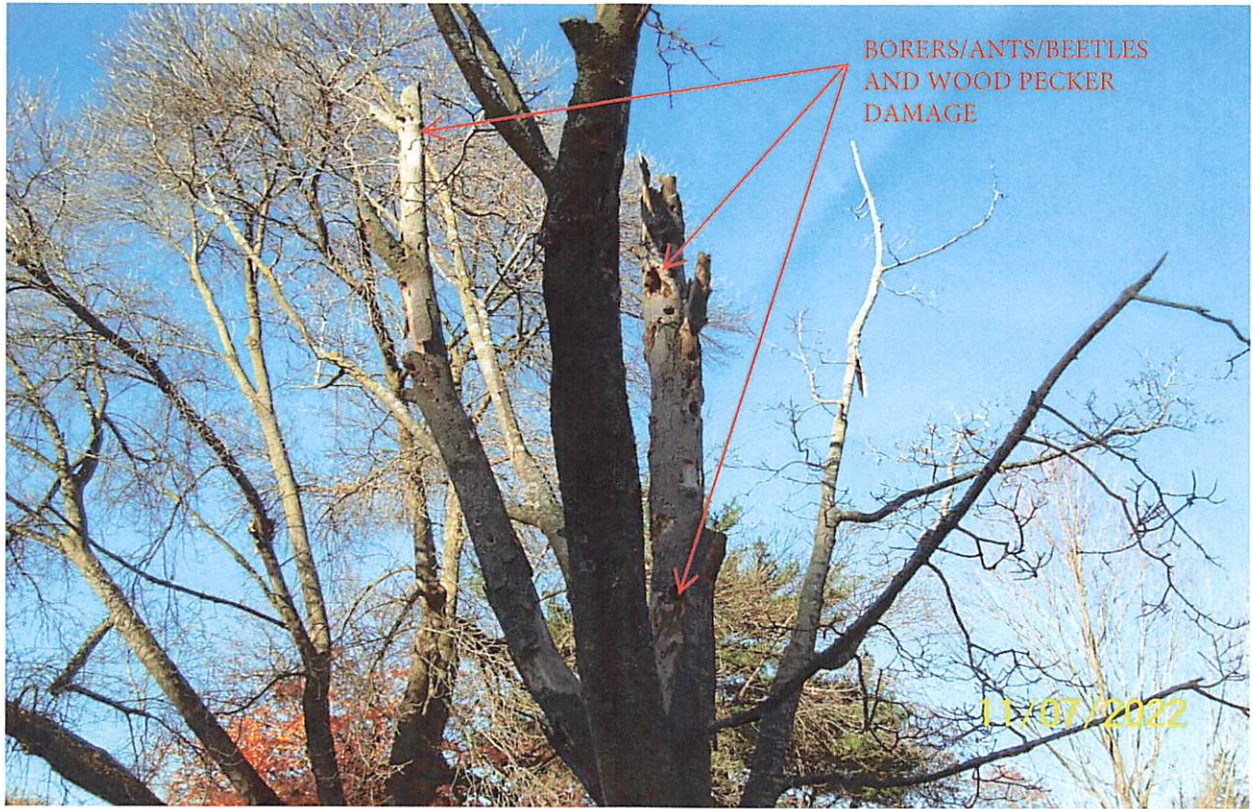
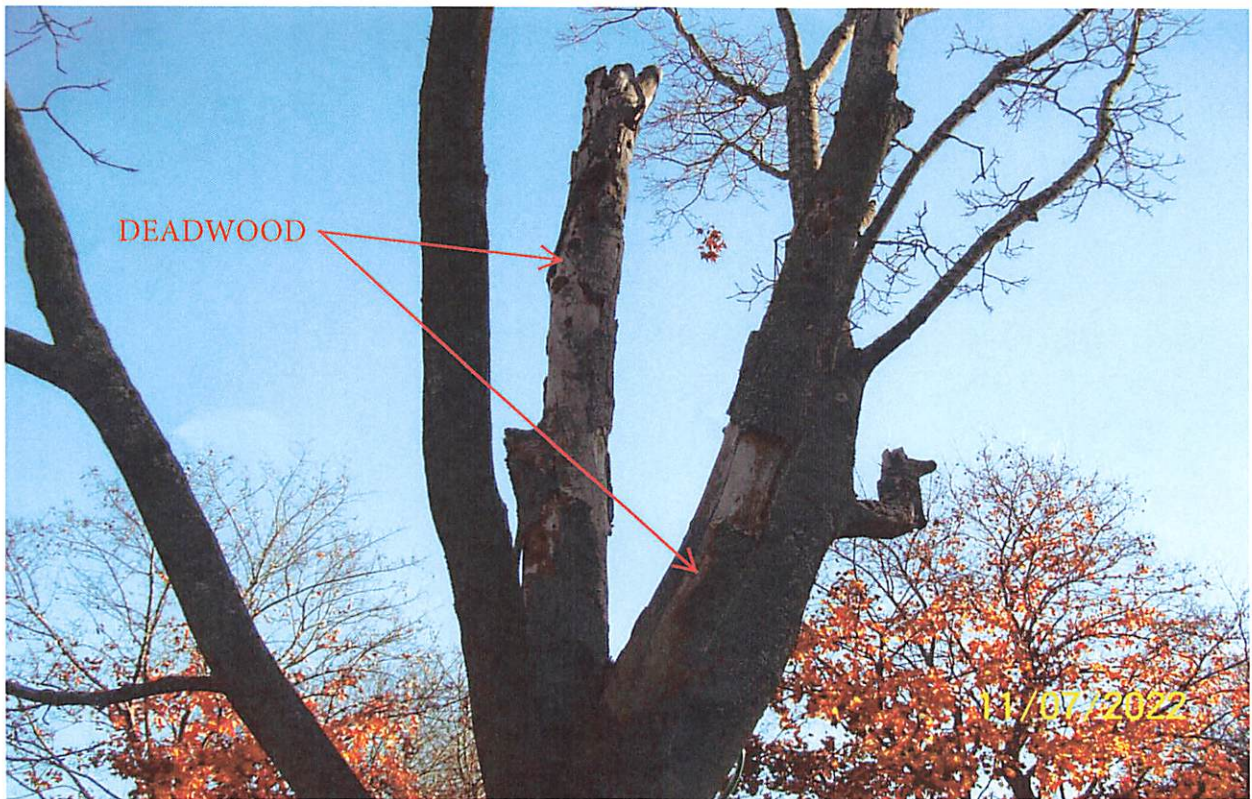
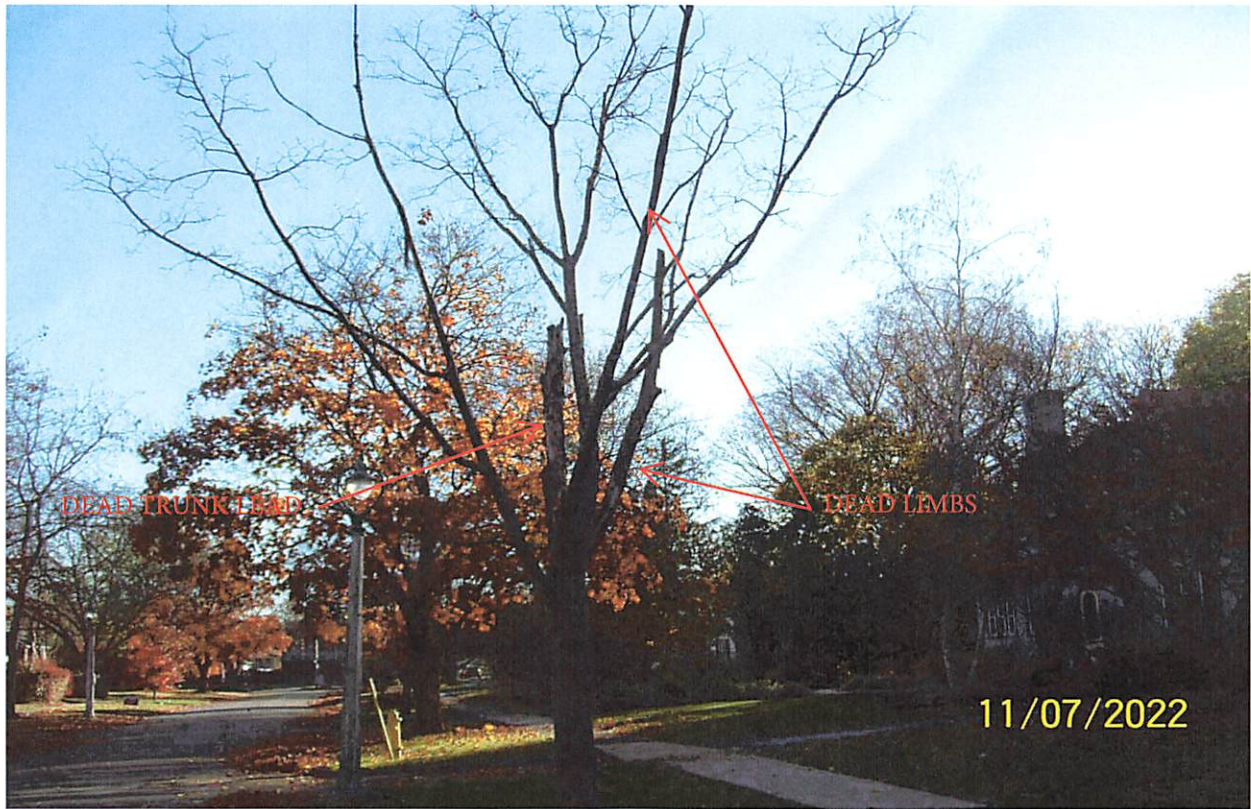
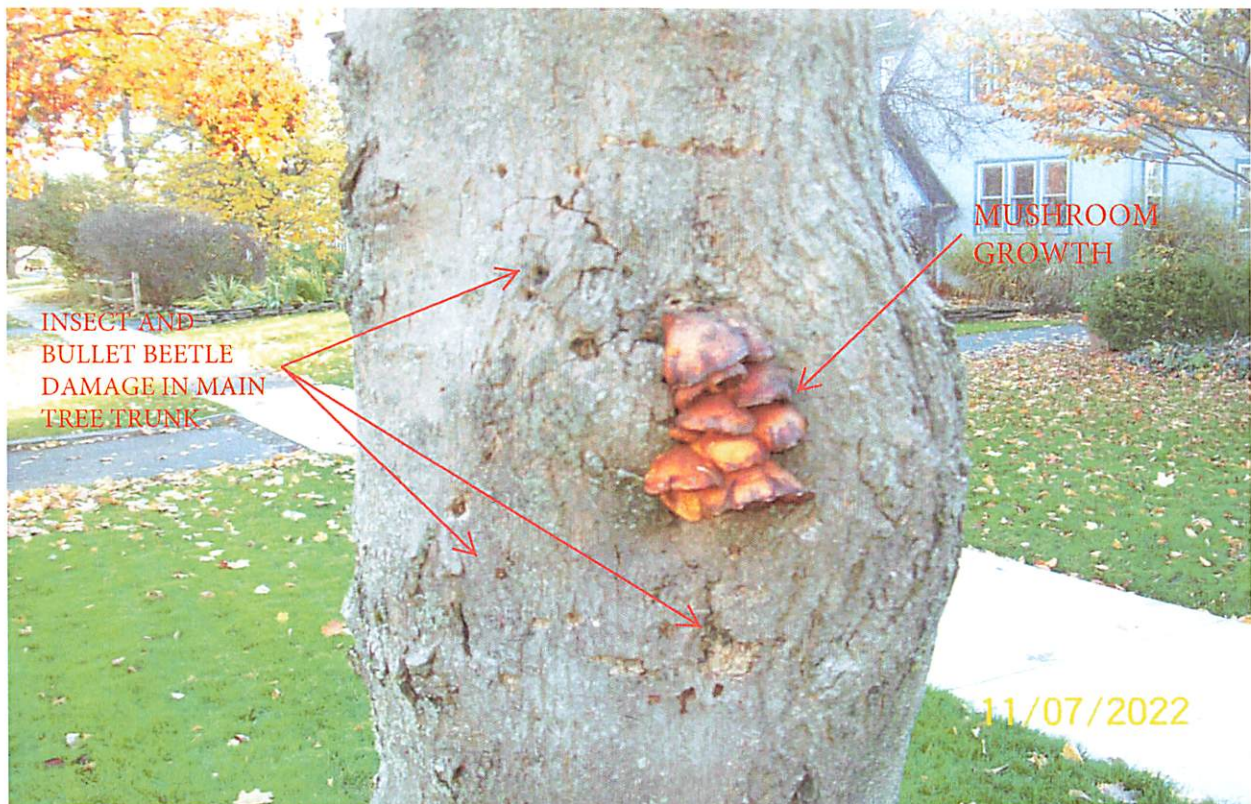
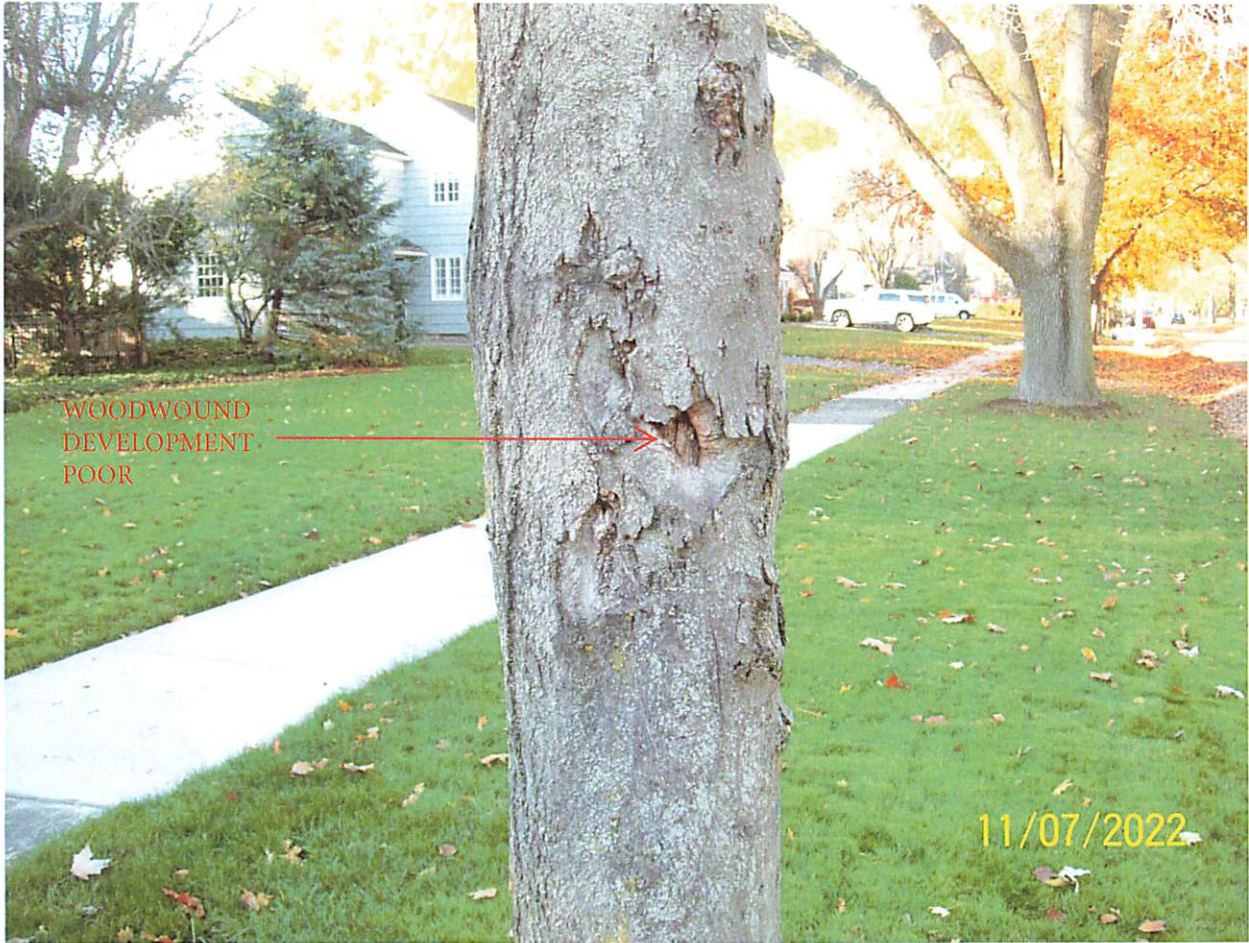
Foliage color: ☐ normal ☒ chlorotic ☒ necrotic Epicormics? Y N
 Foliage density: ☐ normal ☒ sparse Leaf size: ☐ normal ☒ small
 Annual shoot growth: ☐ excellent ☐ average ☒ poor Twig Dieback? Y N
 Woundwood development: ☐ excellent ☐ average ☐ poor ☒ none
 Vigor class: ☐ excellent ☐ average ☐ fair ☒ poor
 Major pests/diseases: Wood Pecker, ants & Beetle Damage, Fungus growing, DEAD TREE

DEAD Tree, Remove & Replace

WOODWOUND
DEVELOPMENT
POOR

Remove tree: ☒ Y ☐ N Replace? ☒ Y ☐ N Move target: Y ☒ N Other: _____
